UI BULLETIN # 76, REV. 1

SUBJECT: PTO (TCC Lockup) Inoperative
w/ Allison Automatic Transmission.

MODELS AFFECTED: Medium Duty C (Chevrolet
& GMC) C4500 – C7500 Series w/ 6.6L Diesel or 8.1L
Gas Engines and Allison Automatic Transmission.

Power Take-Off (PTO) Inoperative or Not Operating Properly (Check TCM Feedback Signal, Modify Wiring If Necessary) #06-08-131-001A - (May 08, 2006)

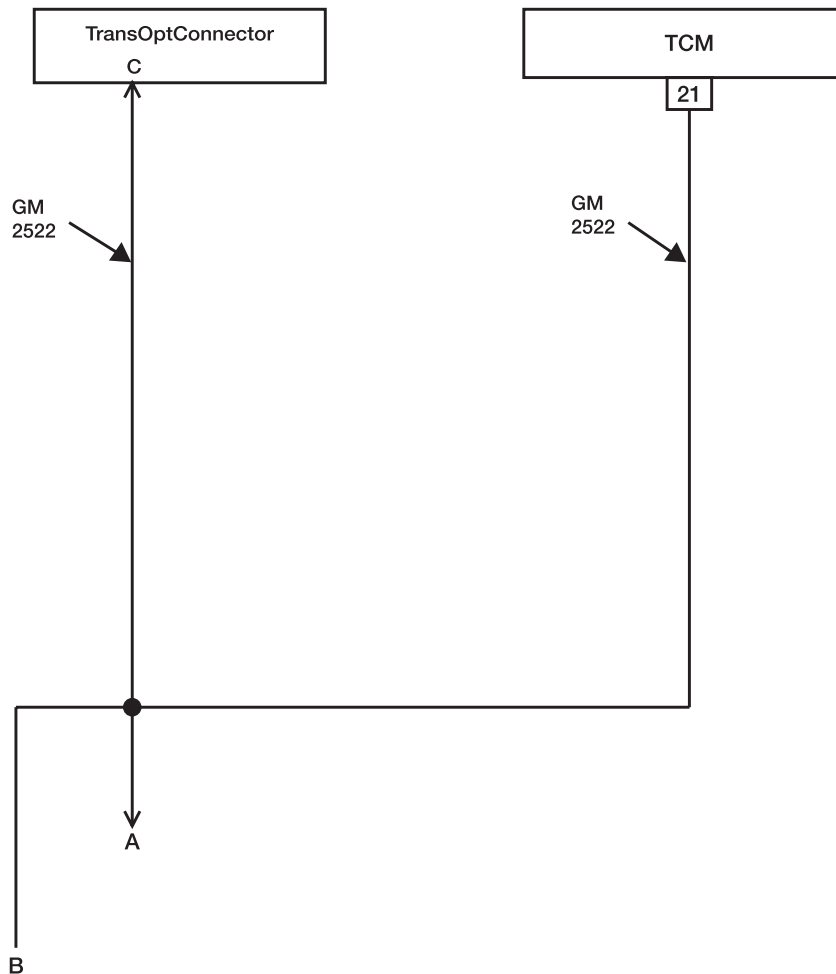
2006 Kodiak/TopKick PTO and Neutral Lockup Wiring - Allison 4th Generation Controls (As Received/Pre-Rework)

The transmission control module (TCM) may be damaged as a result of the wiring harness not being correct for PTO applications on the affected vehicles.

The illustration above shows the PTO feedback circuit for vehicles as built from the factory, without the required modifications. "A" is the PTO feedback to the ECM/PCM. "B" is Pin G of the Upfitter Connector on the vehicle harness (wire 2522).

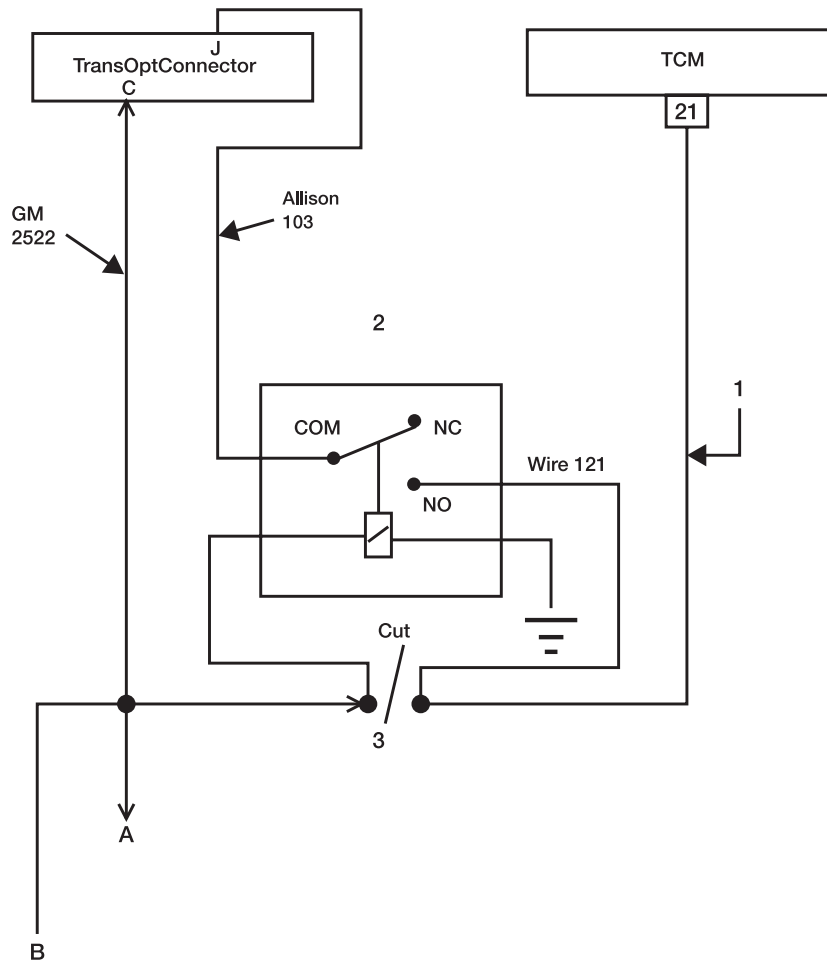
Feedback Circuit Modification Procedure

- (a) PTO feedback to the ECM/PCM
- (b) Pin G of the Upfitter Connector on Circuit 2522

The illustration above shows the modification required for vehicles that have a PTO installed and require TCC lock-up during PTO operation. The wire (circuit 2522) must be cut between TCM terminal 21 and PCM terminal J1-52 (L18 engine) or J1-08 (LLY engine). After cutting the wire, a relay must be installed as shown. With the relay installed, a high signal (12-volt) is sent to the PCM's feedback terminal and a low signal (0-volt) is sent to the TCM's feedback terminal, when the PTO is engaged. Refer to the procedures below to make the required modifications. The location for each step are also shown in the illustration.

1. This was originally GM wire 2522, if present. Remove the wire and terminal from the TCM or cut the wire as shown in the illustration. Connect the wire to the “Normally Open” terminal on the relay to Pin 21 on the TCM with the new wire if needed. Refer to Repairing Connector Terminals in the AFL/EPC Connector repair section of SI for information on connecting terminals to wires. If GM wire 2522 is not present, install a new wire between pin 21 on the TCM and “Normally Open” terminal on the relay. Now call this wire 121.

2. Add wire 103 from Pin J of the TransOpt connector to the common (COM) terminal of the relay.
3. Cut wire 2522 and connect to the relay as shown. Make sure that wire 2522 is cut close to the TCM so that the break is made between the TCM and splice point S121. refer to Splicing Copper Wires Using Splice Sleeves in SI. If the wires are too short, tape wire 2522 on the vehicle side of the harness to itself. Then run a new wire from Pin “C” of the TransOpt connector to the positive (+) side of the relay coil. Ground the other side of the relay coil to the chassis ground.
