UI Bulletin #123c

Subject: Roof Beacon (TRW) Switch Wiring Location/Access

Models Years Affected: 2014-19 Chevrolet Silverado 1500 LD
2014-19 GMC Sierra 1500 LD
2015-19 Chevrolet Silverado 2500/3500 HD
2015-19 GMC Sierra 2500/3500 HD
With option TRW

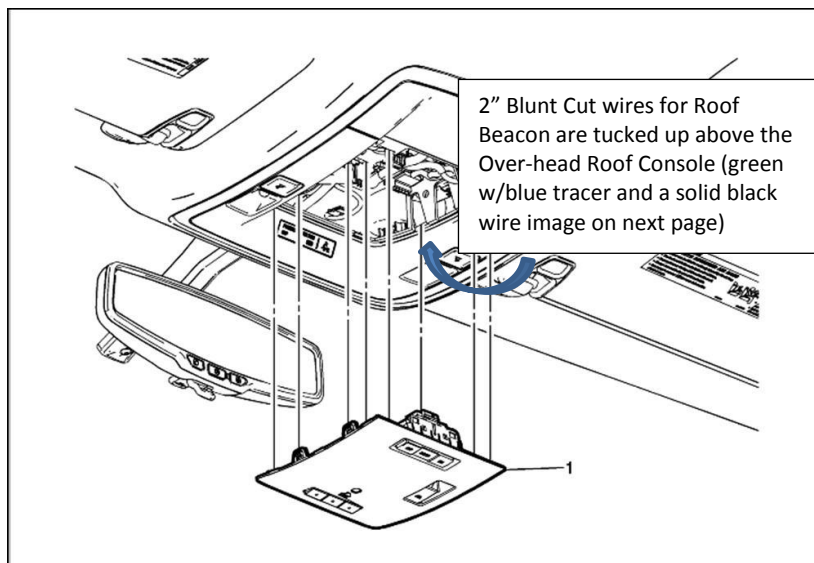
Roof Console Removal

Customer and Upfitters may made several inquiries in search of the location and access methods for the blunt cut wiring for the Roof Beacon provision option (TRW). NOTE: Blunt cut wires are only ~ 2 inches in length.

To access the blunt cut wires for the roof beacon, remove center section of the Roof Console as follows...

1. Use a flat bladed plastic trim tool in order to release the retainer clips securing the trim plate to the roof console assembly.
2. Disconnect electrical connections where/when required.

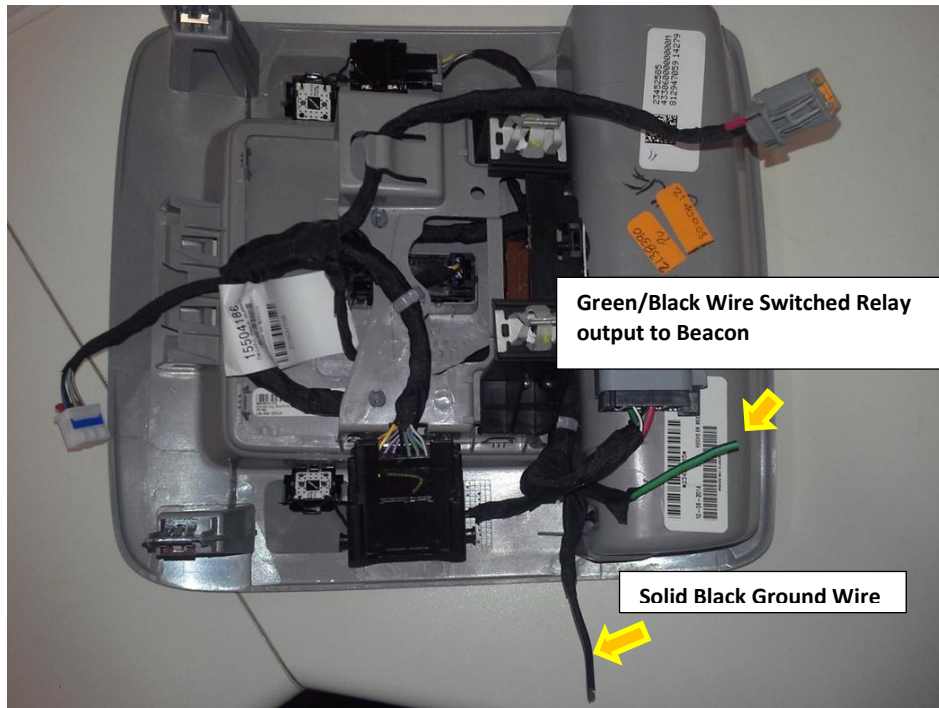
Top View of Removed Overhead Roof Console

Green/Black Wire Switched Relay output to Beacon

Solid Black Ground Wire
