UI Bulletin #126

Optimizing Vehicle Trim Height Subject:

Chevrolet Suburban HD SUV

Model Year: 2016 and beyond

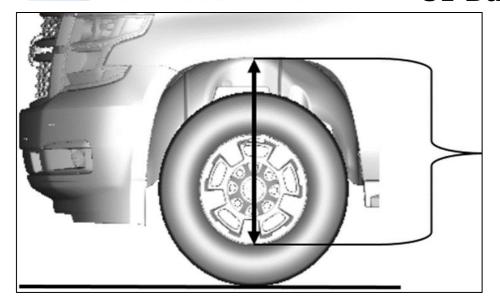
Figure 1

Trim Height: ("as received" value = "X" mm)

- 1. Ensure the vehicle is on a level surface, such as an alignment rack.
 - a. Set the tire pressures to the pressure shown on the Tire Placard label.
 - b. Ensure that the suspension is fully supporting the vehicle and is at rest
 - c. Ensure that the passenger and rear compartments are empty, except for the spare tire.
- 2. Remove wheel center cap.
- 3. Measure the "as received" vehicle trim heights from the bottom of the wheel to the top of the wheel opening as shown in figure 1.
