General Motors Upfitter Integration

UI Bulletin 102d

Auxiliary Battery Connections

Models Chevrolet Express/GMC Savana Cutaway

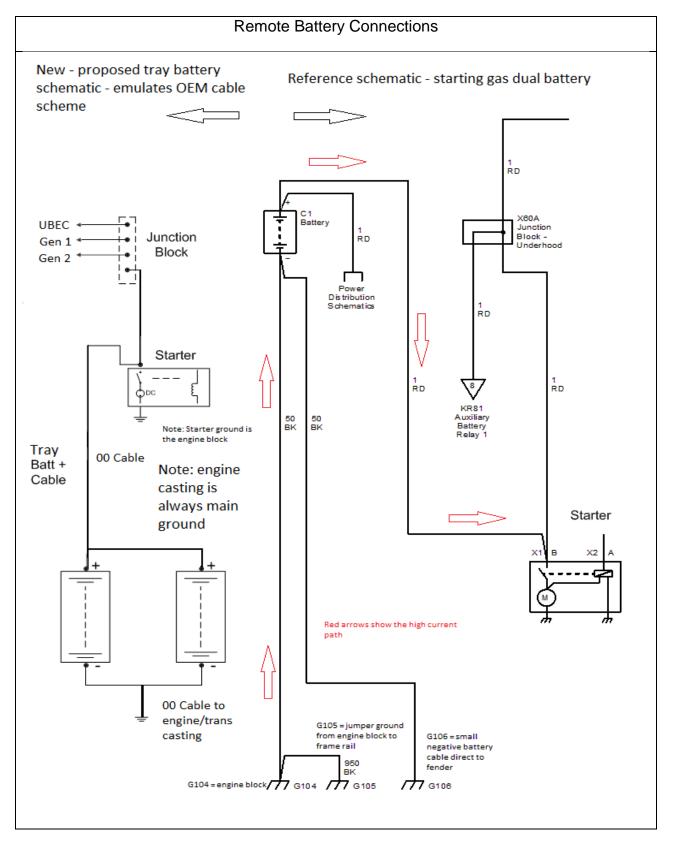
It is essential that the negative ground return path is not compromised. Merely grounding the tray batteries to the frame WILL NOT WORK. Extra care must be used to assure adequate current flow path to the engine/transmission castings. The high current path is from the battery negative terminal to the starter motor casting. The engine block is main ground and the frame and body are secondary. The OEM frame grounding is not sufficient if the frame is used as 'part of the negative battery cable.' and the additional cable to the engine/trans casting is required for this case. The body grounding cable must be maintained in all cases.

- [a] The first and "most recommended" method for remote battery positive cables is a jumper between the battery terminals with a single main 'home run' cable to the starter motor solenoid terminal.
- [b] Connections to generators and main electrical center should be made at the starter motor solenoid [most recommended].
- [c] If the stacking of multiple cables on the starter solenoid stud is a problem a single main cable to a junction block may be indicated. The junction block can facilitate the required connections for the generator[s] and main electrical center.
