Intermittent Cluster, Radio and HVAC Display

Subject: Resets on Snow Plow Trucks

Models/Years 2014 - 2018 Chevrolet Silverado 1500 LD

Page 1 Bulletin #124k November 7, 2019

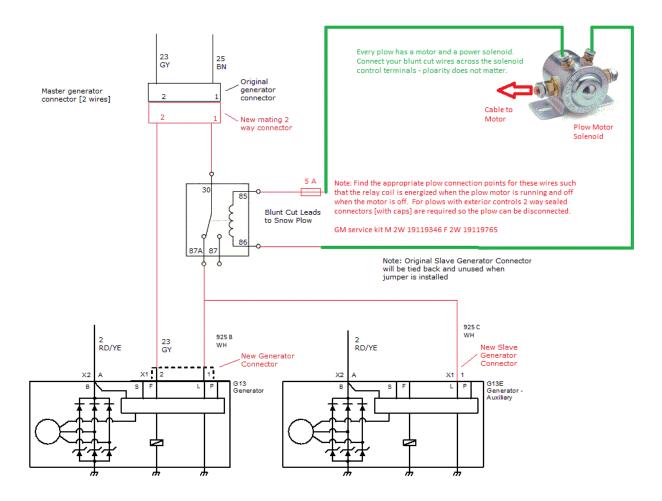
#### Fig 1: Jumper harness wiring schematic

#### VYU Service Harness for both single and dual generator trucks

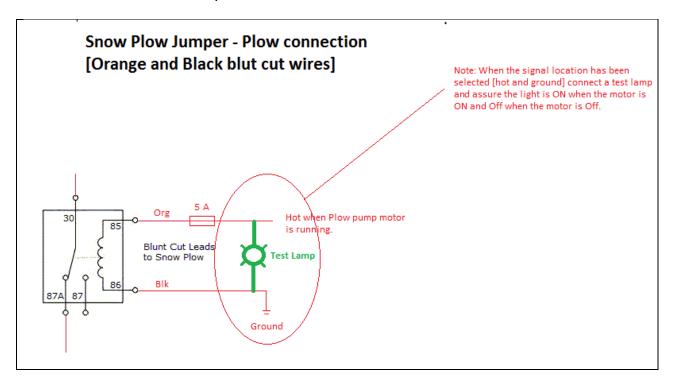
**Note:** To identify the signal needed by the jumper harness perform the following test. Any connection point that passes this test can be used. The best case is a signal from the wiring that remains with the truck but if that is not found then the signal must be found out on the plow itself.

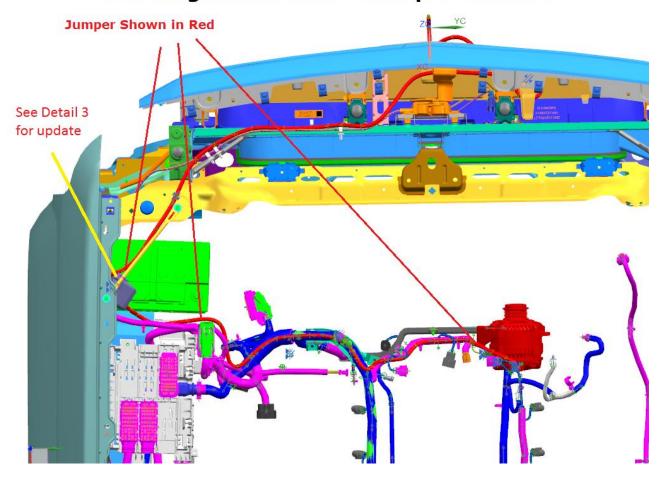
Fig: 3a Jumper Harness Layout – single alternator [see detail 3 for updated relay mounting]

# **VYU Single Alternator - Jumper Harness**

- a) Unplug the 2-way connector on the alternator.
- b) Identify the master alternator connector [at the very tip of the harness when it is fully extended]. Insert it in the alternator.
- c) Take the original alternator connector and plug it into the mating jumper harness connector.
  Note: In this case the second alternator connector will be unused and will remain capped and tied to the harness bundle.

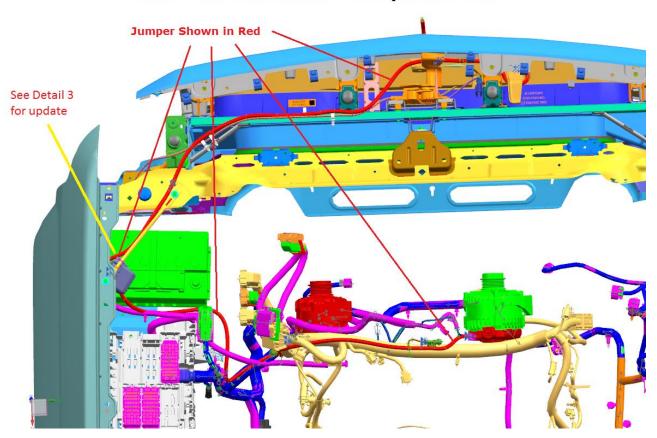
Fig: 3b Jumper Harness Layout – dual alternator [see detail 3 for updated relay mounting]

## **VYU Dual Alternator - Jumper Harness**

- a) Unplug the control connectors on both alternators.
- b) Identify the master alternator connector [at the very tip of the harness when it is fully extended]. Insert it in the 'master' alternator on the RH side of the engine.
- c) Identify the 'slave' alternator connector on the jumper harness and insert it in the LH 'slave' alternator. Insert the removed LH alternator connector into the [unwired] cap on the jumper harness.

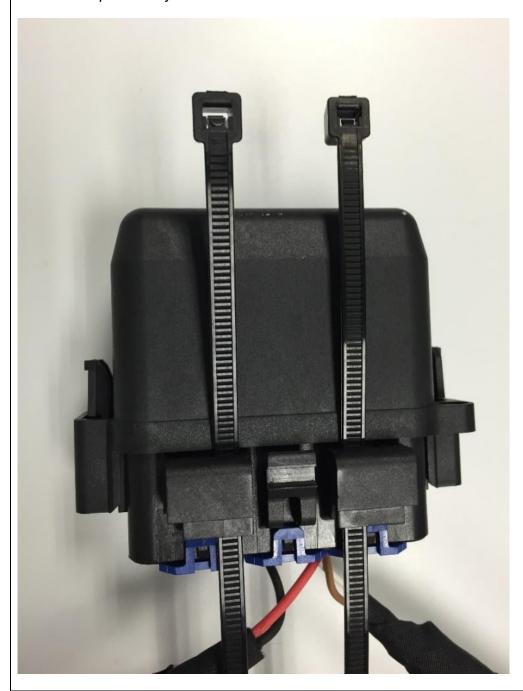
## **Detail 3.1.1**

Details 3.1.1-3 apply to service part and not the factory included [loose shipped] part.

i) Route the snow plow jumper harness along the existing harness routing where possible and secure the relay center with tie straps as shown in Details 3.1.1-3. Allow slack for engine roll and upright orientation of the relay center to prevent water intrusion/collection.

Add tie straps to relay

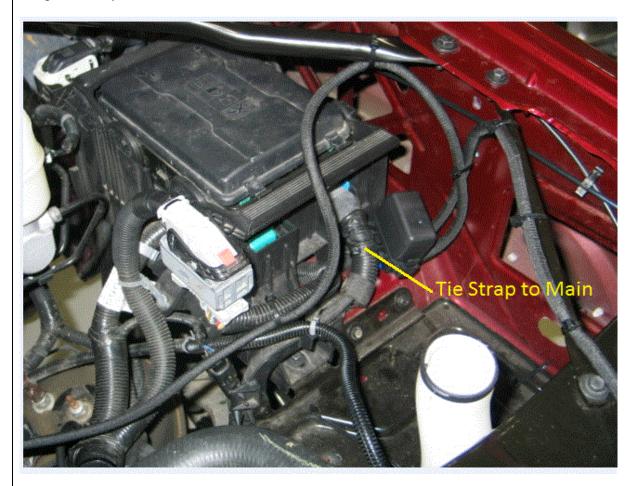
## **Detail 3.1.2**

Single Battery Trucks

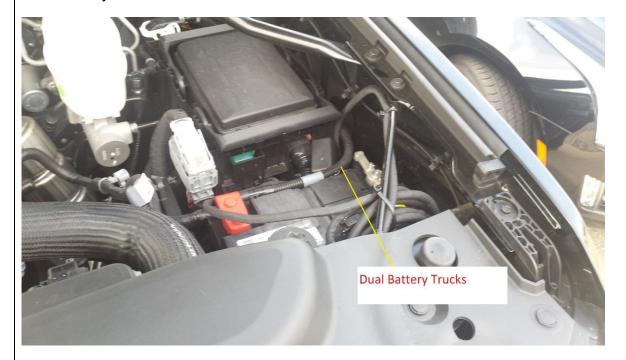
## **Detail 3.1.3**

**Dual Battery Trucks**

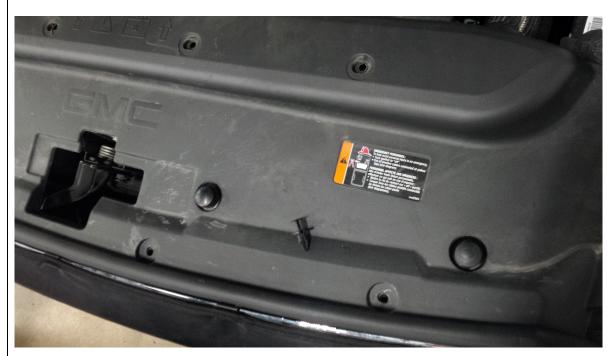
## **Detail 3.2.1**

The following details 3.2.1 – 7 apply only to trucks that came with harness components [loose shipped] from the assembly plant.

Remove the Radiator Air Upper Baffle and Deflector.
