General Motors Upfitter Integration

UI Bulletin #134

Subject:Guidelines for Diesel Fuel Filler Neck
Assembly & InstallationModels Years
Affected:2016 MY and beyondModelsChevrolet Low Cab Forward Trucks
Equipped with a diesel engineOrigination
Date:October 7, 2016N/AN/A

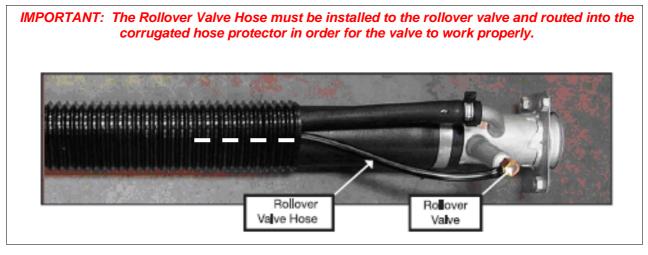
FUEL FILLER NECK ASSEMBLY

The Upfitter should familiarize themselves with the diesel fuel filler assembly as shown below for proper fuel filler neck installation.

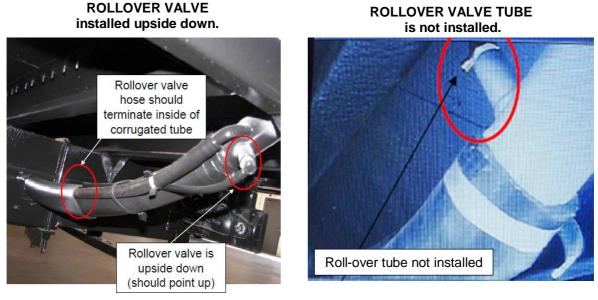
INCORRECT INSTALLATION

Improper installation of the fuel filler neck assembly may result in unwanted materials entering the fuel tank, contaminating the fuel system. Fuel contamination may lead to failures such as plugged fuel filters, poor engine performance, check engine light illumination, fuel system (lines and tank) corrosion (rust), and more.

Fuel filler neck installations shown below will result in fuel contamination.

The fuel filler neck must be installed with proper orientation on the body. The neck should be installed with the roll-over valve pointing upward as shown. The bottom edge of the neck mounting flange must be parallel to the ground. See above photo for reference.
