UI Bulletin #154

Upfit Body Mounting / Chassis Wiring Harness Subject:

Chevrolet Silverado/GMC Sierra 3500 HD Models:

Model Years: 2011 and Beyond

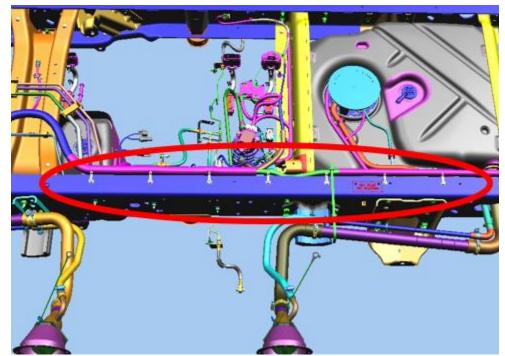
Care must be taken when installing upfit bodies on the rear driver's side chassis to allow clearance to wiring harness/attachments. Wiring Harness `Service Access' could be compromised when mounting an upfit body. Upfit Body mounting provisions should not pinch or lock in the OEM harness/attachments.

Figure 1 Harness Area of Concern

Upfit body mounting practices and provisions should allow for service of chassis wiring harness/attachments.

If the upfitter chooses to relocate the harness inboard, they're responsible for the proper securing and protection of the harness. Similar OEM harness support intervals should also be utilized. Care should be taken so harness does not chafe sensitive chassis lines, components and modules.
