**Subject:** Fuel Cap Tether Strap

**Models:** Chevrolet Express/GMC Savana  
Cutaways with a service body installed

**Model Years:** 2012 and beyond

**Date:** December 13, 2012

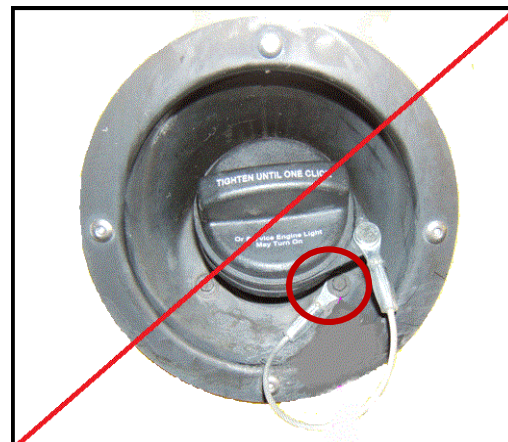
Not This

A condition may be caused by the fuel cap tether binding when installing the fuel cap and not allowing the fuel cap to seal completely or by the fuel cap tether being trapped between the fuel cap seal and the fuel fill pipe, not allowing the fuel cap to seal completely, possibly resulting in a Service Engine Soon Light being illuminated.
