# UI Bulletin #108d

**Subject:** Aftermarket ALDL or DLC Interface Devices Causing Multiple Issues

**Models Affected:** All Passenger Cars and Trucks

**Model Years:** 2006 and beyond

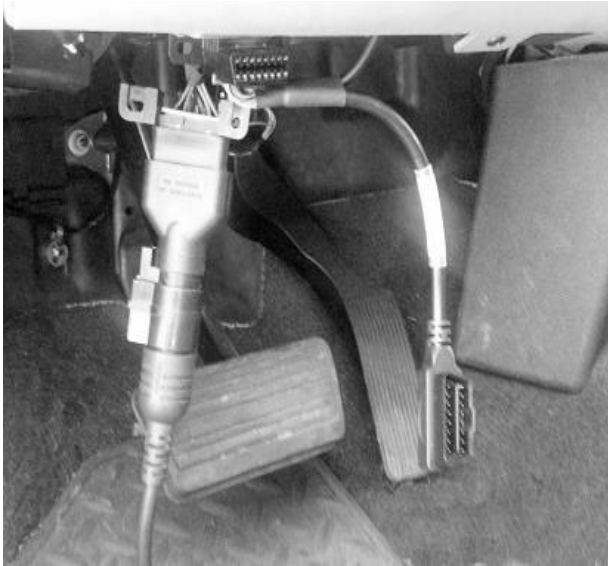
### [Device W/Secondary DLC Connector](#)

This device has another DLC connector on it. The rest of the harness along with the device can be placed out of sight hidden from the technician, who may not notice the diagnostic connector is not in the factory location.

If SI diagnostics do not identify the source of the issue and if the device is available, attempt to duplicate the condition, and then remove the device to determine if the condition is eliminated.
