UI Bulletin #110N

Subject: **Upfitter Auxiliary Switches (RPO 9L7)**

Models Affected: Chevrolet Silverado
GMC Sierra Light Duty Models (1500-3500) *
(does not include the new 1500 series body styles)

Model Years: 2014 – 2019

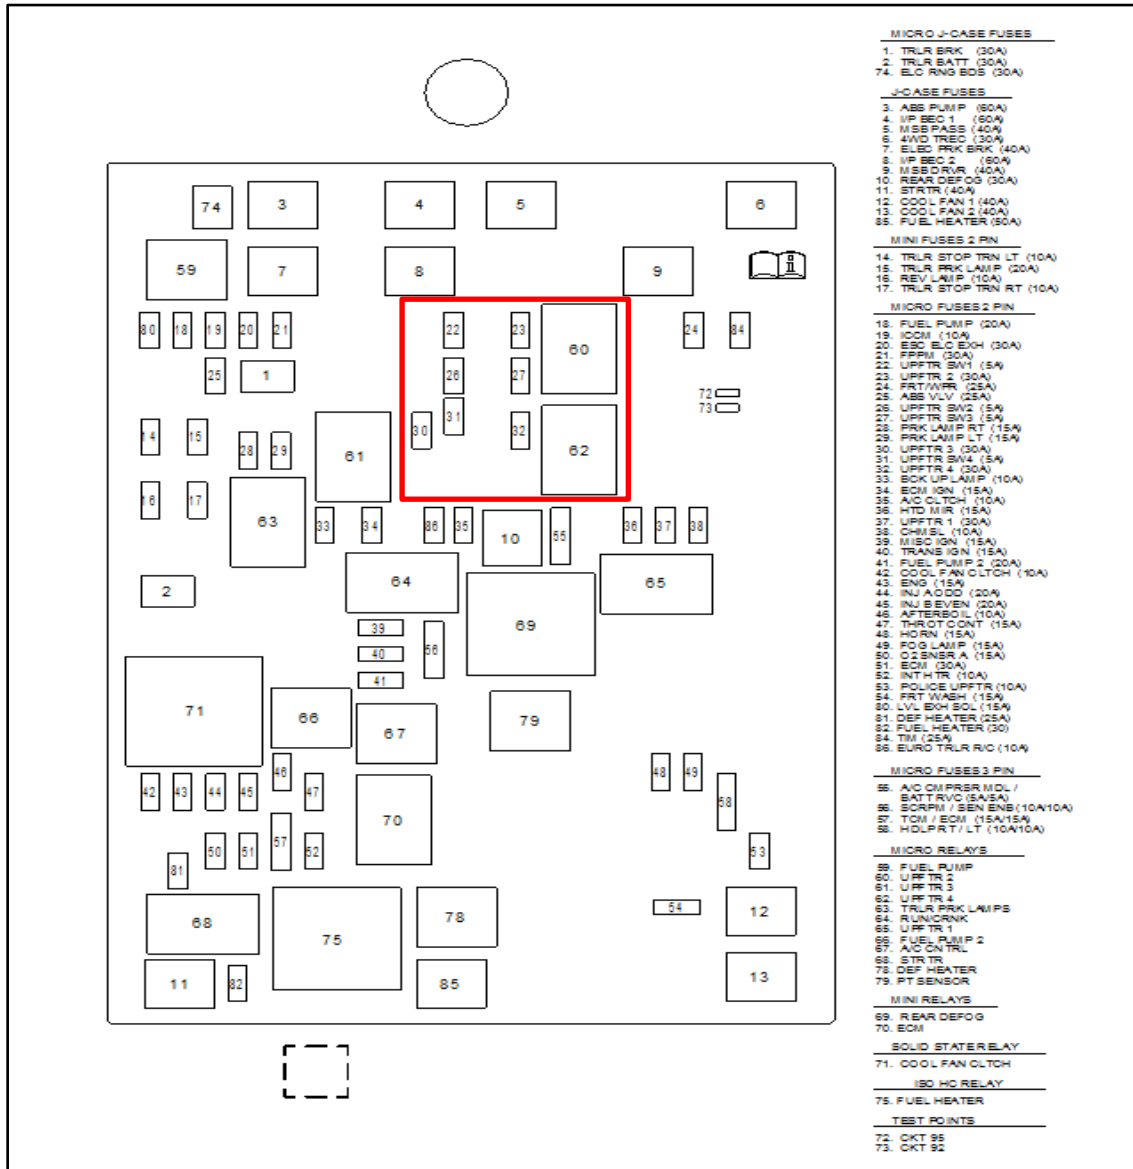
NOTE: The red squared area in Figure 5 reflects the fuses involved in the possible fuse reconfiguration used for the powering of the AUX switches.

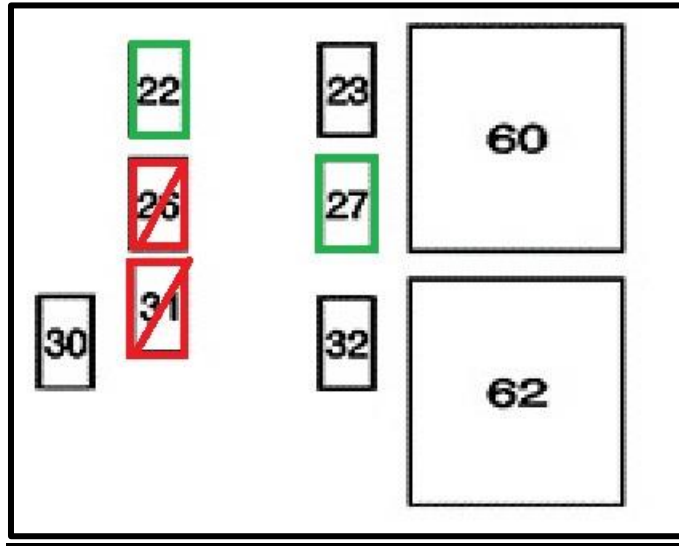
Figure 6 shows the fuses configured for all switches (1, 2, 3 & 4) for battery powered. This is the default fuse location from vehicle manufacturing (note fuse locations 26 & 31 are unpopulated).

Never populate both fuse locations for either pairing of AUX switches. This is to mean do NOT install fuses in both locations of 22 and 26 or in both locations of 27 and 31.

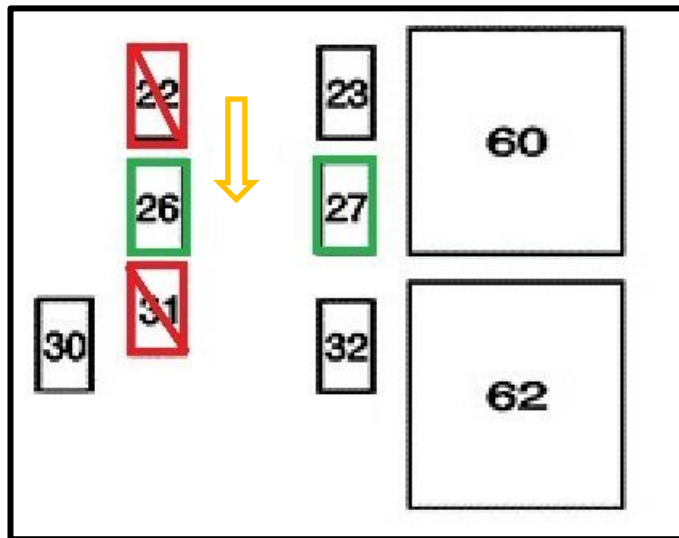
Figure 7 shows the fuses configured for switches 1 & 2 to be Ignition powered and switches 3 & 4 being battery powered. This configuration is accomplished

by **MOVING** the fuse from location 22 **TO** location 26 (leaving locations 22 & 31 unpopulated)

Never populate both fuse locations for either pairing of AUX switches. This is to mean do NOT install fuses in both locations of 22 and 26 or in both locations of 27 and 31.

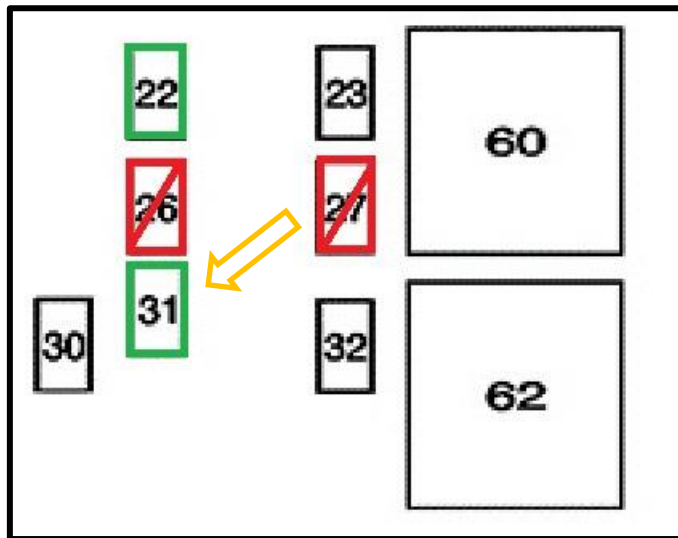
Figure 8 shows the fuses configured for switches 1 & 2 to be Battery powered and switches 3 & 4 being Ignition powered. This configuration is accomplished by **MOVING** the fuse from location 27 **TO** location 31 (leaving locations 26 & 27 unpopulated)

**CAUTION:**
 Never populate both fuse locations for either pairing of AUX switches. This is to mean do NOT install fuses in both locations of 22 and 26 or in both locations of 27 and 31.

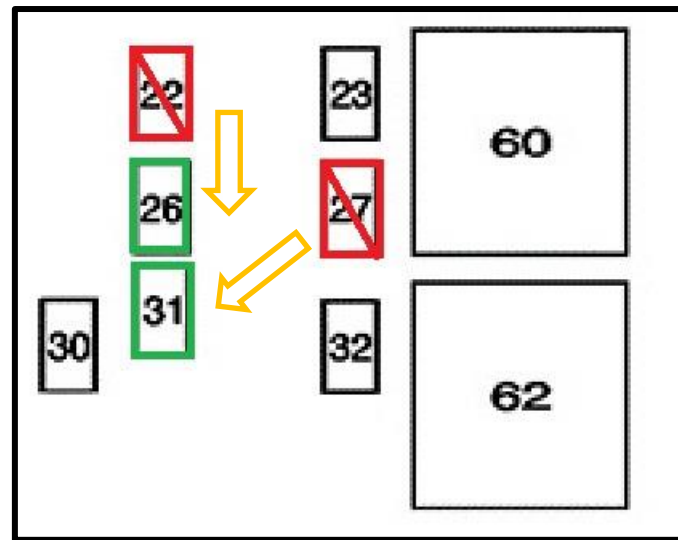
Figure 9 shows the fuses configured for all switches (1, 2, 3 & 4) to be Ignition powered. This configuration is accomplished by **MOVING** the fuse from

location 22 **TO** location 26 and **MOVING** 27 **TO** 31 (leaving fuse locations 22 and 27 unpopulated)

**CAUTION:**
 Never populate both fuse locations for either pairing of AUX switches. This is to mean do NOT install fuses in both locations of 22 and 26 or in both locations of 27 and 31.
