General Motors Upfitter Integration

UI Bulletin #115f

Subject: Upfitter Circuit Provisions

Models
Affected:Chevrolet Silverado
GMC SierraModel Years:2014 and BeyondDate:March 20, 2014Revision
Date:January 12, 2018

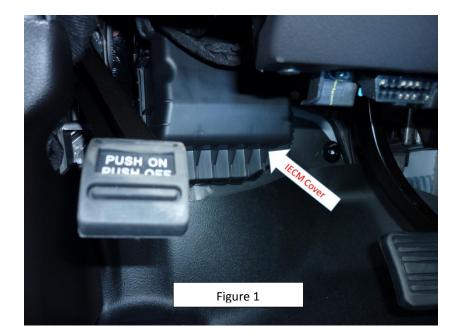
Commonly utilized circuits are available for use in the ICEM (formally referred to as the Mid-BEC or MBEC) which is located in the LH foot well, near or below the parking brake mechanism (see figure 1)

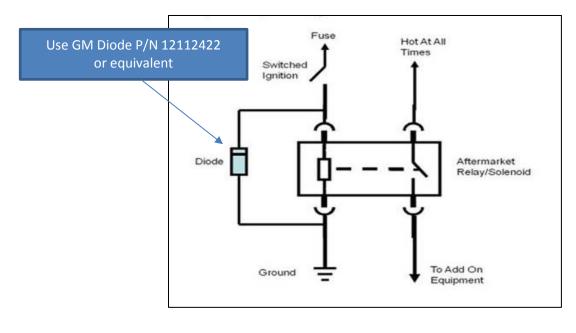
To prevent damage to electronic components from voltage spike, use of a diode as shown below is recommended. Components damaged by voltage spikes from added after-market equipment is not covered by the vehicle warranty

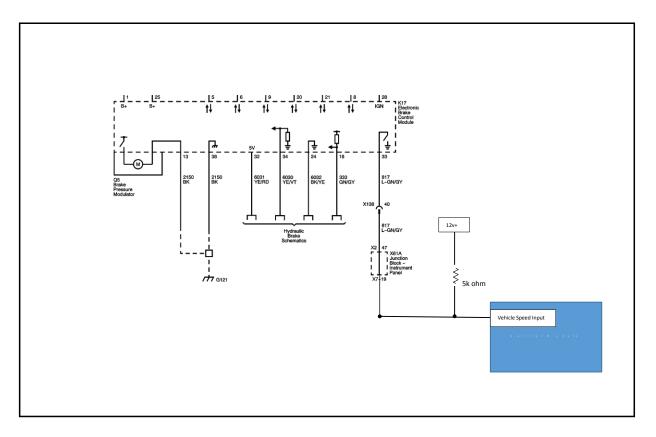
Vehicle Speed Signal Circuit

If your device to which you are providing a Vehicle Speed signal to requires a pulse high you will need to add the mechanization above. The EBCM will pull a high low, but does not provide any high signal. The above will give the high for the EBCM to pull low and when release will provide the upfitter device a high signal when the EBCM releases the circuit. This "pulse" occurs at a rate of 4000 pulses per mile (4k PPM).
