## **General Motors Upfitter Integration**

## **UI Bulletin 116b**

**Snow Plow Lamp Activation**

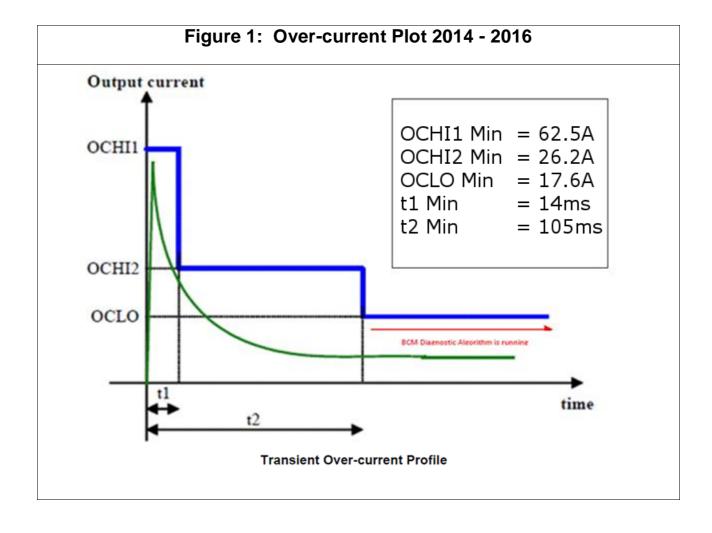
The plots below show the expected 'actual' headlamp current vs the 'over current' limits at headlamp activation. The BCM expects to see a a single 'high current inrush and decay event' [current spike] as is normal with both incandescent and HID headlamps. If the headlamp circuit is switched [disconnected and then reconnected] after initial turn ON the subsequent [later] current spike may cause the diagnostic to turn the lamp off. Each time the headlamp is turned ON the diagnostic runs and a single current spike occurs. However, once normal running current is reached if a [later] second current spike occurs the BCM may turn off the lamp to protect the driver chip. Switching or interrupting the headlamp circuit causes current spikes. High current is not expected after lamp warm up and 'looks like' a short circuit.

For best results, switch lights to Park or OFF before connecting the electrical plugs when mounting the plow. This avoids current surges that could cause headlamp low beam shut down. Once the plow lights are connected the headlamps may be turned back ON.

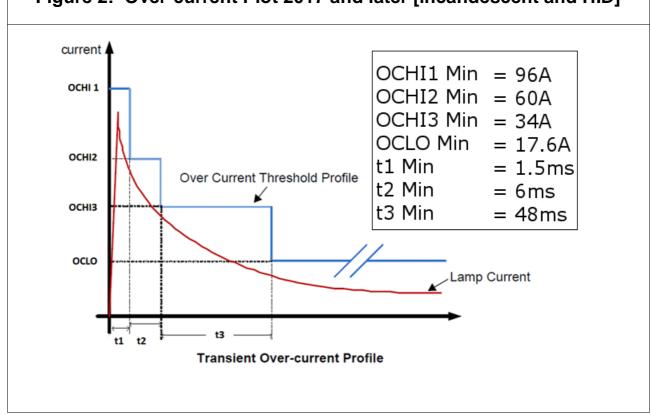
Figure 2: Over-current Plot 2017 and later [incandescent and HID]

Later version trucks have limited 'retry' provisions in the headlamp lamp diagnostic which renders the system somewhat tolerant to a 'switch over' event. [It will try a few times before shutting down.] Turning headlamps OFF at plow connection is best.
