Subject: Info - Radio Telephone/Mobile Radio

(Transceiver) Installation and Troubleshooting Guidelines

Models All GM Passenger Cars and Trucks

Date: August 14, 2014

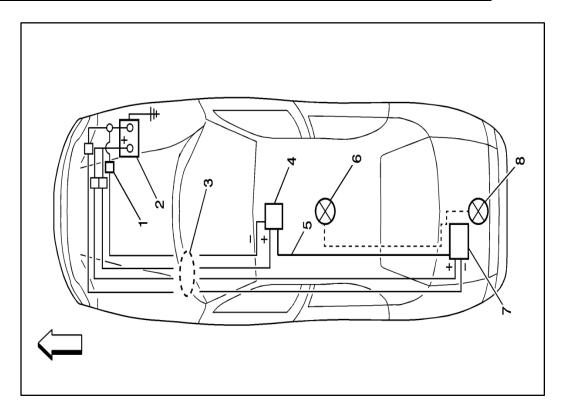
Figure 1A — Transceiver Installation – Example of Remote Mounted Transceiver

- Locate transceiver for remote radios on driver's side of trunk as near to the vehicle body side as possible.
- One piece transceivers should be mounted under the dash or on transmission hump where they will not interfere with vehicle controls or passenger movement.
- Great care should be taken not to mount any transceivers, microphones, speakers or any other item in the deployment path of a Supplemental Inflatable Restraint (air bag).

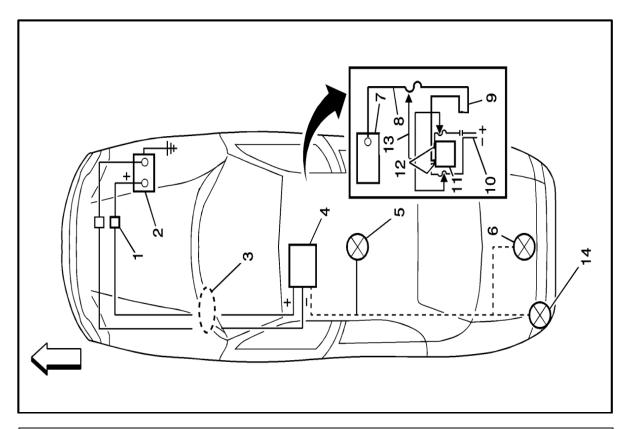
Figure 1B — Transceiver Installation – Example of One Piece Transceiver

- o For ONE-PIECE TRANSCEIVERS where ignition switch control is desired and no SEO wiring exists, a 12 volt power contactor must be installed in the transceiver positive lead. The contactor should be located near a proper 12 volt feed. The coil of the contactor should be connected through an appropriate in-line fuse to an available accessory circuit or ignition circuit not powered during cranking. The contactor coil must return to a proper negative point. The detailed view in Figure 1B illustrates direct connection to the vehicle battery.

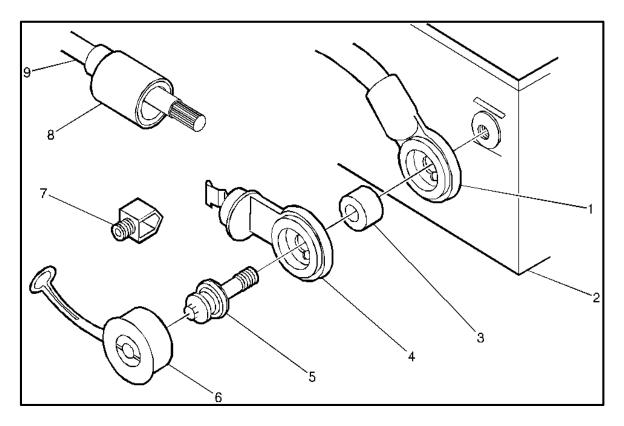
<u>Figure 2 — Auxiliary Electrical Equipment – GM Recommended Installation</u>

- Connect the positive and negative leads to the Special Equipment Option (SEO) wiring provided for this purpose.
 - o If connections are made directly to the battery terminals, the GM-approved methods of connecting auxiliary wiring include the adapter package illustrated in Figure 2, NAPA-Belden replacement battery bolts, P/N 728198, or drilling and tapping the hex end of the original battery bolts 10-32 X 3/8" deep. Note that it is recommended that a fuse be placed in the transceiver negative lead to prevent possible transceiver damage in the event the battery-to-engine block ground lead is inadvertently disconnected.

AC-Delco Side Terminal Adapter Package 1846855, when combined with the longer battery bolt and spacer will provide the simple, light, corrosion-resistant connection illustrated.
