UI Bulletin #123d

Subject: Roof Beacon (TRW) Switch Wiring Location/Access
Models Years Affected: 2014-19 Chevrolet Silverado 1500 LD
2014-19 GMC Sierra 1500 LD
2015-19 Chevrolet Silverado 2500/3500 HD
2015-19 GMC Sierra 2500/3500 HD
2019 – beyond Chevrolet Silverado MD Trucks With option TRW
Origination Date: February 6, 2015
Revision Date: May 11, 2020

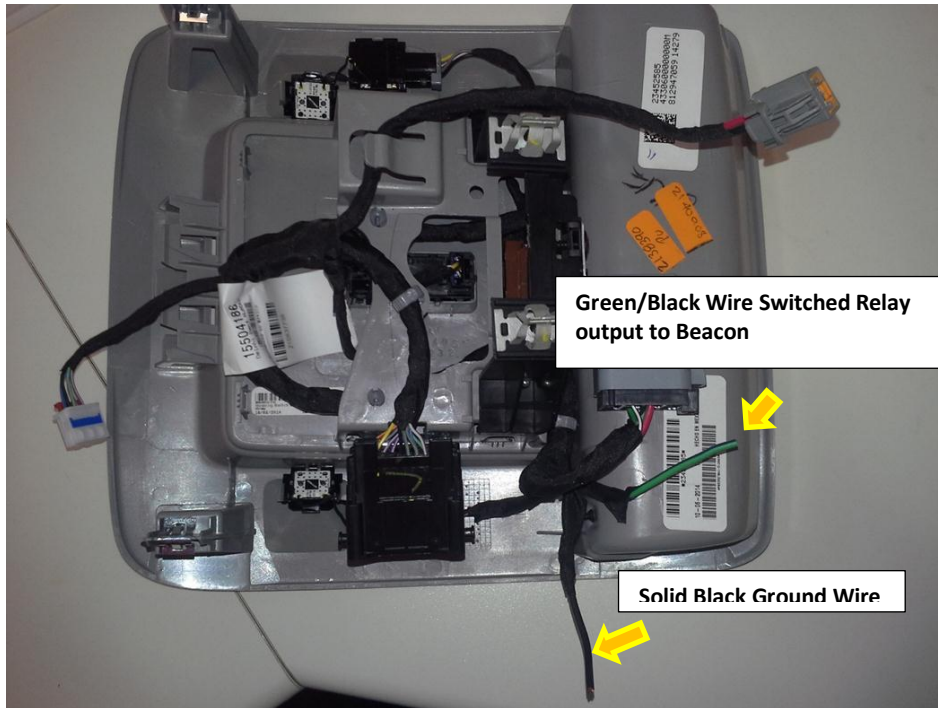
Top View of Removed Overhead Roof Console

Green/Black Wire Switched Relay output to Beacon

Solid Black Ground Wire
