Subject: Adding/deleting a Rear-View Camera to a Box Delete (ZW9) or Chassis Cab Vehicle

Models Affected: Chevrolet Silverado (1500-3500)
GMC Sierra (1500-3500)
w/Box Delete (ZW9) or Chassis Cab*
**does NOT include the 2019MY new body style models*

Model Years 2015i –Beyond

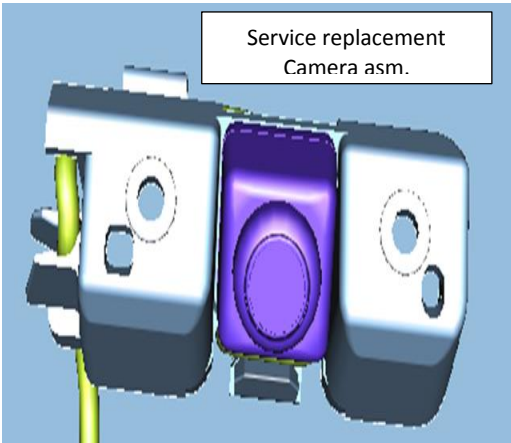
Figure 1

The service replacement camera comes mounted in a bracket assembly (see figure 1). The bracket needs to be removed and discarded. Remove the camera by removing the 2 screws as shown in figure 2.

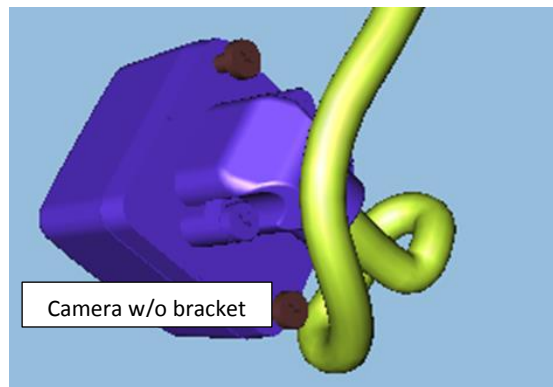
Once the bracket is removed, the camera becomes a stand-alone component (refer to figure 3). This camera can now be mounted in an upfitter provided bracket/housing for mounting to the vehicle.

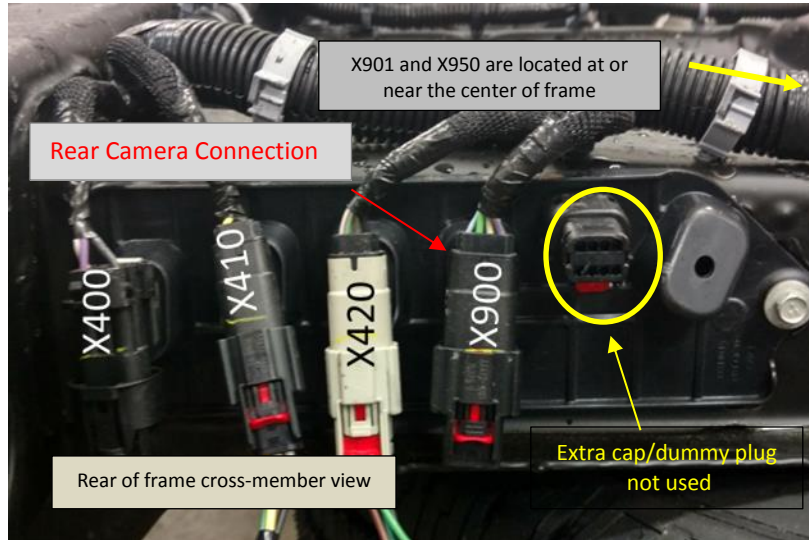
Figure 4

Vehicles manufactured with RPO 5F9 (Camera Ready option) DO NOT require any reprogramming of any modules to enable the video display. These vehicles come from the factory with display enabled and will exhibit a "blank" screen when put into reverse due to the absence of the camera. Dealers/Upfitters simply need to add a compatible camera to the vehicle using the OEM connector located at the rear of the frame (see figure 4).
