**Subject:** Rear Axle Vent Hose

**Models Affected:** Chevrolet Silverado  
GMC Sierra  
Chassis Cab or Box Delete (ZW9) vehicles

## **ADVISORY:**

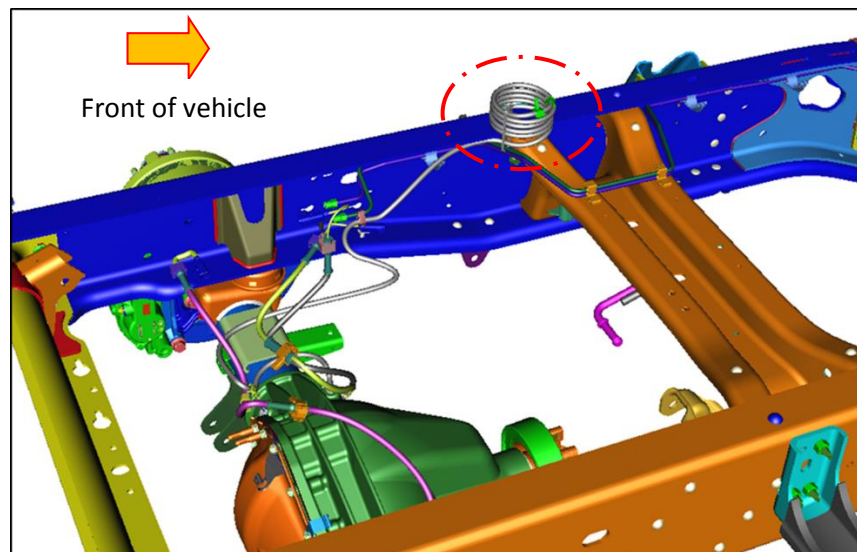
Figure 1 (example)

Chassis Cabs and ZW9 Box delete vehicles are shipped with the rear axle vent tube coiled and secured to the frame (see example in Figure 1)

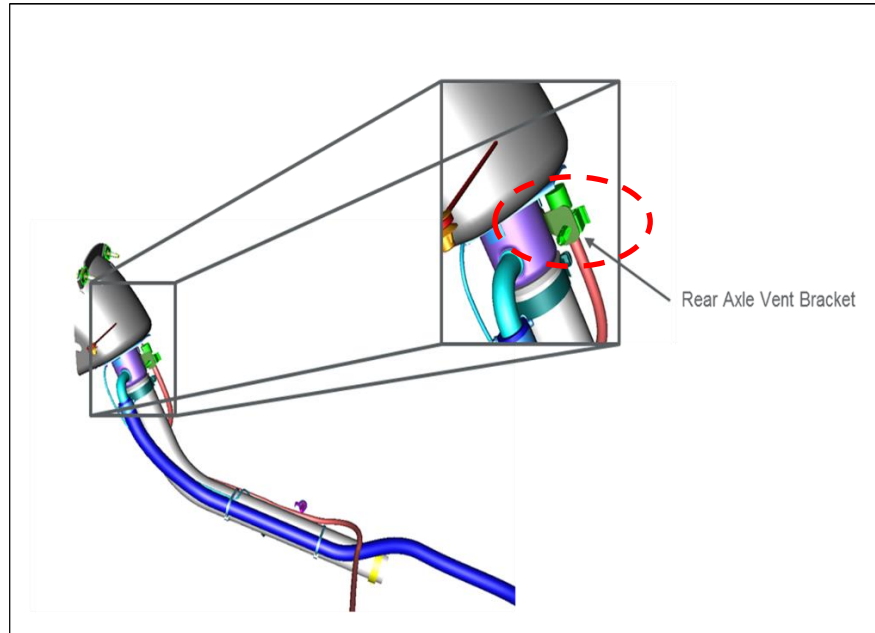
Figure 2

The purpose of this bulletin is to advise upfitters of the requirement(s) to mount the rear axle vent hose in its designated location to prevent water intrusion into the rear axle differential case.

When installing filler neck assembly on a service body be sure to route and secure the rear axle vent tube in the location shown in Figure 2.

When performing a pick up box removal and service body installation, be sure that the rear axle vent hose is secured in the location shown in figure 2. For further information please refer to the vehicle model Special Applications – Pick Up Box Removal Body Builder Manual.
