Subject: Fuel Fill Tube Repositioning
Models Years Affected: 2017 and Beyond
Models Affected: GMT610 Cutaway w/33 Gallon Fuel Tank
Origination Date: July 19, 2017
Revision Date: August 22, 2018

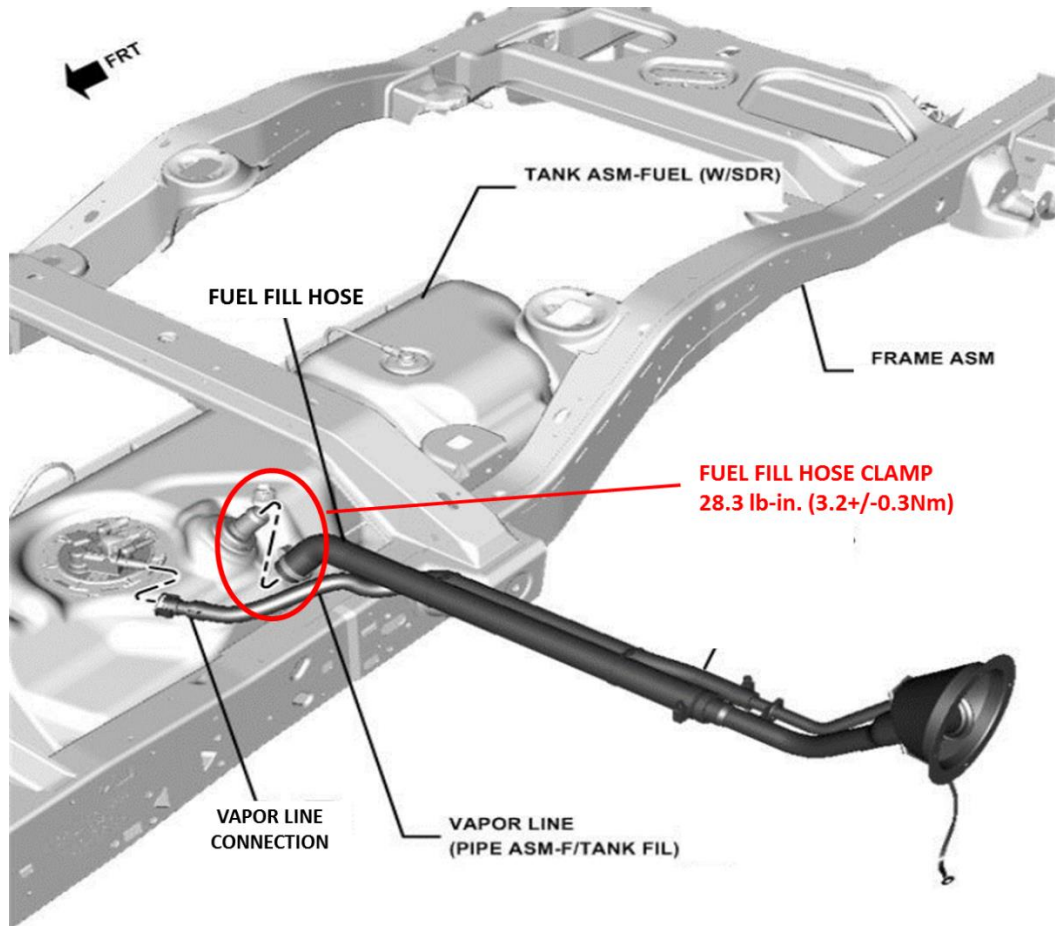
The fuel fill tube used on the 2017 model year GMT610 Cutaway models with side mounted 33-gallon fuel tank was changed. During the vehicle build the fuel fill tube is installed to facilitate filling the fuel tank at the assembly plant. To prepare the vehicle for shipping purposes, the fuel fill tube was secured to the frame with tie wraps. With this process the rubber hose used to attach the fill tube to the fuel tank would twist, collapse and not return to its original shape after release from the frame, causing a complaint of hard to fill the fuel tank.

To reposition the fuel fill tube, the clamp closest to the fuel tank must be loosened and the fuel fill tube and hose assembly rotated to the vertical position, as installed in a completed vehicle. The lower hose clamp must be retightened to **28.3 lb.-in. (3.2 +/-0.3Nm)**.
