Subject: Relocating Roof Mounted Antenna

Models Years Affected: 2016 - Beyond

Models Affected: Chevrolet Express/GMC Savana
Cut-away vans equipped with OnStar® (RPO UE1)

Origination Date: October 30, 2017

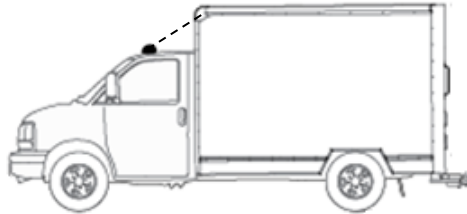
Vehicle models that are listed above and equipped with OnStar (UE1) and a roof top antenna may notice under certain conditions reduced system performance when the vehicle is upfitted with a service body that has a higher elevation than that of the OEM roofline (see example below).

To optimize performance of both the cellular and GPS systems in all areas throughout the U.S and Canada, it is **RECOMMENDED** that when installing a service body which is higher than that of the OEM roofline, the antenna be relocated to a location where the cellular signal is not obstructed.

BE FURTHER ADVISED: Vehicles with service bodies that overhang or cover the roof mounted antenna should have the antenna relocated to enable the noted system(s) to operate properly.

A kit is available (RPO = G7K) for ordering at the time of vehicle. This kit will include an additional antenna, an extension cable assembly (25ft), metal grounding plate and instructions.
