Subject: Cap-less Fuel Cover
Models Years Affected: 2017 - 2019
Models Affected: Chevrolet Silverado (old body style)
GMC Sierra (old body style)
With Cap-less Fuel Fill and Gasoline Engines
Origination Date: September 4, 2019
Revision Date: N/A

ADVISORY:

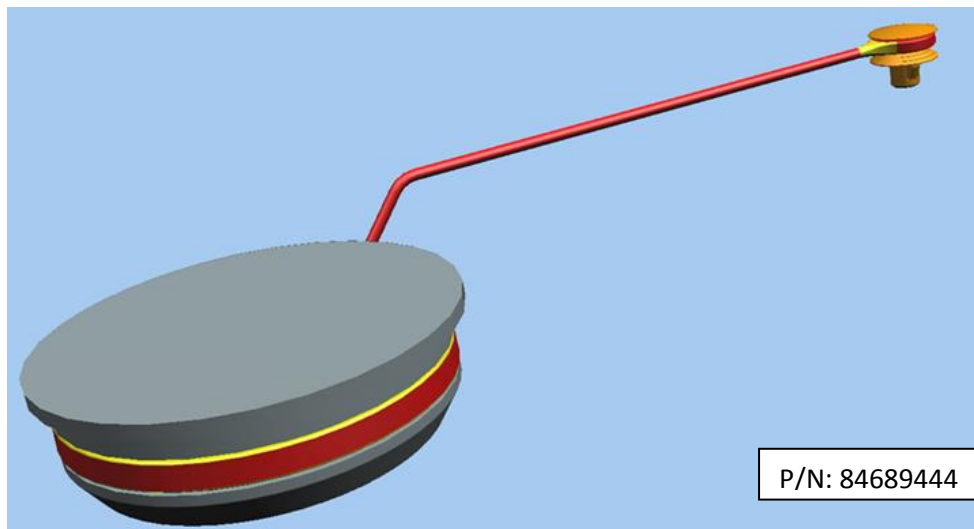
Figure 1

Some customer/vehicle operators may express a concern that dirt, dust and other contaminants have a potential of entering the fuel filler/tank due to contaminants making their way past the seals on the cap less unit. This issue may occur on vehicles that predominately drive on unsealed or dirt roads. This issue occurs because the fill pocket is unsealed near the hinge, and the fill pocket door is also unsealed.

Adding a tethered cap that covers the cap-less unit preventing contaminants from settling on the outer sealing door of the cap less unit. Refer to Additional Information for an illustration (Figure 1) and the part number of the tethered cap.
