UI Bulletin #103

Subject: Aftermarket Installed Service, Tool or Utility Box Sagging, Mis-Aligned, Forward Box Mount Fractured on Trucks Equipped with Aftermarket Bodies

Models: Chevrolet Silverado 2500HD-3500HD
GMC Sierra 2500HD-3500HD
w/ZW9 Box Delete or removal and an after-market service body installed

Model Years: 2011-2012

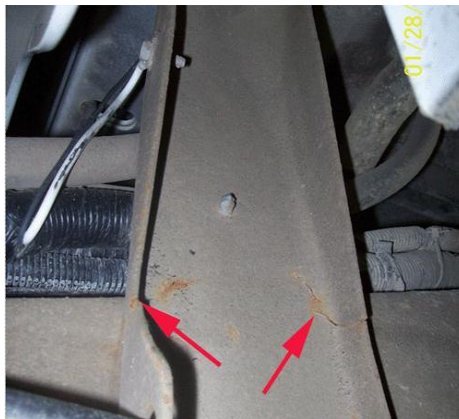
Some customers may comment that the utility box is sagging, not level or misaligned. Upon inspection, the technician may find cracked or fractured front bed mount bracket(s).

In rare occasions, situations have been identified where the incomplete pickup trucks have had an aftermarket body (typically a service body or utility type body) installed. Upon inspection, it was noted that the aftermarket bed was not installed using all of the recommended/available mounting points as outlined in UI Bulletin #98 (available at www.gmupfitter.com). Every case identified, thus far, has involved an aftermarket body that only used four mounting points; one in each corner, with no additional load bearing points as described in UI Bulletin #98.

Figure 1:
Example of a front mount bracket cracking as a result of not all mounting locations being utilized

Important Notice: If the existing body is going to be re-installed after the repair, then the mounting set up of the body that contributed to this condition must be corrected to utilize the attachment scheme outlined in UI Bulletin #98. This repair only replaces the same style of bracket, which requires the correct mounting of the aftermarket body. If the body is not mounted properly, the condition may repeat. Refer to GM Upfitter Bulletin #98.

Use the following steps, if deemed necessary, to replace one or both of the affected front bed mounts brackets.

1. Remove the box assembly. Identify the bracket(s) that need to be replaced.
2. Using a general purpose adhesive remover, remove any factory protective coatings and clean the area to be repaired.

4. Scribe a line around the existing bracket to aid in aligning the replacement bracket.
5. Using a cut off wheel, cut the welds that attach the affected bracket to the frame.

6. Using a grinder, remove the remaining weld from the frame.
7. Prepare all attachment surfaces as necessary.
8. Apply GM-approved Weld-Thru Coating or equivalent to all mating surfaces. Refer to Anti-Corrosion Treatment and Repair in SI.

9. Use the scribe marks to locate the bracket. Position the new bracket on the frame and clamp in place.
10. Weld the bracket to the frame.
11. Clean and prepare all of the welded surfaces.

12. Apply the required sealers and anti-corrosion materials to the repair area. Refer to Anti-Corrosion Treatment and Repair in SI
13. Reinstall the box assembly. (refer to the Important Notice above regarding the use of the original body)

14. Using an appropriately size drill, drill the mounting hole in the bracket.
15. Coat the hole with GM P/N 12371287 (in Canada, 10953437) SYNTHETIC LUBRICANT WITH TEFLON® to prevent corrosion.

16. Install the mounting bolt.
