Subject: Adding or Installing a Rearview Camera
Models Years Affected: 2019 - beyond
Models Affected: Chevrolet Silverado/GMC Sierra Full-Size Pickups and Chassis Cabs with Box Delete (ZW9) or Box Removal
Origination Date: June 21, 2019
Revision Date: April 25, 2023

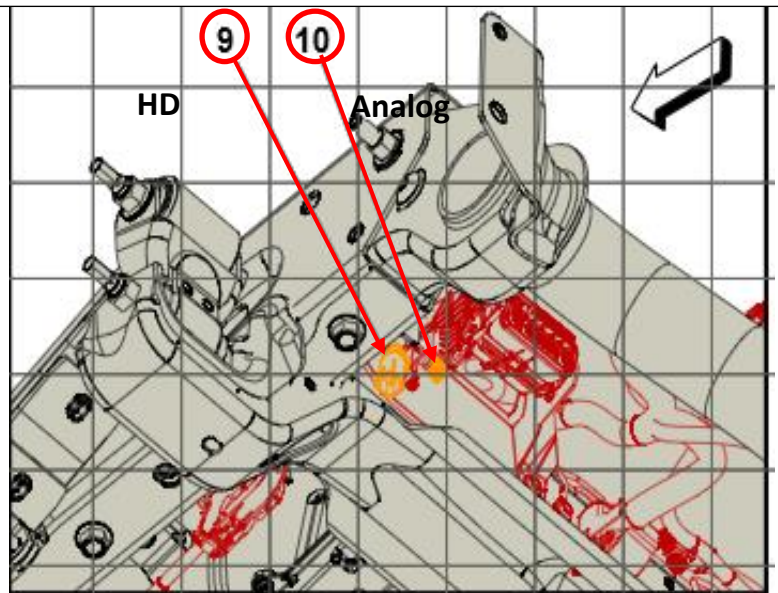
Vehicle Connector Locations P/U - ZW9/Box Removal

Mating (end gate) connector located rear of frame
