Subject: Adding or Installing a Rearview Camera
Models Years Affected: 2019 - beyond
Models Affected: Chevrolet Silverado/GMC Sierra Full-Size Pickups and Chassis Cabs with Box Delete (ZW9) or Box Removal
Origination Date: June 21, 2019
Revision Date: June 26, 2023

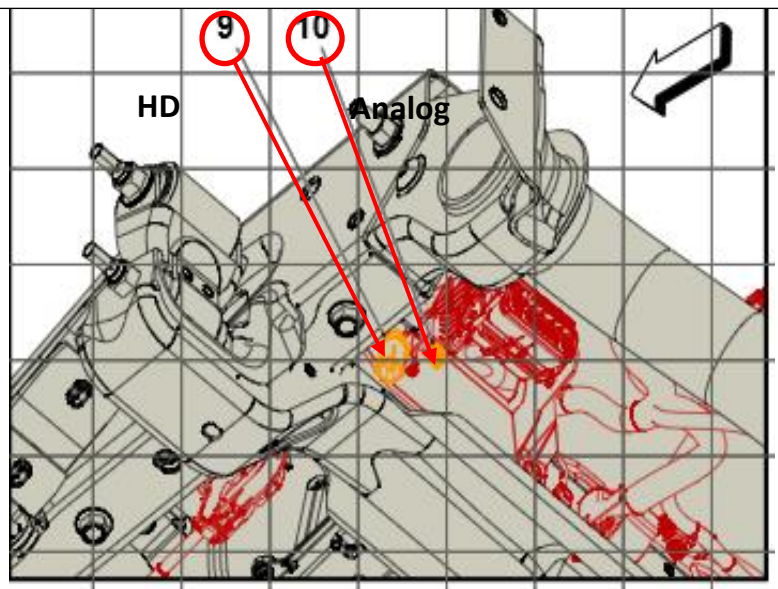
Vehicle Connector Locations P/U - ZW9/Box Removal

Mating (end gate) connector located rear of frame
