## UI Bulletin #152p

Subject: Adding or Installing a Rearview Camera

Models Years 2019 - beyond

Chevrolet Silverado/GMC Sierra Full-Size Pickups Models and Chassis Cabs with Box Delete (ZW9) or Box Affected:

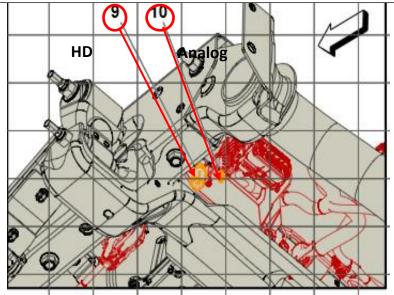
## **Vehicle Connector Locations P/U - ZW9/Box Removal**

Mating (end gate) connector located rear of frame
