# UI Bulletin #175

**Subject:** Back-up Alarm Installation (8S3)  
**Models Years Affected:** 2020 - Beyond  
**Models Affected:** Chevrolet Silverado/GMC Sierra  
3500 HD Series - Chassis Cabs models (only 31xxx)  
**Origination Date:** January 6, 2021  
**Revision Date:** TBD

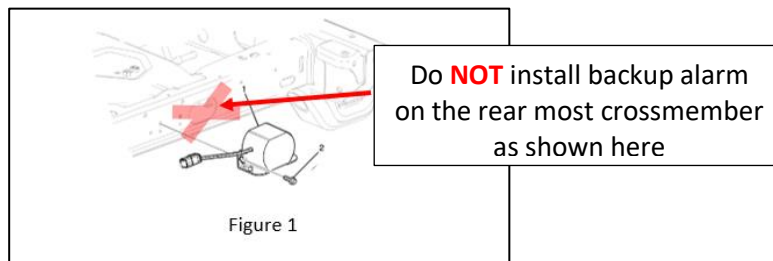
For the 2020 and forward model year 3500 HD series Chassis Cabs models when ordered with the Back-up alarm option (8S3), the alarm is shipped loosely inside the passenger compartment. This is because installation of the alarm on the most rearward frame crossmember when vehicle is equipped with a rear fuel tank as the fasteners will protrude through the crossmember and be near proximity of the rear tank and may in certain conditions, result in a fuel tank puncture. It is **NOT** recommend that the backup alarm be installed on the most rearward crossmember as it is in the pickup truck applications (refer to figure 1).

Installers must select an alternate location to mount the alarm assembly and the alarm be spliced into the reverse lamps circuit for power when vehicle is in reverse. Refer to page 51 of GM Upfitter Integration Electric Best Practices manual for recommendation on performing multiple wire splices ([GM UI Electrical Best Practices](#))
