Subject: RPO ENC, Provisions for a Rear Auxiliary Heater

Models Years Affected: 2008 - 2018

Models Affected: Chevrolet Express Cut-away Chassis
GMC Savanna Cut-away Chassis

Origination Date: 02/19/2008

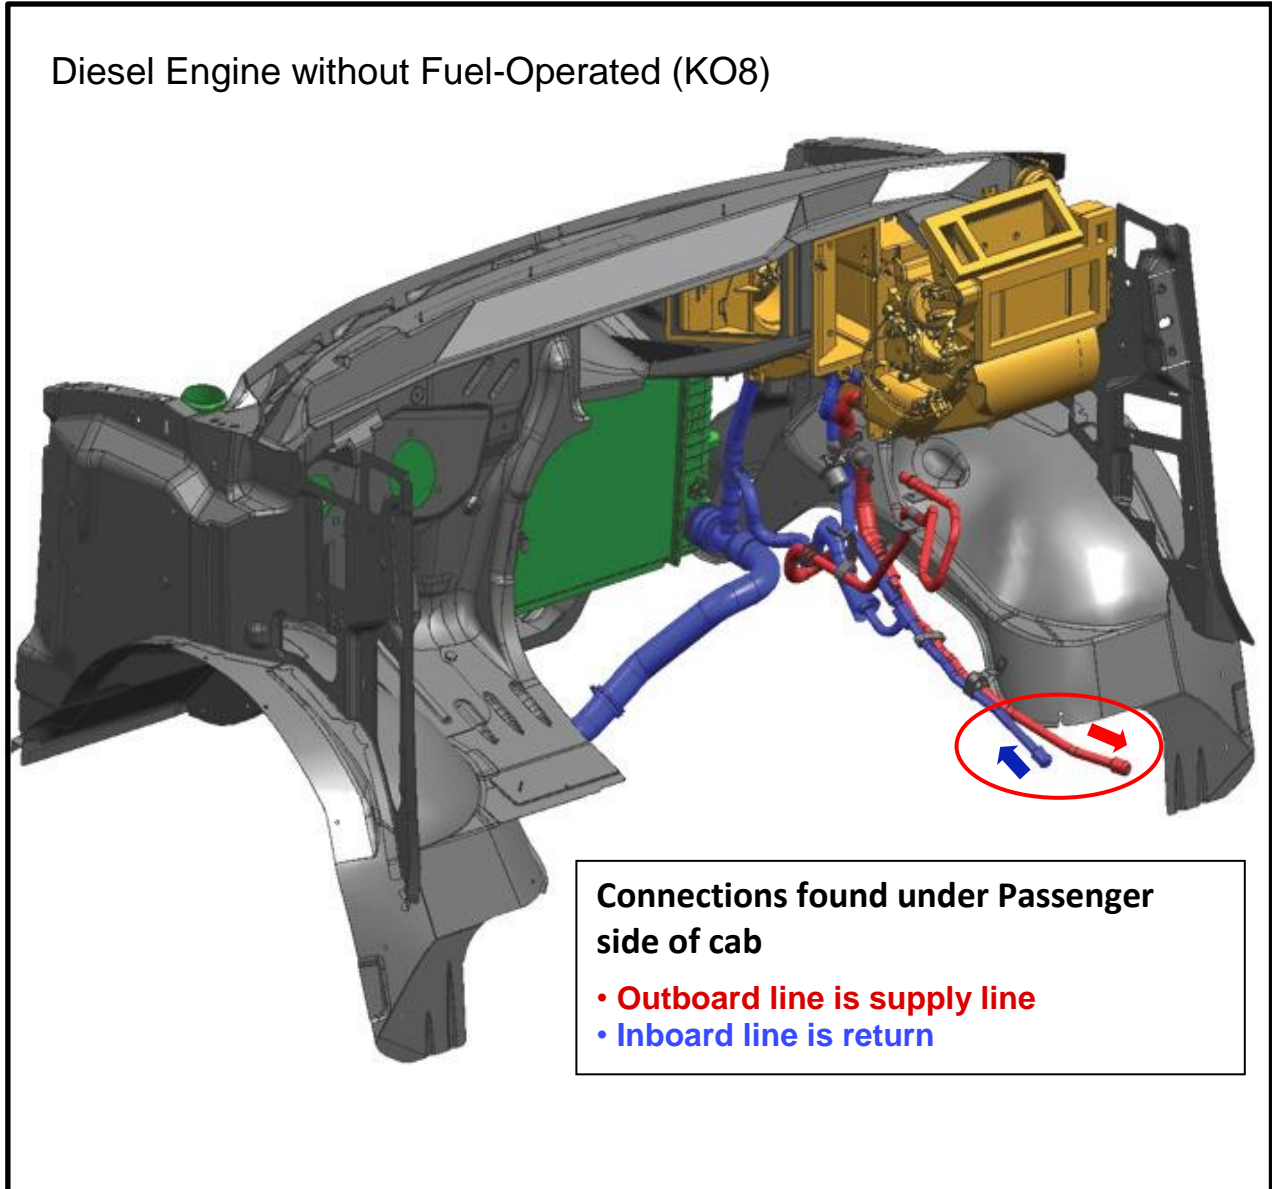
- For diesel-equipped vehicles the outboard pipe (as viewed from the rear of the vehicles) is the supply of engine coolant to the rear auxiliary heater, with and without the K08 fuel operated heater. The inboard pipe is the return of engine coolant from the rear auxiliary heater to the engine cooling system.

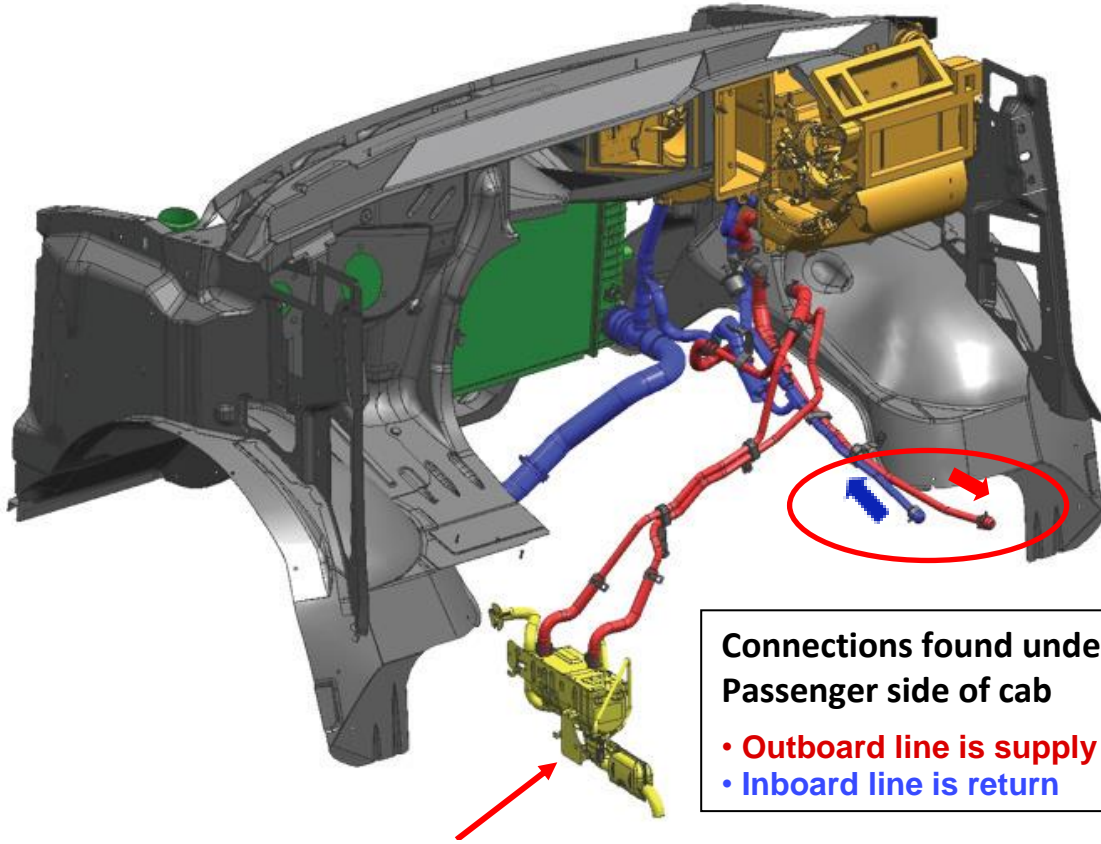
Diesel Engine with Fuel-Operated Heater (K08)

Connections found under Passenger side of cab

- Outboard line is supply line
- Inboard line is return

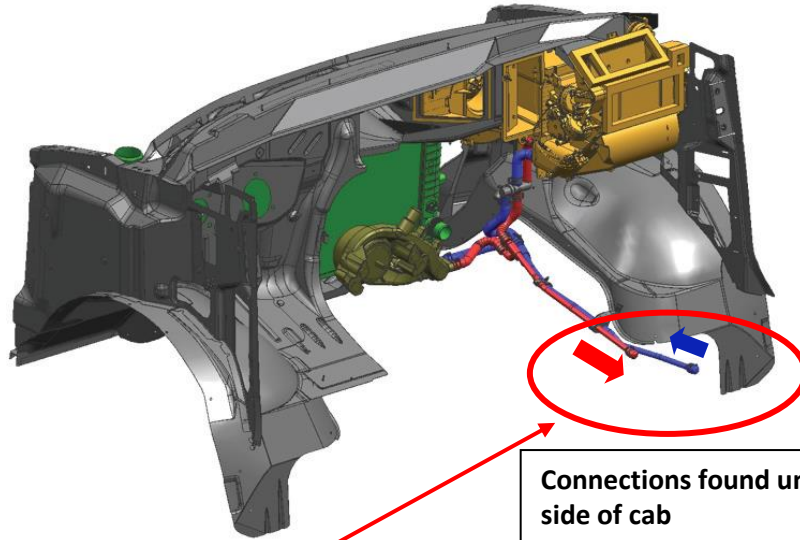
Gasoline Engine

Connections found under Passenger side of cab

- Outboard line is return
- Inboard line is supply line

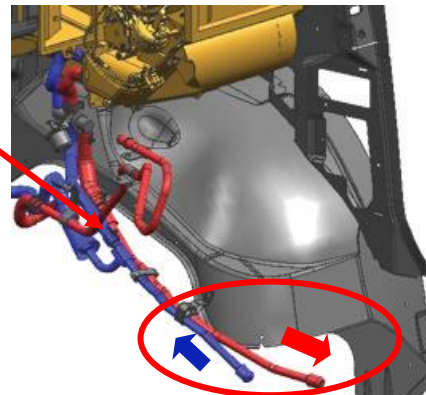
Diesel Engine

Connections found under Passenger side of cab

- Outboard line is supply line
- Inboard line is return
