UI Bulletin #172b

Subject: Mid-Size Pickup Box Removal /
 FMVSS/Component Information Resource
Models Chevrolet Colorado/GMC Canyon 2WD
Affected: Extended Cab – 36.2” CA `Short Box`
Models Years 2017 - Beyond
Origination
Date: September 15, 2020
Revision
Date: November 4, 2020

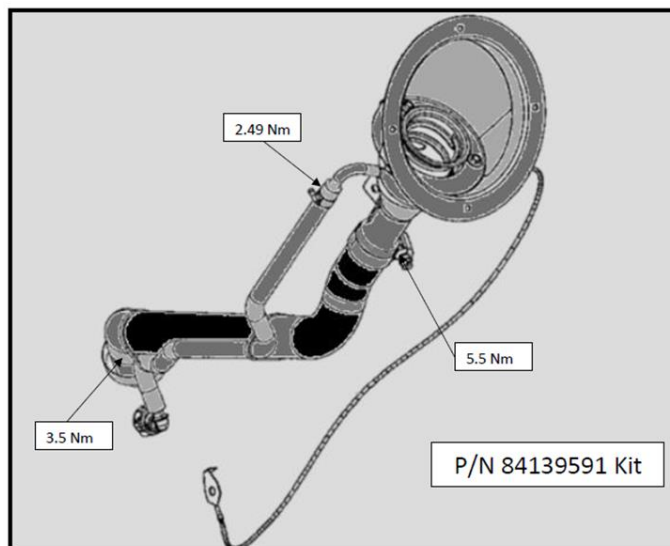
Colorado / Canyon models approved for ‘Pickup Box Removal’ require refitting the vehicle with the approved RPO-ZW9 Capped Fuel Fill Assembly Components. Care must be taken to follow GM UI BBM Fuel Fill Installation & Positioning Guidelines and when installing upfit bodies on the chassis. Upfitters should use the following combination of approved RPO- ZW9 Fuel Filler Components for completing ‘Pickup Box Removal’ upfit applications.

84139591 Gas-Filler Assembly, 23361879 Cap (RPO-BJA),

Refer to GM UI BEST PRACTICES ‘CHASSIS’ Section regarding routing & serviceability and securing hose assembly. <http://www.gmupfitter.com>
