UI Bulletin #172c

Subject: Mid-Size Pickup Box Removal /
 FMVSS/Component Information Resource
Models Chevrolet Colorado/GMC Canyon 2WD
Affected: Extended Cab – 36.2” CA `Short Box`
Models Years 2017 - 2022
Origination
Date: September 15, 2020
Revision
Date: August 23, 2022

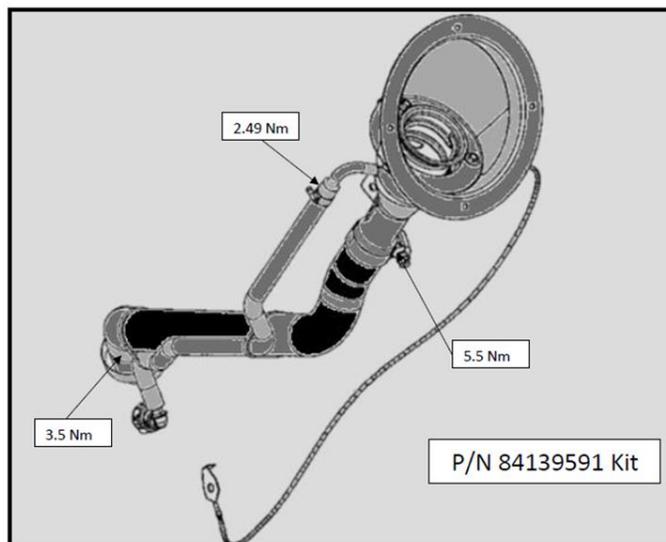
Colorado / Canyon models approved for ‘Pickup Box Removal’ require refitting the vehicle with the approved RPO-ZW9 Capped Fuel Fill Assembly Components. Care must be taken to follow GM UI BBM Fuel Fill Installation & Positioning Guidelines and when installing upfit bodies on the chassis. Upfitters should use the following combination of approved RPO- ZW9 Fuel Filler Components for completing ‘Pickup Box Removal’ upfit applications.

84139591 Gas-Filler Assembly, 23361879 Cap (RPO-BJA),

Refer to GM UI BEST PRACTICES ‘CHASSIS’ Section regarding routing & serviceability and securing hose assembly. <http://www.gmupfitter.com>
