UI Bulletin #174

Subject: Rear Camera Inoperative - Camera kit 5N5
Models Years Affected: 2021
Models Affected: Chevrolet Silverado/GMC Sierra pick up models with Options - Box Delete (ZW9), Rear Camera kit (5N5) and Audio System (IOR)
Origination Date: November 19, 2020
Revision Date: N/A

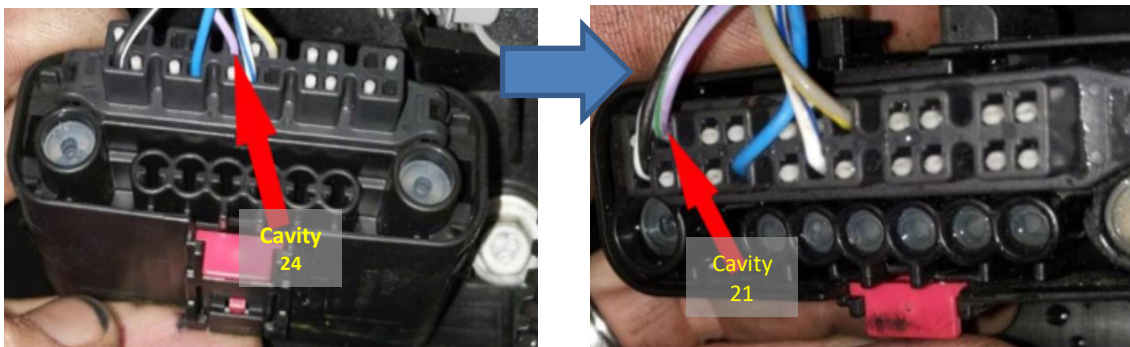
The cause of the rear camera inoperative condition may be that a change was implemented to the chassis harness from 2020 to 2021 trucks, there was an issue with camera flicker and circuit 1739 was moved from pin 24 to pin 21.

The camera extension harness P/N 84852714 in the 5N5 Rearview Camera kit was not updated to correspond to the change in the chassis harness. This mis-match leaves the camera inoperative when installed by the dealer or upfitter and as such stalls the delivery to the end customer

To eliminate the "service" message and enable the center screen display from the rear camera, circuit 1739 (violet/green wire) must be relocated in the X926 connector of the extension harness for cavity 24 to cavity 21 as shown below. A link to a video that shows how to service the connector is provided below as well
