General Motors Upfitter Integration

UI Bulletin #169

Subject: Information on Removing Protective Film Bumper Covers Upon Delivery of Vehicle.

Models Affected: Chevrolet Express GMC Savana Origination May 28, 2020

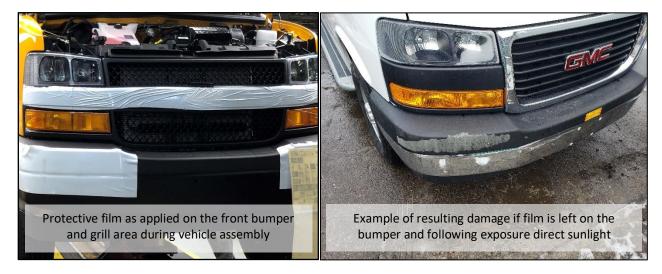
This bulletin is being issued to inform dealers and upfitters to remove the protective film covers from the vehicle upon delivery. These protective film covers are used for transit purposes only. These protective film covers may be found on the front bumper/grille corners and rear bumper corners (if the vehicle is equipped with a rear bumper).

These protective film bumper/grille covers should be removed before the vehicle is stored. If the film covers are not removed and left in the sunlight, the adhesive backing on the film cover could transfer to the bumper/grille surface.

1. Remove the protective film cover in one continuous motion in order to reduce the amount of adhesive material left behind.

2. Clean the area with a 50/50 mixture of isopropyl alcohol and water (or alcohol wipe) to remove any adhesive.
