General Motors Upfitter Integration

UI Bulletin #161b

Intermittent Cluster, Radio and HVAC Display

Subject: Resets on Snow Plow Trucks

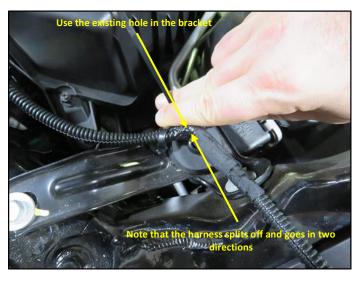
8) Continue routing and securing the wiring harness using the combination tie strap/clips provide. Secure to the center radiator support bracket as shown in figure TBD

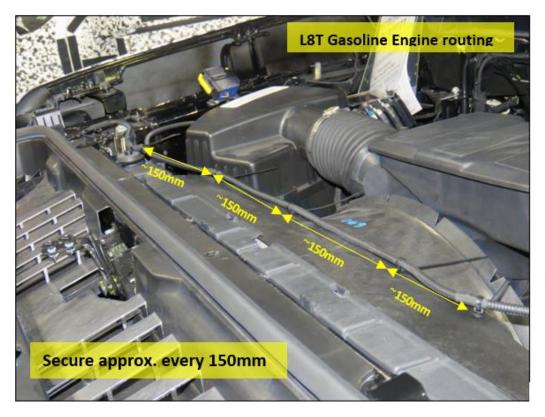
9) In figures TBD it is shown the harness splits off in 2 different directions. The large bundle will be routed across and secured using the tie strap/clips to the 6.5mm holes that are needed to be drilled into the cooling fan shroud as shown in figure TBD
