# UI Bulletin #181

**Subject:** Out of Park Signal  
**Models Years Affected:** 2021 and Beyond  
**Models Affected:** Chevrolet Tahoe and Suburban  
GMC Yukon and Yukon XL  
**Origination Date:** September 8, 2021  
**Revision Date:** N/A

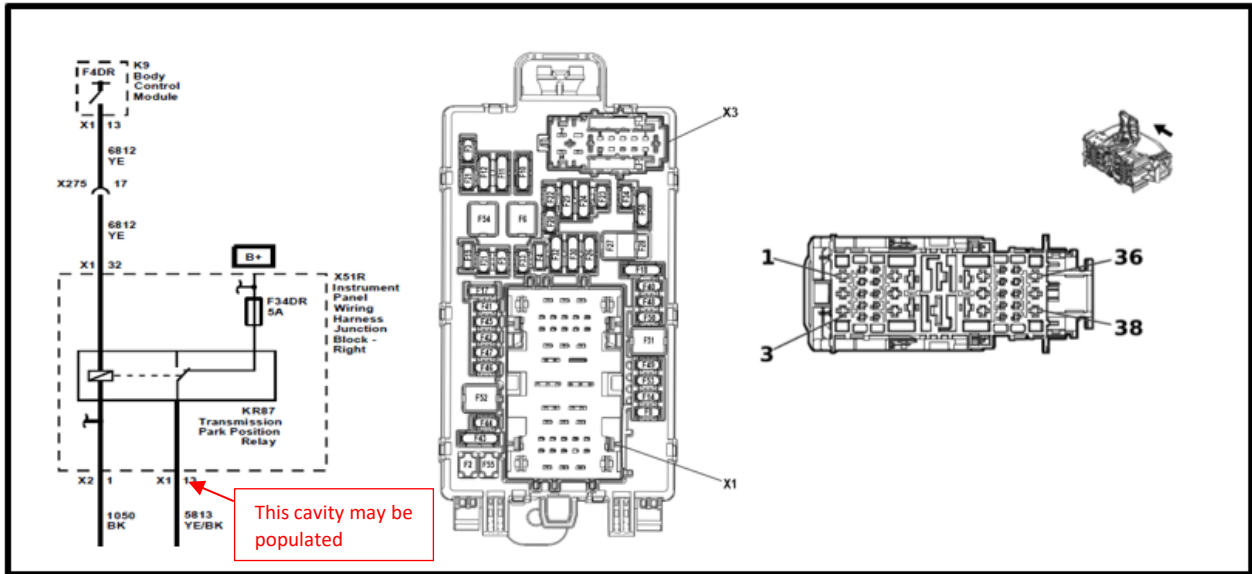
Some customers/upfitter may indicate a need for a discrete "Out of Park" signal which is only available on some full-size SUV models with certain option content.

The discrete Out of Park signal is only available on models with the power folding second row seats (ATN or ATT) and on the Police Pursuit (9C1) or Special Services (5W4) vehicles. This discrete signal can be enable on models which do not have any of the above option codes for upfitter purposes. Enabling the signal is accomplished by adding Special Equipment Option (SEO) SK0 to the Vehicle Configuration Index (VCI) and reprogramming the Body Control Module (BCM). The reprogramming of the BCM can be performed by any GM dealer and the dealer is required to contact Techline Customer Support Center to have the VCI updated with the SK0 option.

Once enabled, the output circuit from the **BCM** X1/Cavity 13 will be active as 350mA high side driver and will drive the Transmission Park Position relay (KR87) in the RH fuse block active/closed. When the relay closes, 12v Battery power from the F34DR 5a fuse, outputting the signal to X1/Cavity 13 of the **RH IP Fuse Block**. Without options noted above there may not be a wire occupying the fuse block cavity and you will need to add one by inserting a terminated wire lead (P/N 19371175) and soldering your wire to the blunt cut lead. Refer to the images on the next page as reference.

**NOTE: DO NOT DIRECTLY CONNECT ANY LOADS TO THE BCM – THE OUTPUT IS DESIGNED AND INTENDED FOR THE ACTIVATION OF A RELAY ONLY.**
