UI Bulletin #183

Subject: First responder installed equipment disables or shuts down when the LH doors of the vehicle are opened, or the Star/Stop button is pressed.

Models Chevrolet Tahoe

Affected: PPV (9C1) and SSV (5W4) models

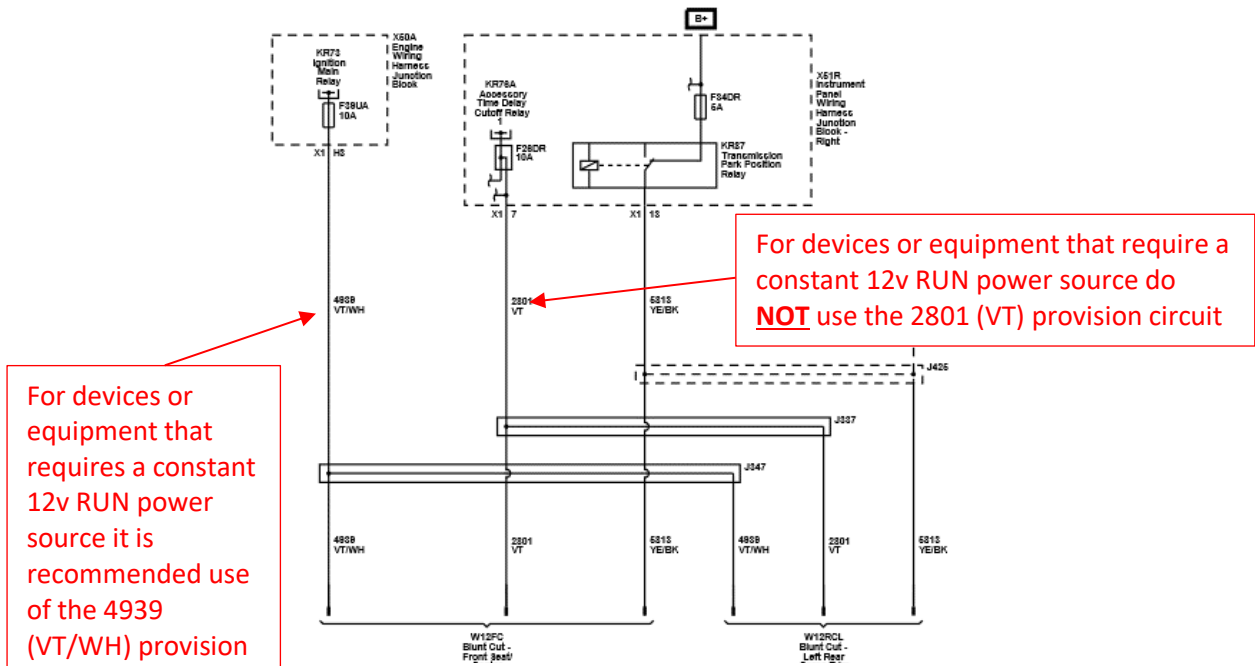
Some upfitter/customers may indicate that certain equipment installed will be disabled or shut-down when either of the vehicle's Driver or Passenger LH doors are opened or the Start/Stop button is pressed. This condition is caused when the installer/upfitter utilizes the Violet (VT) 2801 wire/circuit. This circuit is functionally tied to a feature called IRAP (Interruptible Retained Accessory Power). IRAP operates as described below and its function as noted is tied to the 2801 circuit and as such the devices connected to this power source are subjected to the power interruptions as well.

For devices or equipment that require a constant 12v RUN power source do **NOT** use the 2801 (VT) provision circuit

To avoid the power interruptions and provide a steady “RUN” mode power source for devices requiring such, it is recommended that the provisional 4939 (VT/WH wire) be used in place of the 2801 circuit. Refer to the schematic and notes below for more details.

For devices or equipment that requires a constant 12v RUN power source it is recommended use of the 4939 (VT/WH) provision circuit

Both the 2801 and 4939 provisional circuit are available in the blunt cut harnesses located in both the cargo and center console area
