Subject	Installation of Upfitter (AUX) Switches (9L7) components
Model Years Affected	2022i -2024
Models	Chevrolet Silverado
Affected	GMC Sierra Refer to the UI Bulletin Usage table below
Origination Date	August 1, 2023
Revision Date	August 4, 2023
۸г

Bulletin #193b

Condition/Concern:

Beginning with the 2022i the Full-Size Pickup Trucks, the Upfitter (AUX) Switch option (9L7) will require, depending on model, some or all components will need to be installed to make the feature fully functional. The installation instructions vary by vehicle trim levels and those instructions are broken down by trim option codes.

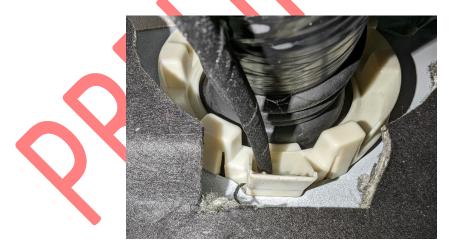
Prior to attempting to pass the wire/harness into the cabin the silver-colored insulation and plastic conduit must be removed, leaving only fabric like tape wrapping on the wire.

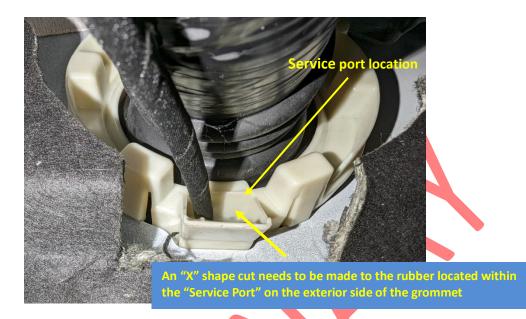
The "service port" or wire pass-thru is located at the 6 o'clock position on the wire harness grommet as shown below. The rubber seal inside of the service port will need to have an "X" cut into to provide for the wire to be passed.

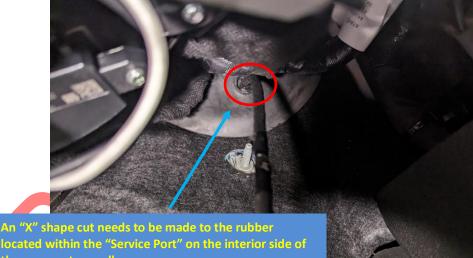
A similar "X" shape cut must be made to the interior cabin side of the grommet located under the IP on the RH side just below the HVAC module– see below

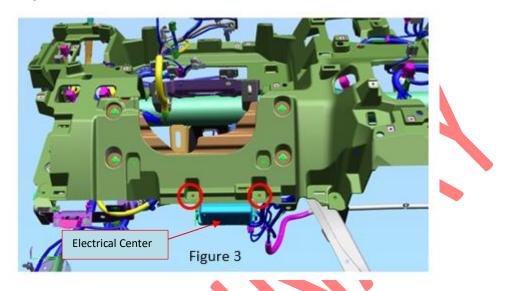
1. Mount the IP Aux. Fuse block using the 2 screws in the locations circled in RED as shown in figure 3

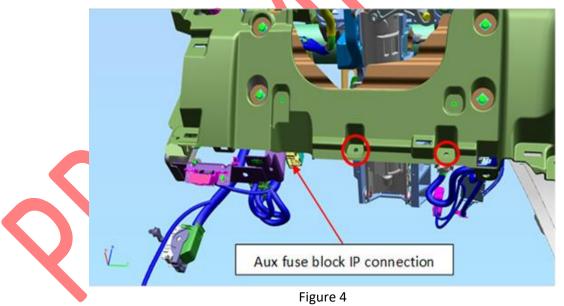
Connect the 14-pin connector Aux Fuse Block to the connector shown in figure 4 (note vehicle is shipped from the assembly plant with a blank connector in place to protect the terminals in the IP Harness. Remove this prior to connecting the connector from the fuse block)

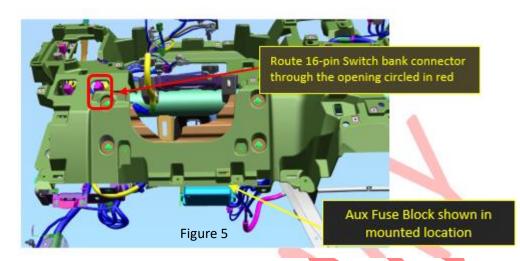
2. Route the 16-pin switch bank connector through the opening in the Instrument Panel as shown in figure 5

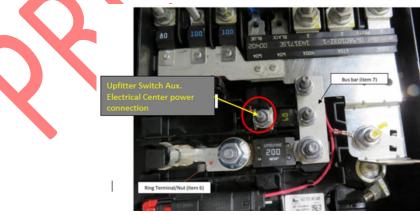
- Once all "kit" components have been installed, the Aux Fuse Block can now be powered, for detailed instructions on adding the fuses to the battery mounted electrical center refer to the latest revision of UI Bulletin #147. (<u>http://www.gmupfitter.com/pages/technicalbulletins</u>)
- 2. Following the installation of the fuse kit to the battery mounted electrical center, connect the power cable ring terminal to the 60-amp fuse output side stud.

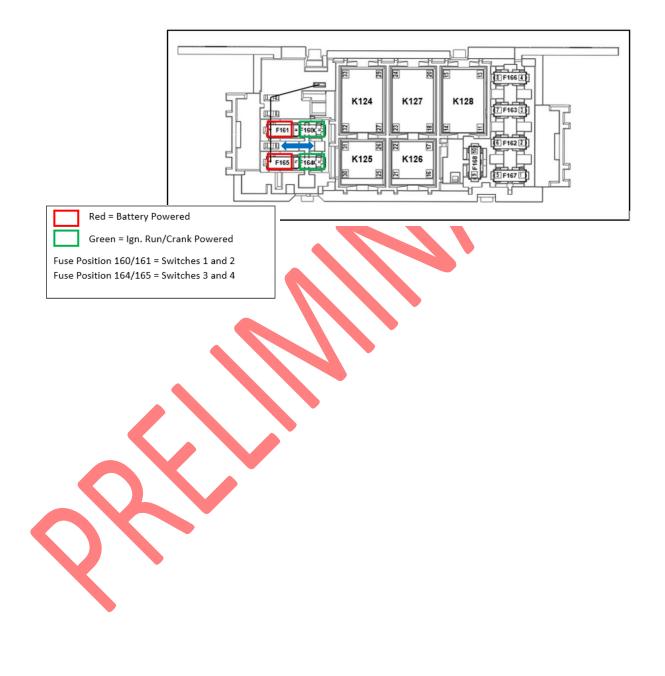
The upfitter switches are defaulted to being battery powered but can be reconfigured in pairs to operate only when in accessory/ignition ON by relocating one or two fuses as shown below.
