UI Bulletin #182

Subject: Vehicle Speed Signal
Models Years Affected: 2021
Models Affected: Silverado HD 4500/5500/6500 Models
Origination Date: October 6, 2021
Revision Date: N/A

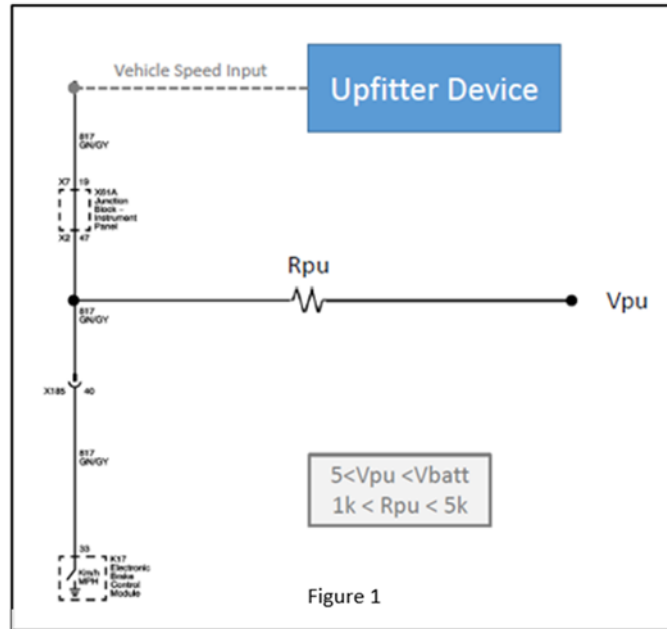
Some customers/upfitters may indicate that the Vehicle Speed Signal (VSS) at cavity 19 of the X7 connector in the IP junction block, is no longer working or has changed from previous model years. This causing the equipment installed to not operate as it had on previous model year builds. This condition is due in the 2021 model year where the VSS now being provided by the Electronic Brake Control Module (EBCM) and not the Transmission control module (TCM). Both control module provides the signal at the same frequency (4k/PPM) but in different manners. The TCM provide a V+ pulse and the EBCM a V- pulse of which can be used as input to the added equipment.

If the added equipment requires a V+ pulse to operate you can use the signal as it is provided, however you will need to add a current limited V+ circuit which is pulled low by the EBCM and release back to the V+ state. The release of the V+ signal appears to the added equipment as pulsed + signal. For use of this signal please refer to Figure 1 below for mechanization instructions.
