Subject: Backup Alarm Installation Recommendations
Models Years Affected: 2020-Beyond
Models Affected: Chevrolet Silverado/GMC Sierra
2500/3500 HD Series
Origination Date: June 13, 2024
Revision Date: TBD

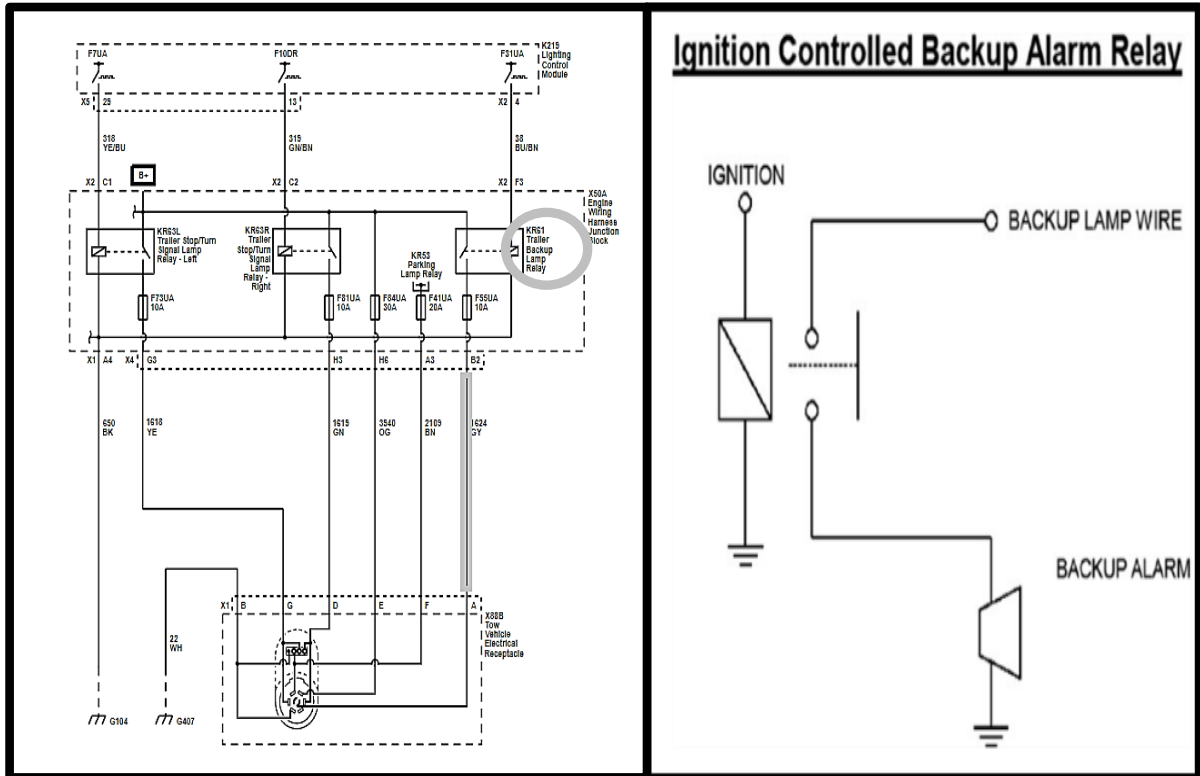
Some customers, dealers, or upfitters may have concerns or questions about adding a backup alarm to vehicles that do not have option code 8S3. They may notice that the alarm sounds when the customer is entering or exiting the vehicle, due to the backup lamps being activated with the perimeter lighting and key fob acknowledgment.

2. Install an ignition-controlled relay to connect the backup alarm to the backup lamp circuit. This setup ensures that the backup alarm will only function when the ignition is on, and the backup lamps are illuminated (see the sample mechanism below).

Note: Ignition source can be found in the X260/X213A upfitter connector - pin 13, up under the IP. See [UI TSB 155x](#) for more information on the location and connector diagram.
