Subject: Installation of Upfitter (AUX) Switches (9L7) components
Models Years 2024-Current
Affected:
Models Affected Full-size GMC Trucks – Premium Uplevel Trim
Denali/Ultimate/AT4/AT4X
Origination Date: 10/24/2024
Revision Date: N/A

<u>UI Bulletin Usage Table</u>			
<u>Model Year(s)</u>	<u>Brand</u>	<u>Model</u>	<u>Bulletin #</u>
2024-2025	GMC	2500/3500 Denali/AT4	205

Install Procedure #3 = AT4 (GFG), AT4X (GA4), Denali (GFW), Denali Ult (GFY) - UI TSB 205

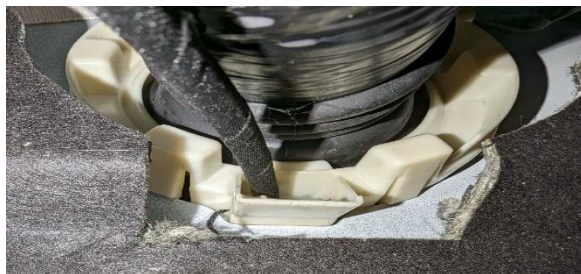
Prior to attempting to pass the wire/harness into the cabin the silver-colored insulation and plastic conduit must be removed, leaving only fabric like tape wrapping on the wire.

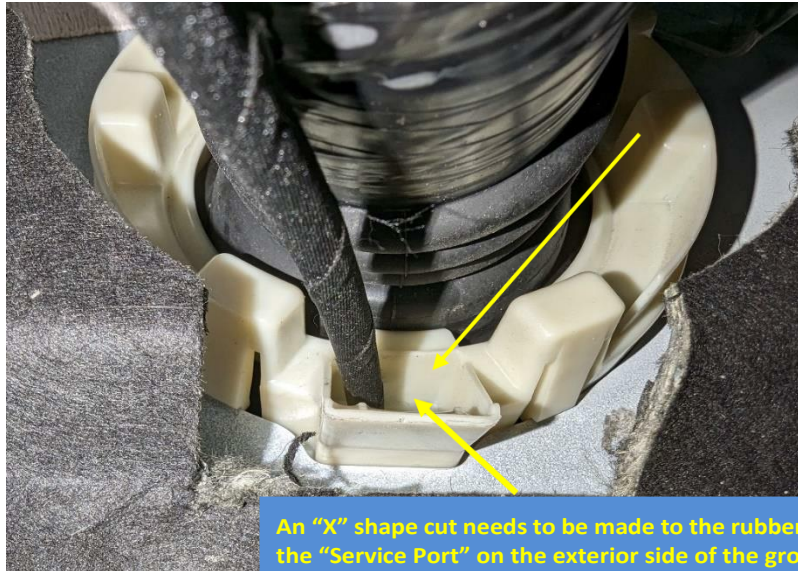
The “service port” or wire pass-thru is located at the 6 o’clock position on the wire harness grommet as shown below. The rubber seal inside of the service port will need to have an “X” cut into to provide for the wire to be passed.

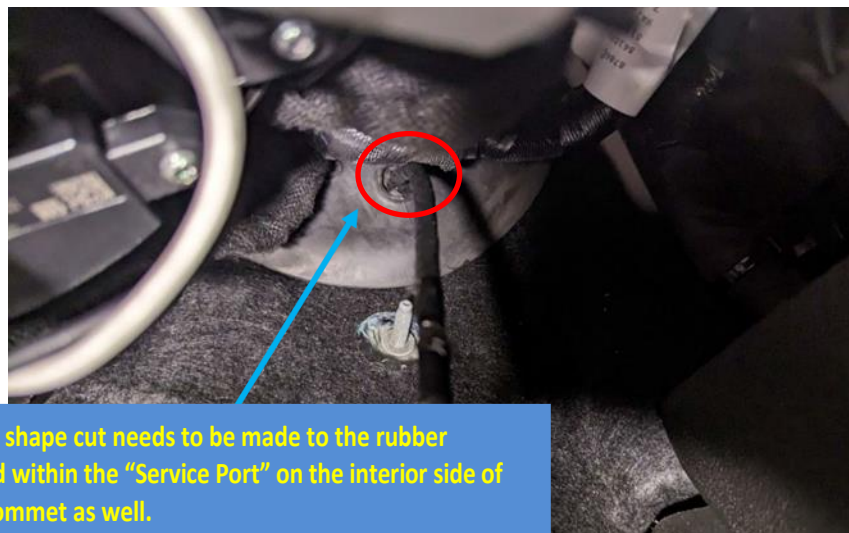
A similar “X” shape cut must be made to the interior cabin side of the grommet located under the IP on the LH side just below the HVAC module– see below.

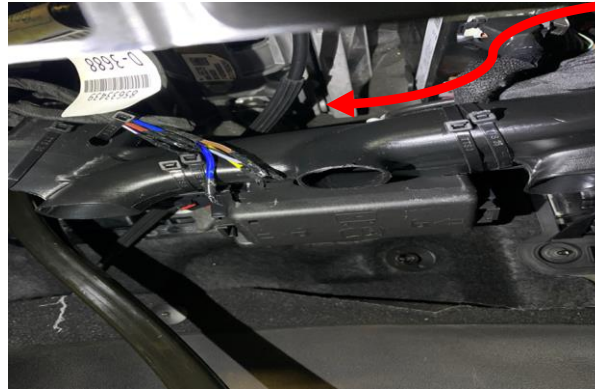
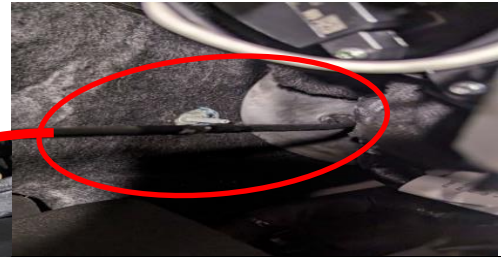
Generously lubricate the exterior area of the service port with glass cleaner. Using a 6” to 8” rigid feeder wire (metal hanger type wire) taped the terminated end (non-ring terminal) of the harness. Feed the rigid feeder wire through the exterior service port using care to ensure the feeder wire exits inside the cab through the X cut. While applying support pressure to the inside X cut area, pull the feeder wire, and harness terminal through the X cut into the cabin. Once the terminated end of the harness is inside the cabin, continue to pull the harness into the cabin and route behind the HVAC duct as shown below. You will need to leave enough of the harness Under hood to route

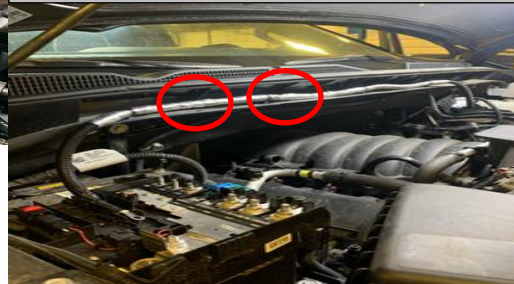
To run the power harness to the fuse block two 6mm holes, need to be drilled to add access for retainer clip on these Denali and AT4 trucks. The holes are in the sheet metal but not in the plastic.

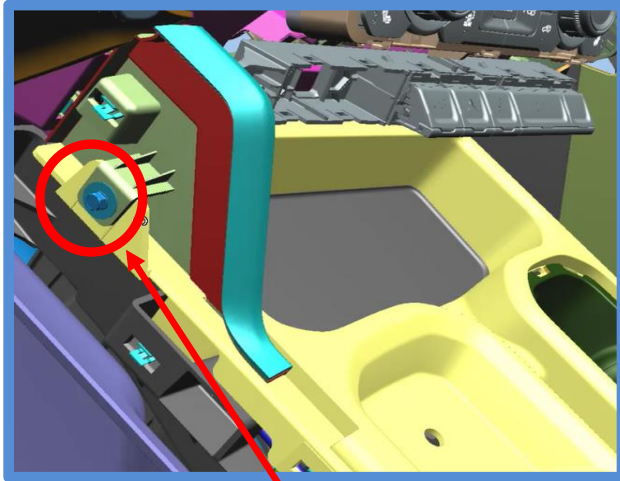
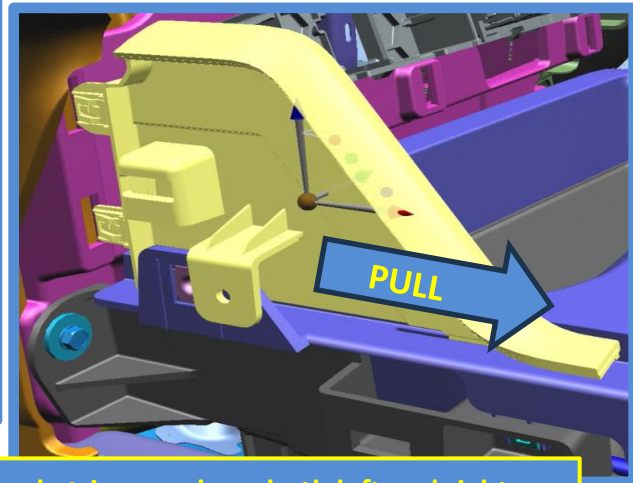
1. You will need to remove the - [Front Floor Console Extension Panel - Left Side](#)
2. Removing both Left and right - [Front Floor Console Applique](#)

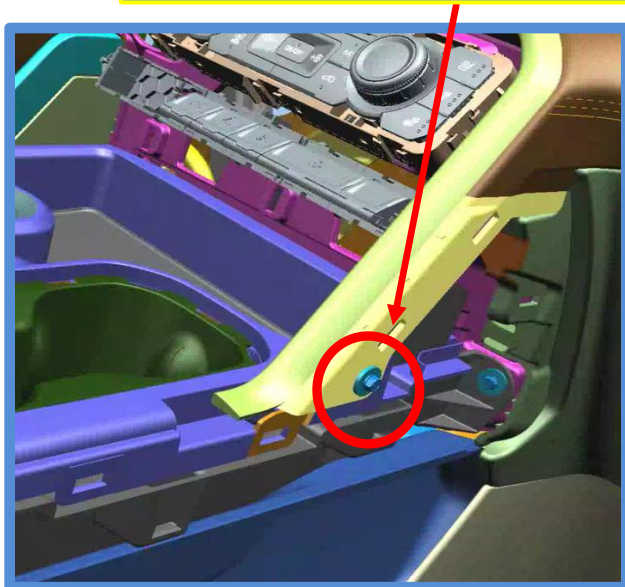
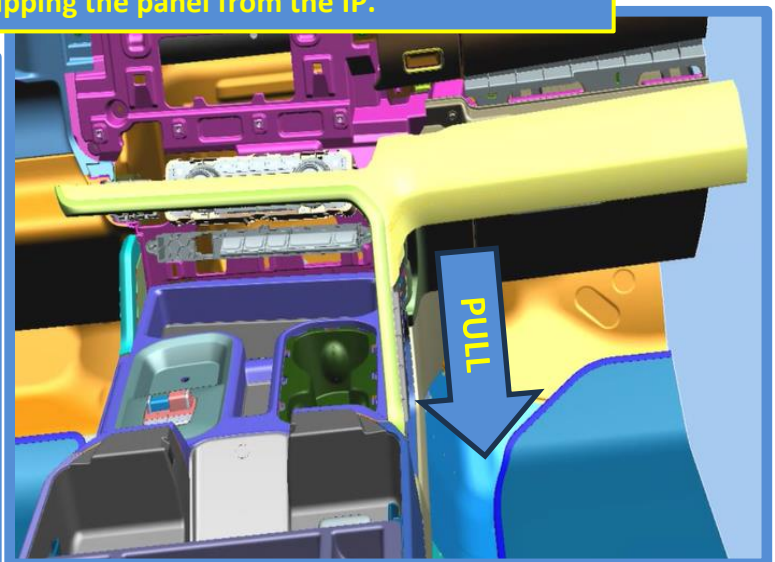
Next you need to remove the lower console trim panels on both left and right side by removing the screw and unclipping the panel from the IP.

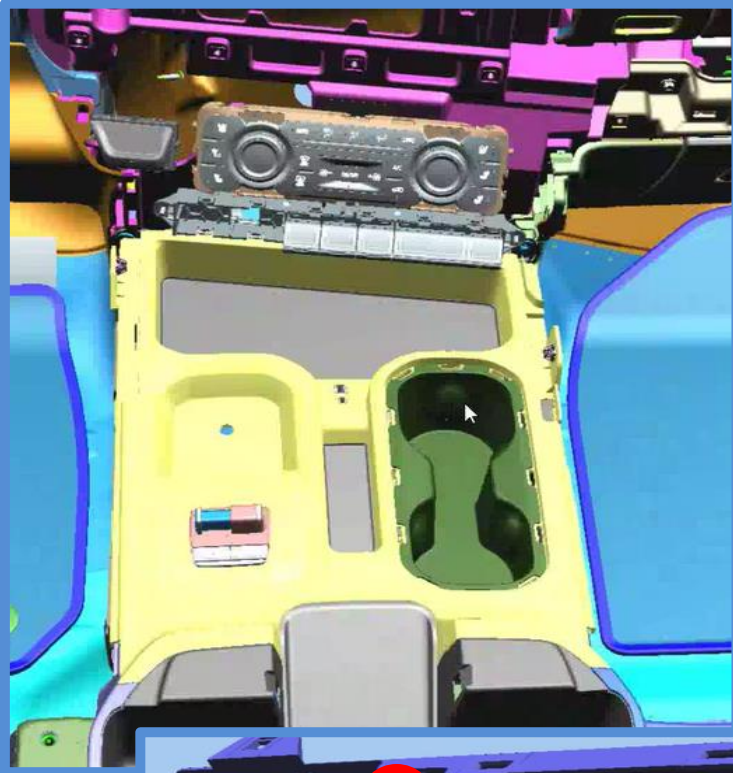
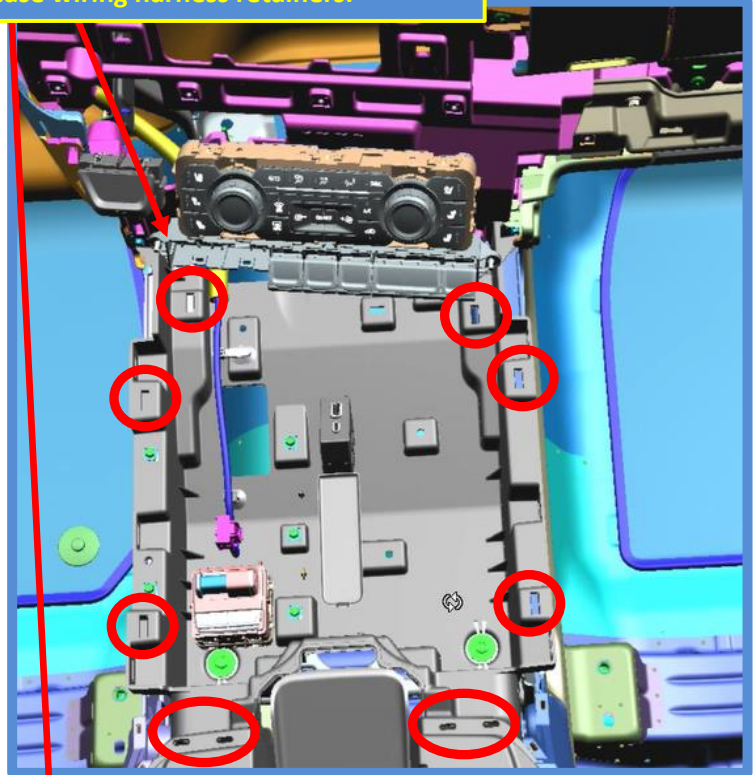
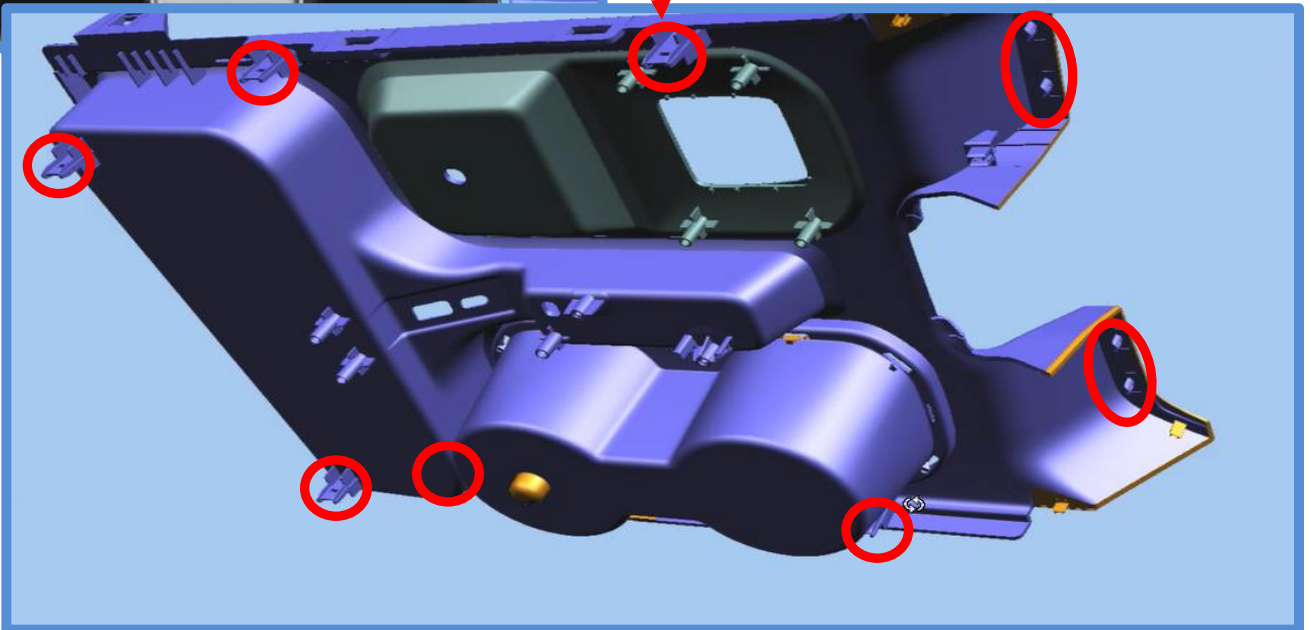
When removing the Console panel, there are ten(10) retainer clips holding down this panel. Use a flat-bladed plastic trim tool. Caution when lifting as the USB, trailer brake controller, ignition lock key antenna, low frequency console antenna etc. will be attached. Disconnect Electrical connectors and release wiring harness retainers.

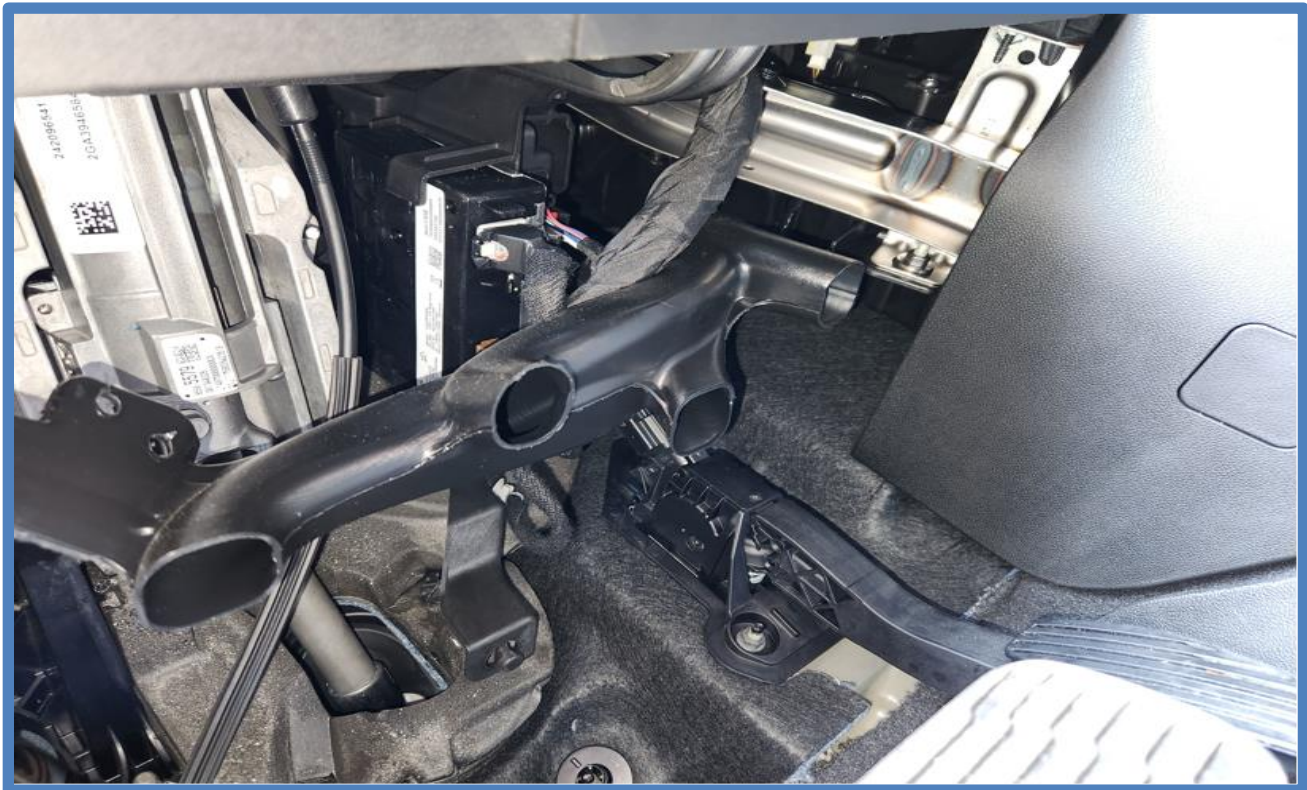
2. Mount the IP Aux. Fuse block using Zip ties on the front(engine side) of the driver's side HVAC extension duct under IP. Where the harness exits the aux fuse block, it should face toward drivers' outboard side, when the fuse block is mounted on the driver's side HVAC extension duct. Remove the u-nuts from the mounting ears of the aux fuse block. Apply two-sided tape to the aux fuse block, spanning between the two mounting ears. Insert a zip tie thru the hole for each of the mounting ears. Position the aux fuse block to the front (engine side) of the driver's side HVAC extension duct as shown, then secure the two-sided tape and zip ties. Add two additional zip ties, one on each mounting ear, positioned between the first zip ties and the body of the fuse block, as shown below.

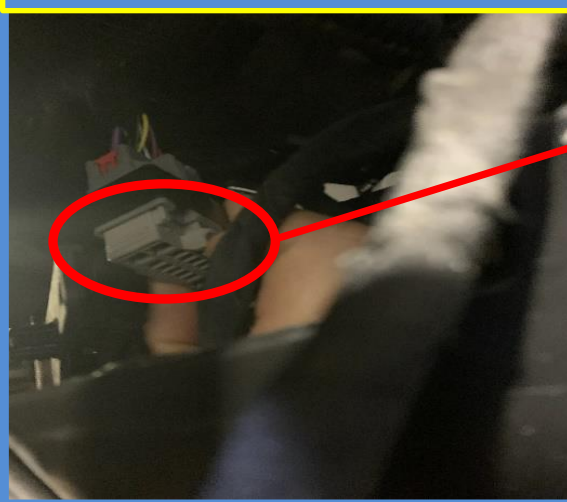
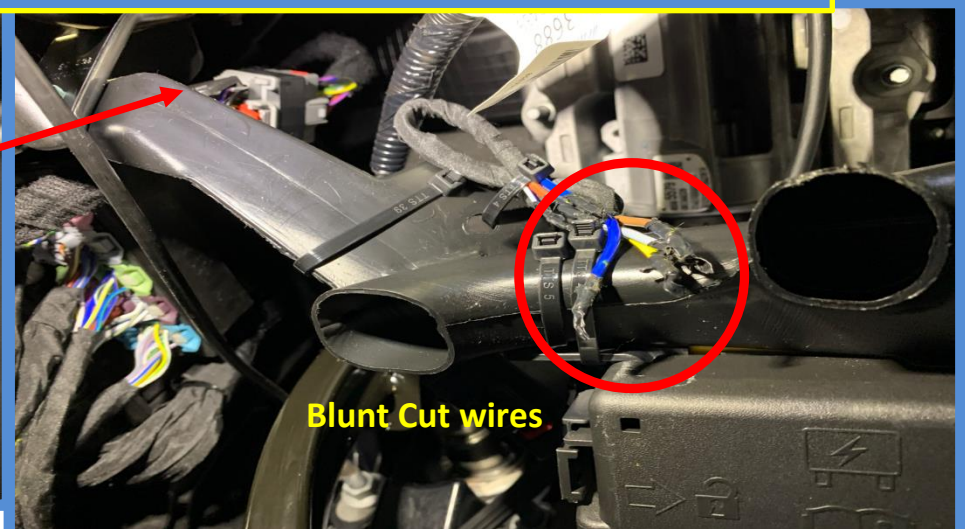
Figure 2

Connect the 14-pin connector Aux Fuse Block to the connector shown in figure 2 (note vehicle is shipped from the assembly plant with a blank connector in place to protect the terminals in the IP Harness. Remove this prior to connecting the connector from the fuse block)

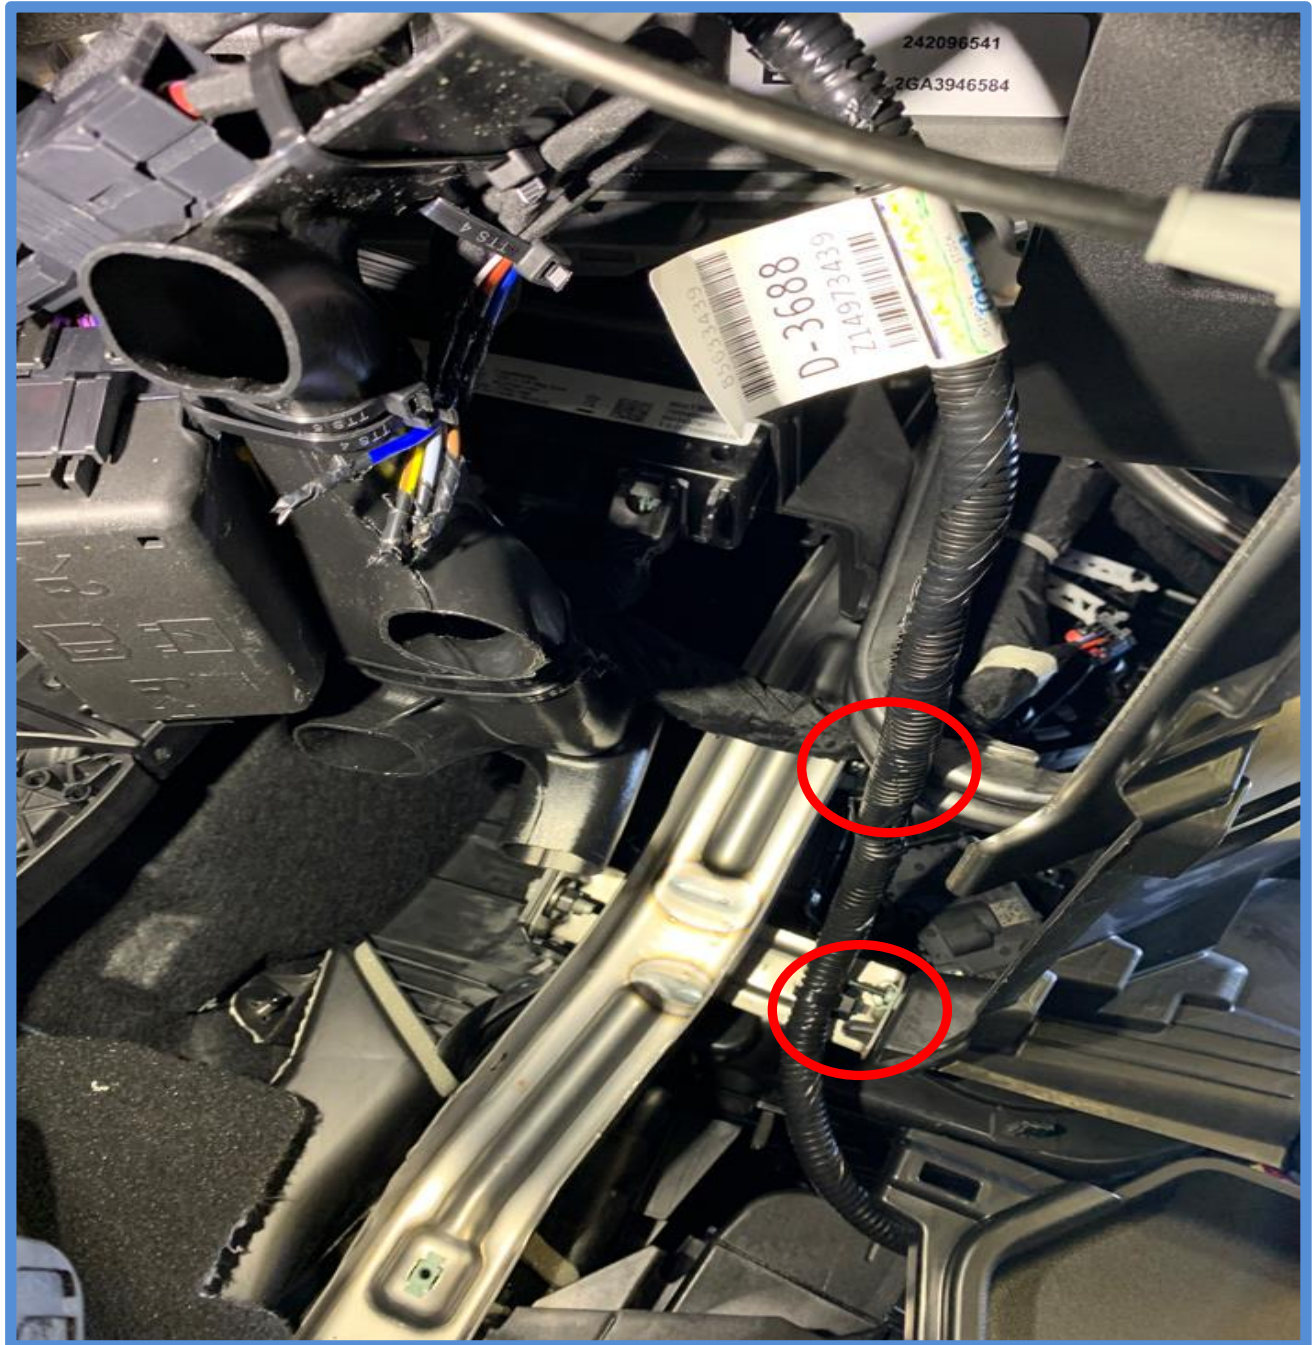
3. Route the 16-pin switch bank connector harness on the front side of the driver side HVAC extension duct meeting your first retainer clip on the IP. Through the opening in the IP illustrated below insert the retainer clip and continue to route the harness under the HVAC control center, continuing into the console securing the harness retainer clips as illustrated in figure 5. Retrofits will need to drill a 6mm hole to insert the final harness retainer clip see figure 5 for illustration.

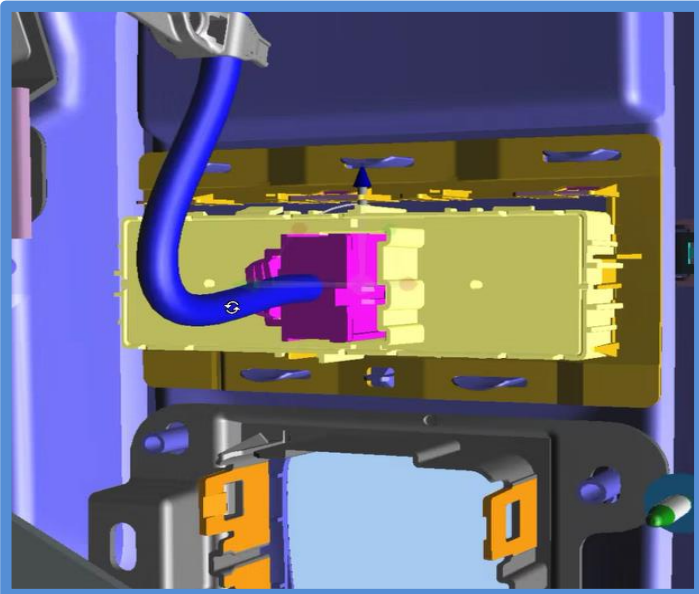
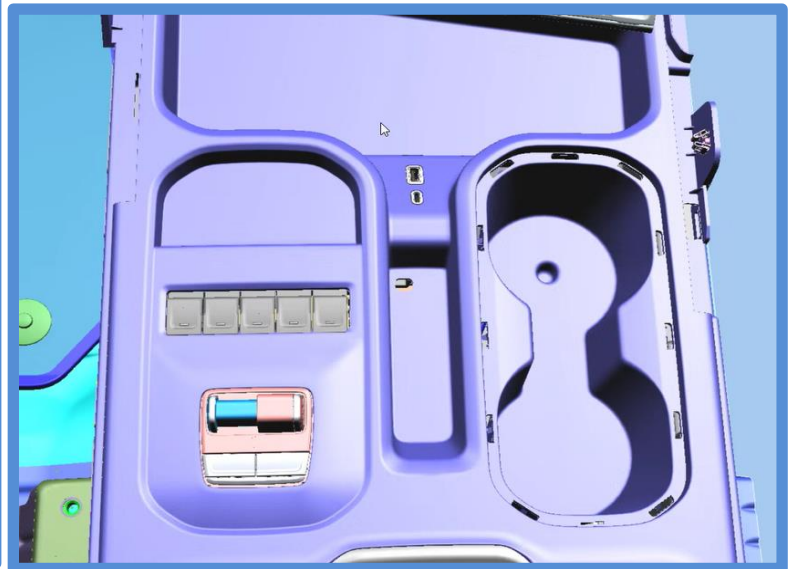
4. With switches installed into the new console panel in the provided cut-out. Connect the switch connector/harness and any other electrical connections – Installed the console panel and reassemble the removed components per the GM service procedures used to remove them, as listed throughout this bulletin.

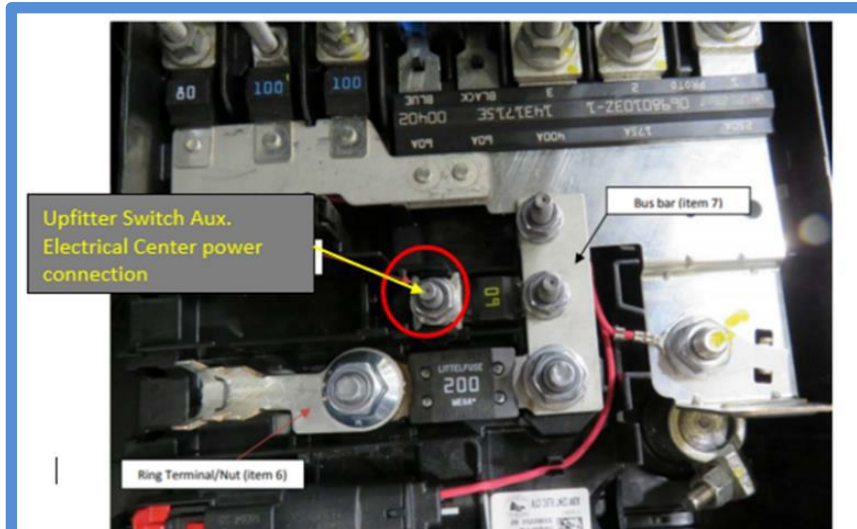
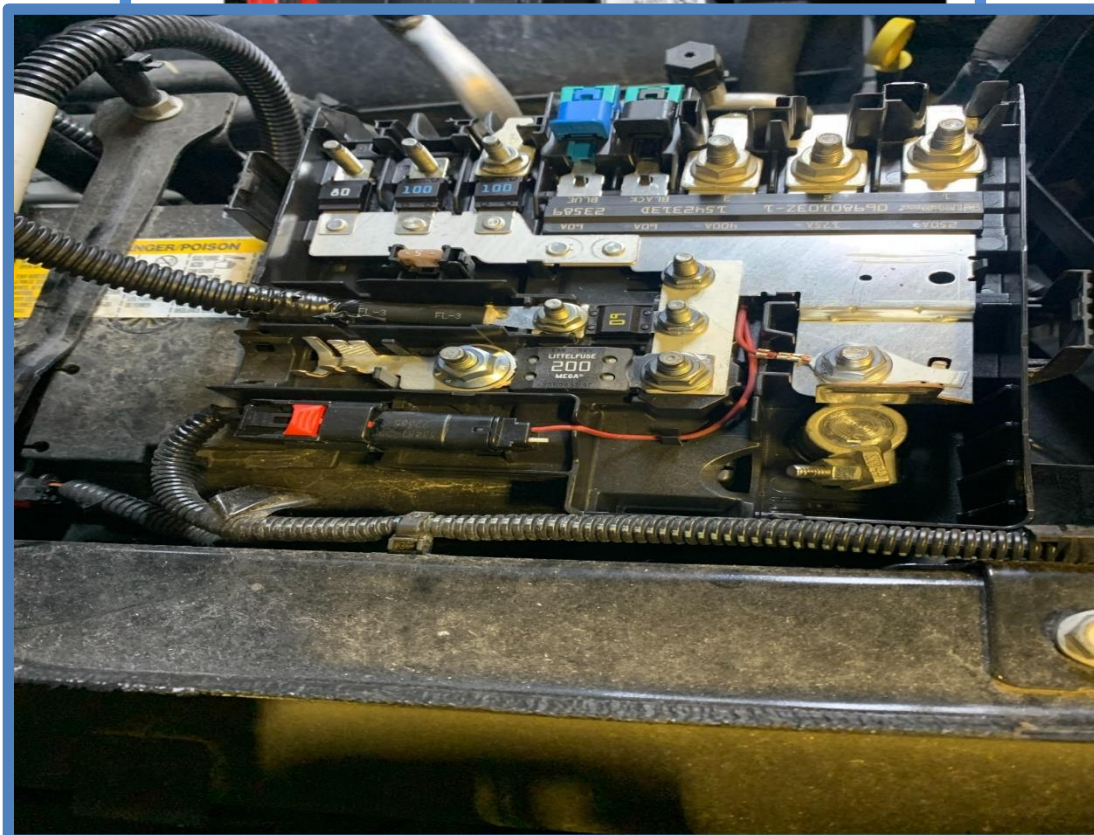
1. Once all "kit" components have been installed, the Aux Fuse Block can now be powered, for detailed instructions on adding the fuses to the battery mounted electrical center refer to the latest revision of UI Bulletin #147. (<http://www.gmupfitter.com/pages/technical-bulletins>)
2. Following the installation of the fuse kit to the battery mounted electrical center, connect the power cable ring terminal to the 60-amp fuse output side stud.

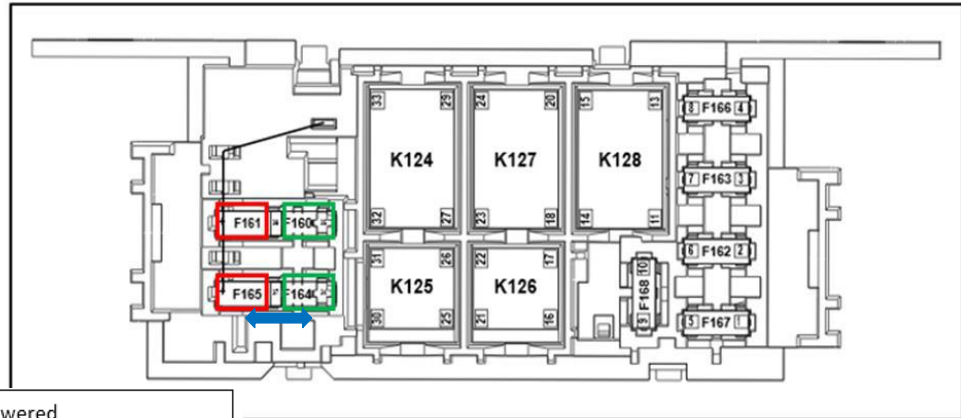
The upfitter switches are defaulted to being battery powered but can be reconfigured in pairs to operate only when in accessory/ignition ON by relocating one or two fuses as shown below.

- Red = Battery Powered
 - Green = Ign. Run/Crank Powered
- Fuse Position 160/161 = Switches 1 and 2
 Fuse Position 164/165 = Switches 3 and 4
