Subject: Installation of Upfitter (AUX) Switches (9L7) components
Models Years 2024-Current
Affected:
Models Affected Full-size GMC Trucks – Premium Uplevel Trim
 Denali/Ultimate/AT4/AT4X
Origination Date: 10/24/2024
Revision Date: N/A

<u>UI Bulletin Usage Table</u>			
<u>Model Year(s)</u>	<u>Brand</u>	<u>Model</u>	<u>Bulletin #</u>
2024-2025	GMC	2500/3500 Denali/AT4	205

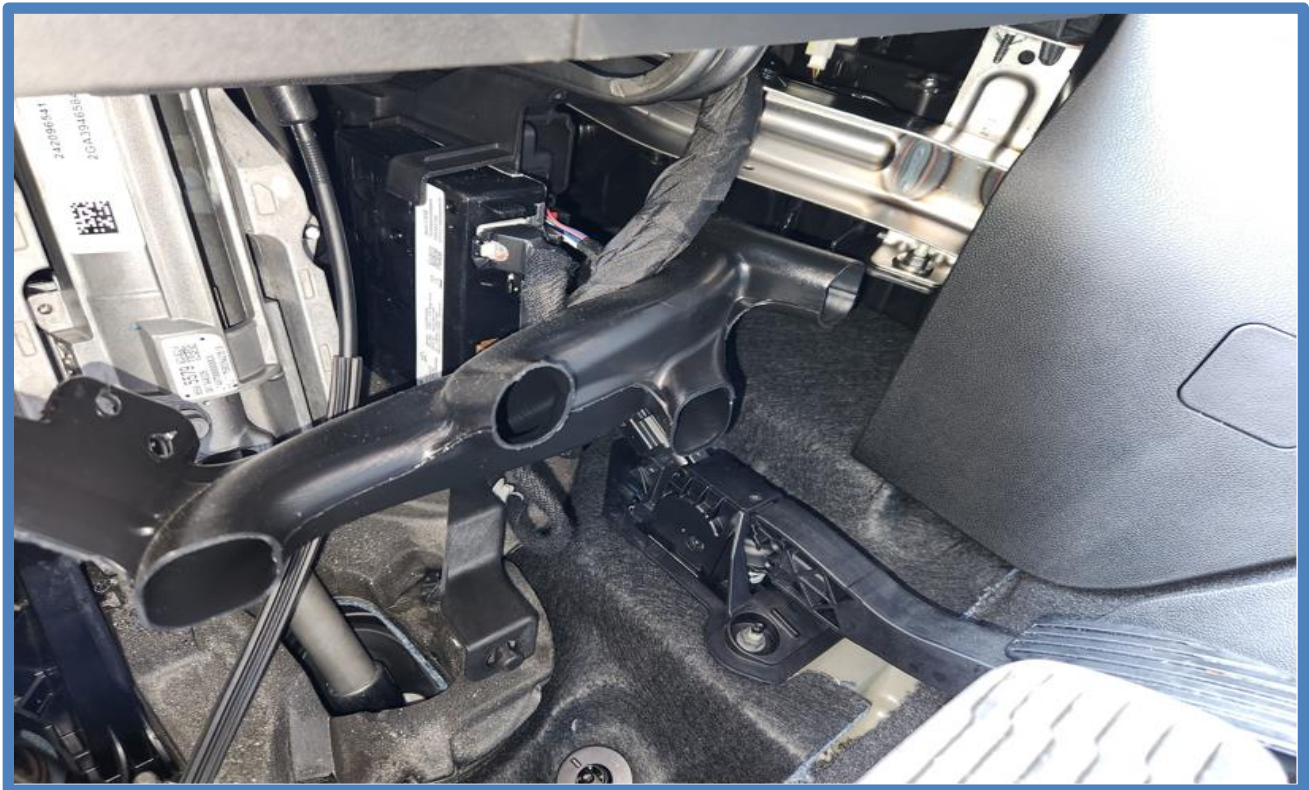
2. Mount the IP Aux. Fuse block using Zip ties on the front(engine side) of the driver's side HVAC extension duct under IP. Where the harness exits the aux fuse block, it should face toward drivers' outboard side, when the fuse block is mounted on the driver's side HVAC extension duct. Remove the u-nuts from the mounting ears of the aux fuse block. Apply two-sided tape to the aux fuse block, spanning between the two mounting ears. Insert a zip tie thru the hole for each of the mounting ears. Position the aux fuse block to the front (engine side) of the driver's side HVAC extension duct as shown, then secure the two-sided tape and zip ties. Add two additional zip ties, one on each mounting ear, positioned between the first zip ties and the body of the fuse block, as shown below.

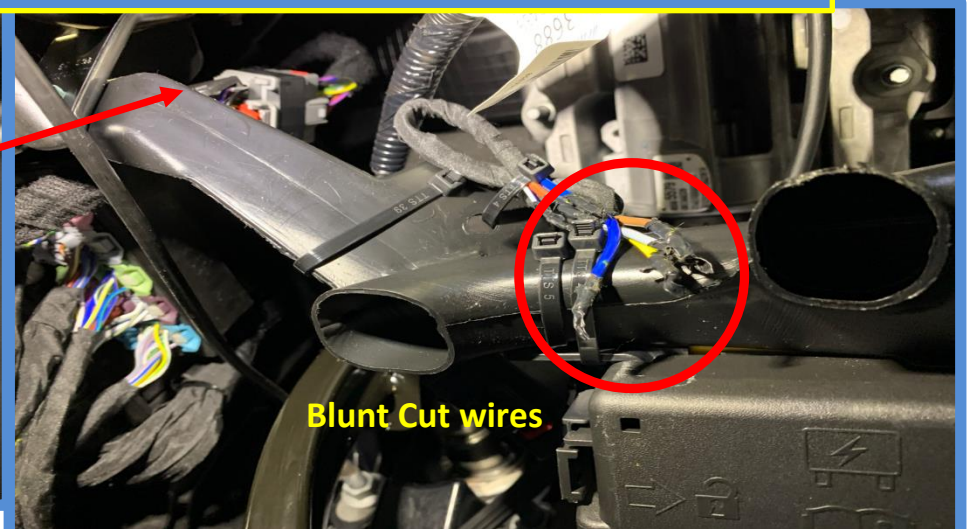
Figure 2

Connect the 14-pin connector Aux Fuse Block to the connector shown in figure 2 (note vehicle is shipped from the assembly plant with a blank connector in place to protect the terminals in the IP Harness. Remove this prior to connecting the connector from the fuse block)
