Subject: Information on Hesitation and/or Misfire
Sensation When Passing Under High Voltage
Transmission (Power) Lines, - Multiple
Intermittent ABS DTCs Set

Models Chevrolet Express/GMC Savana

Origination October 30, 2025

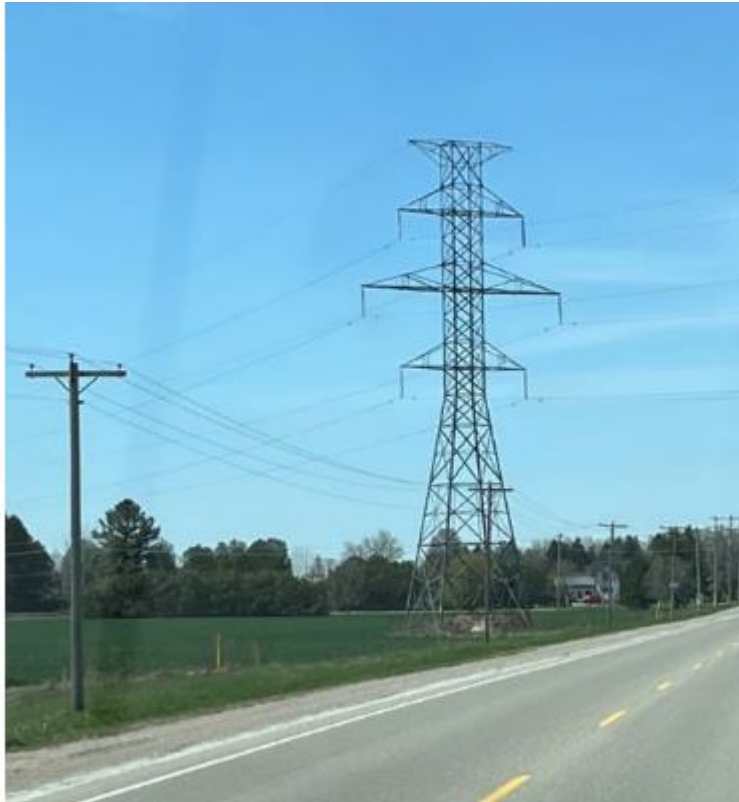
This condition may be caused by an Upfitter Box aluminum roof bows, acting as an antenna when passing under high voltage lines.

- The roof bows are dissipating electrical spikes into the vehicles electrical system.
- Suspect that the proximity of the EBCM to the ungrounded portion of vehicle, is why most DTCs are EBCM related.

To mitigate the interference into the electrical system, at least the first three roof bows need to be grounded.

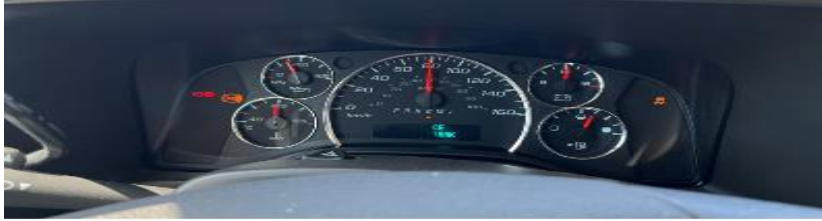
When looking at GDS Freeze Frame Data, rear wheel speed sensors will appear to have momentarily increased in speed. Pico scope voltage measurement across battery terminals will intermittently spike in voltage to over 30V at times.

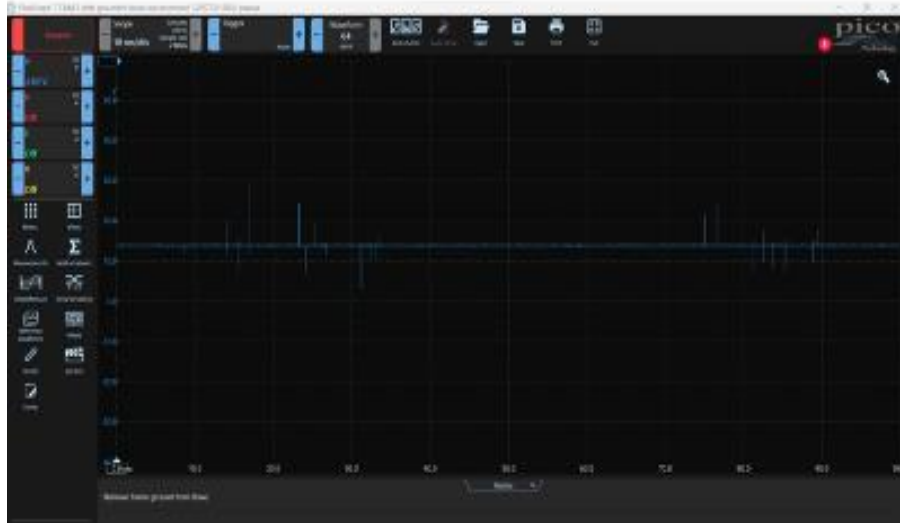
PICO Scope reading measured across battery terminals. Picture shown is prior to adding ground cable to box roof bows.

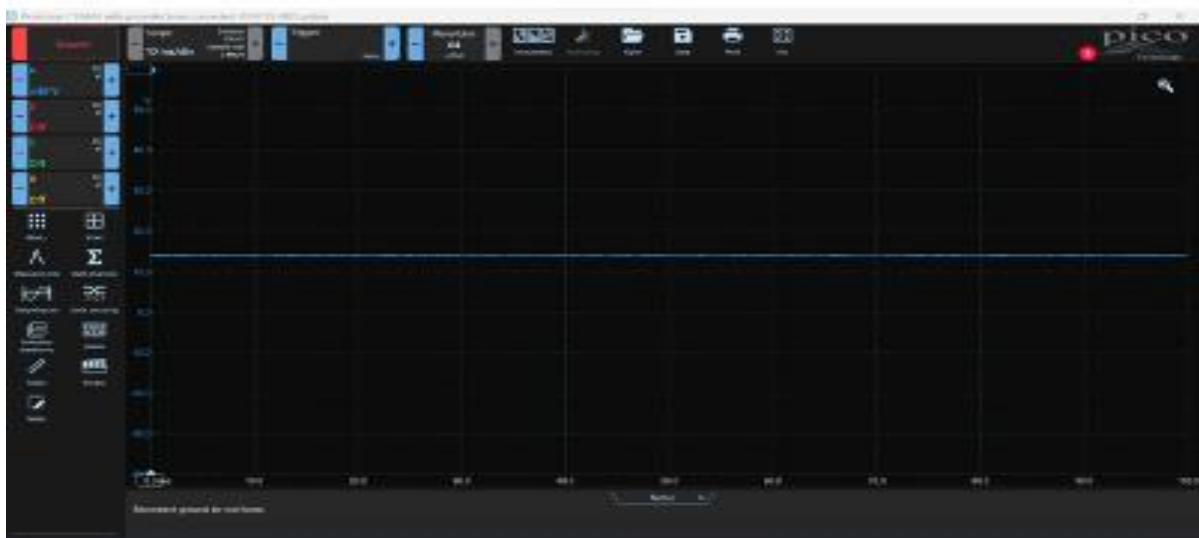
PICO Scope reading measured across battery terminals after ground cable installation.
