Subject Installation of Upfitter (AUX) Switches
(9L7) components

Model Years Affected 2022i -2024

Models Affected Chevrolet Silverado
GMC Sierra

Origination Date August 1, 2023

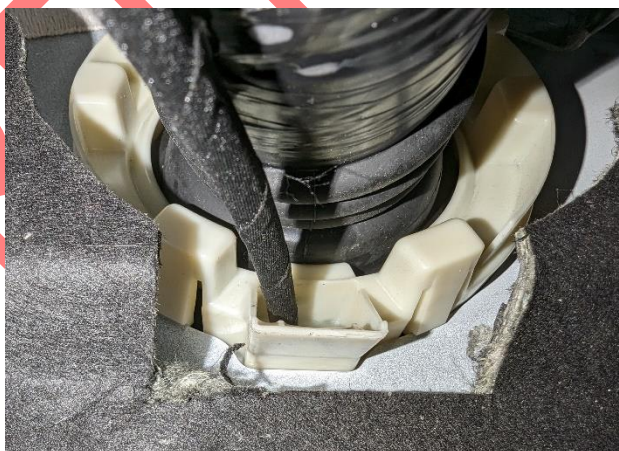
Prior to attempting to pass the wire/harness into the cabin the silver-colored insulation and plastic conduit must be removed, leaving only fabric like tape wrapping on the wire.

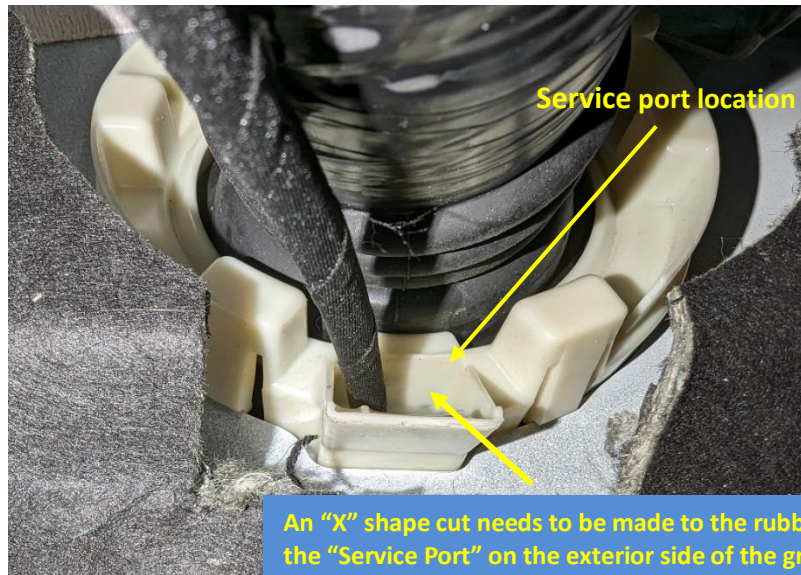
The "service port" or wire pass-thru is located at the 6 o'clock position on the wire harness grommet as shown below. The rubber seal inside of the service port will need to have an "X" cut into to provide for the wire to be passed.

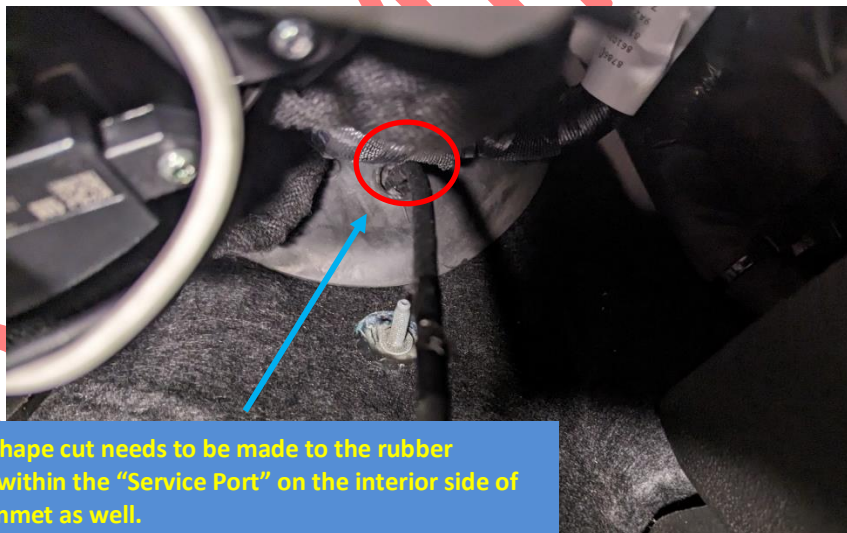
A similar "X" shape cut must be made to the interior cabin side of the grommet located under the IP on the RH side just below the HVAC module— see below

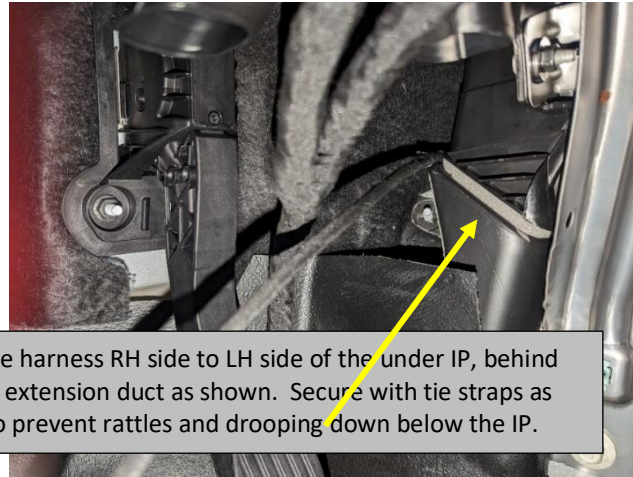
Route wire harness RH side to LH side of the under IP, behind the HVAC extension duct as shown. Secure with tie straps as needed to prevent rattles and drooping down below the IP.

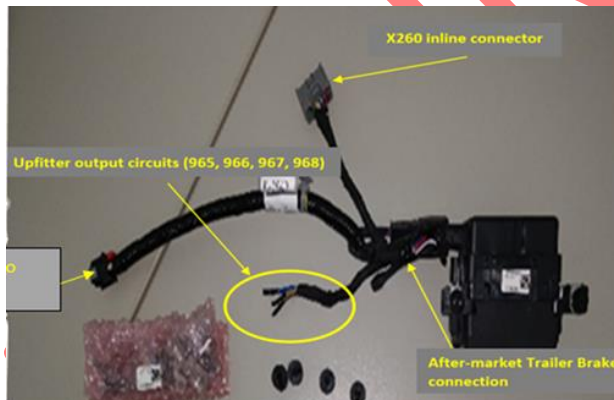
NOTE: For all vehicle trim level applications the components shown below will need to be installed

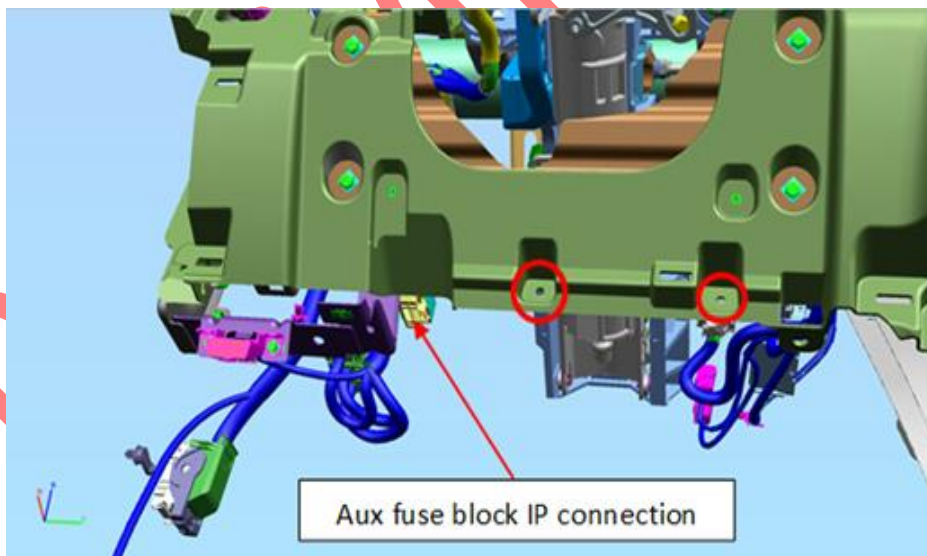
Connect the 14-pin connector Aux Fuse Block to the connector shown in figure 4 (note vehicle is shipped from the assembly plant with a blank connector in place to protect the terminals in the IP Harness. Remove this prior to connecting the connector from the fuse block)

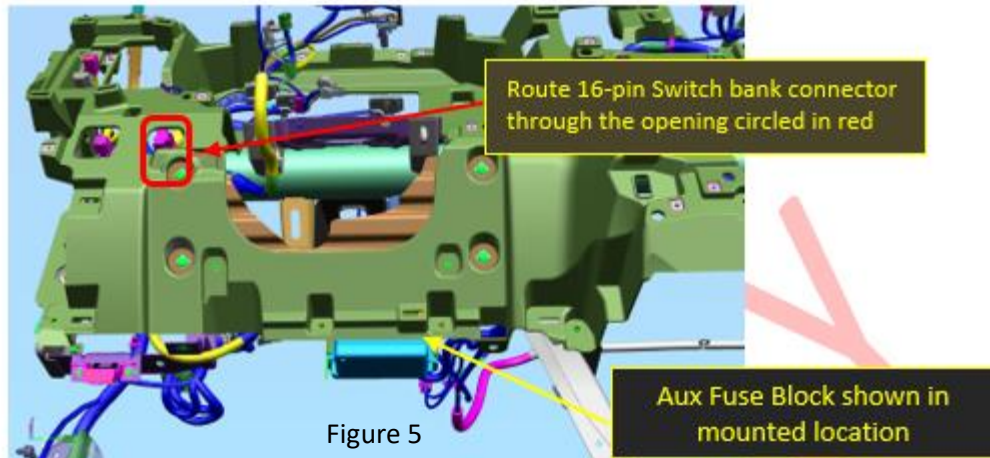
2. Route the 16-pin switch bank connector through the opening in the Instrument Panel as shown in figure 5

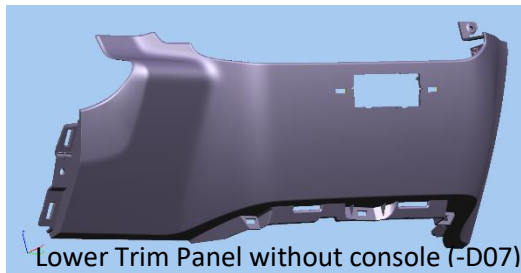
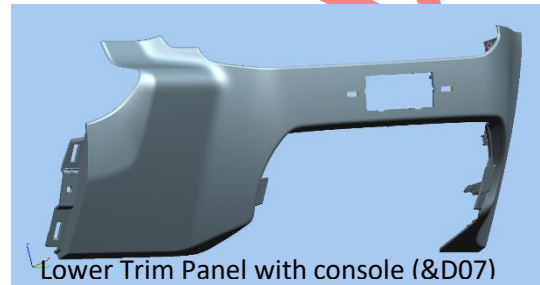
3. Using the listed fasteners, install the Aux Electrical Center using the mounting holes locations shown in the figure above.
4. Install switches (if not already installed from the factory) in the lower trim panel extension (using new trim panel if adding the 9L7 option) as shown in the figures below

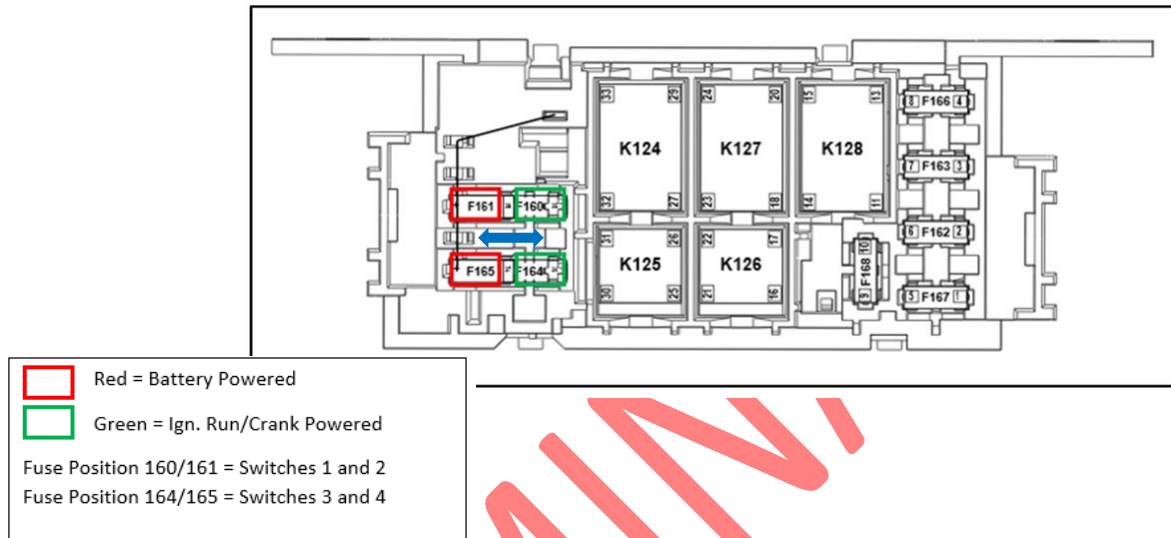
The upfitter switches are defaulted to being battery powered but can be reconfigured in pairs to operate only when in accessory/ignition ON by relocating one or two fuses as shown below.
