UI Bulletin #193d

Subject Installation of Upfitter (AUX) Switches
(9L7) components
Model Years 2022i -2024
Affected
Models Chevrolet Silverado
Affected GMC Sierra
Refer to the UI Bulletin Usage table below
Origination
Date May 29, 2024
Revision
Date N/A

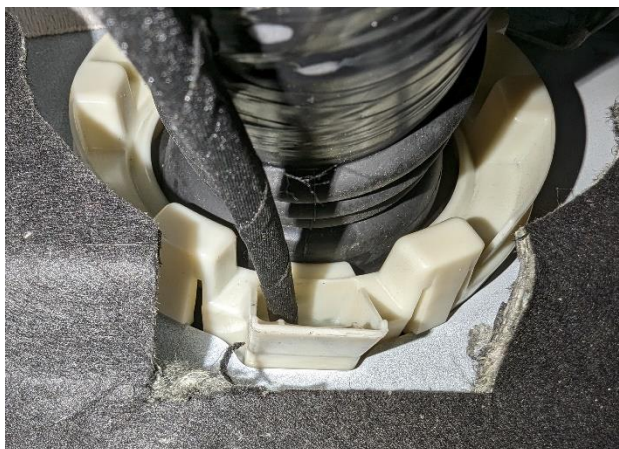
Prior to attempting to pass the wire/harness into the cabin the silver-colored insulation and plastic conduit must be removed, leaving only fabric like tape wrapping on the wire.

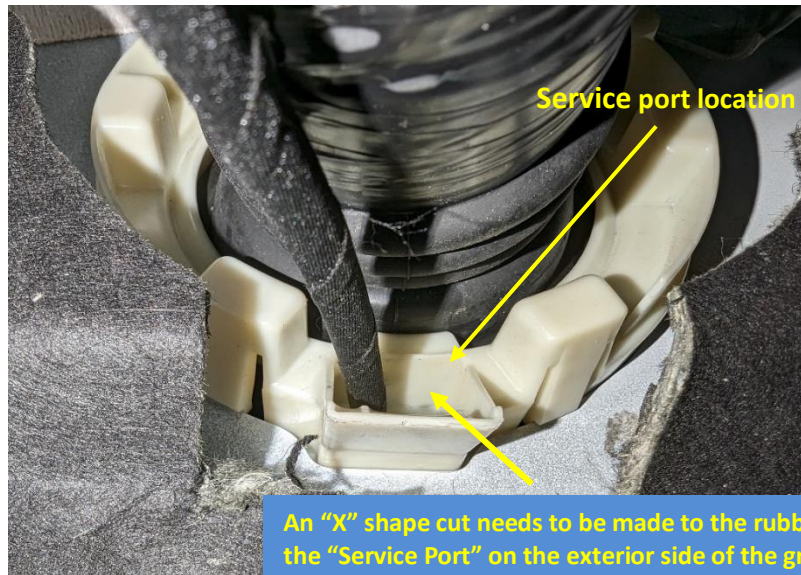
The "service port" or wire pass-thru is located at the 6 o'clock position on the wire harness grommet as shown below. The rubber seal inside of the service port will need to have an "X" cut into to provide for the wire to be passed.

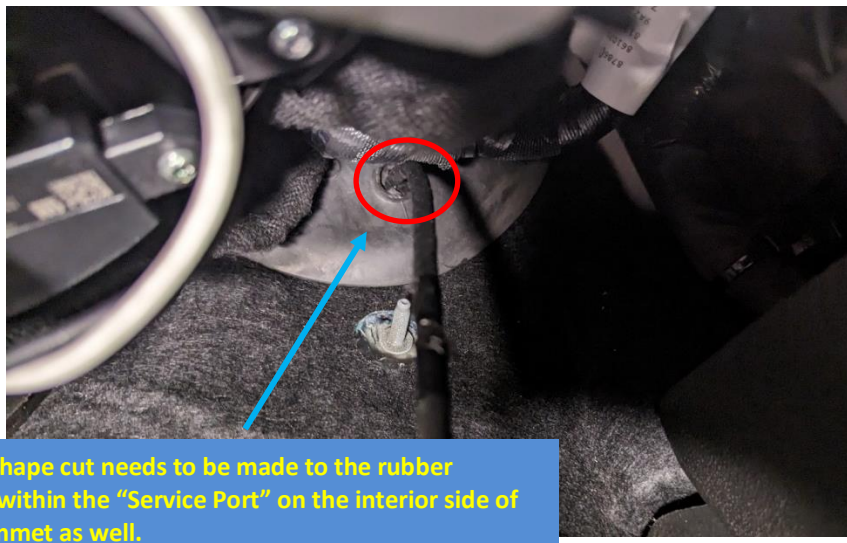
A similar "X" shape cut must be made to the interior cabin side of the grommet located under the IP on the RH side just below the HVAC module— see below

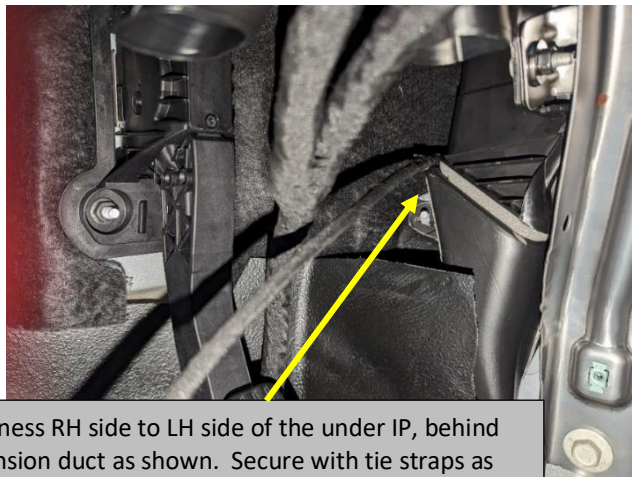
Route wire harness RH side to LH side of the under IP, behind the HVAC extension duct as shown. Secure with tie straps as needed to prevent rattles and drooping down below the IP.

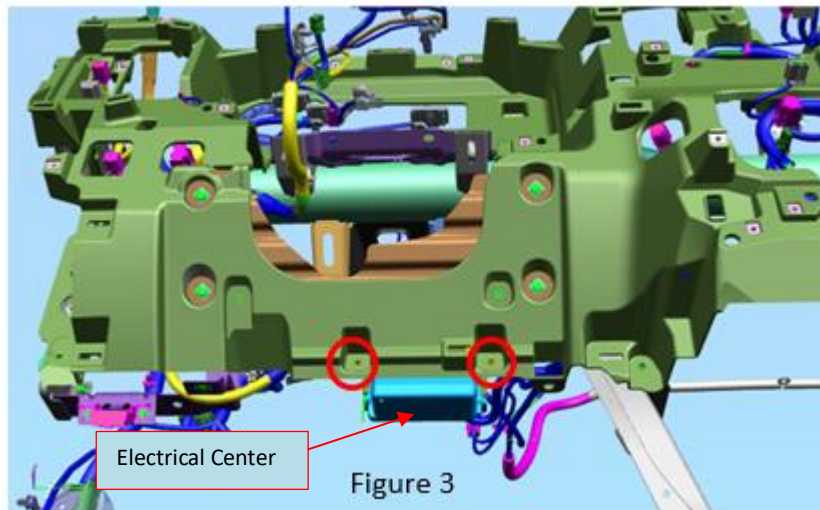
1. Mount the IP Aux. Fuse block using the 2 screws in the locations circled in RED as shown in figure 3

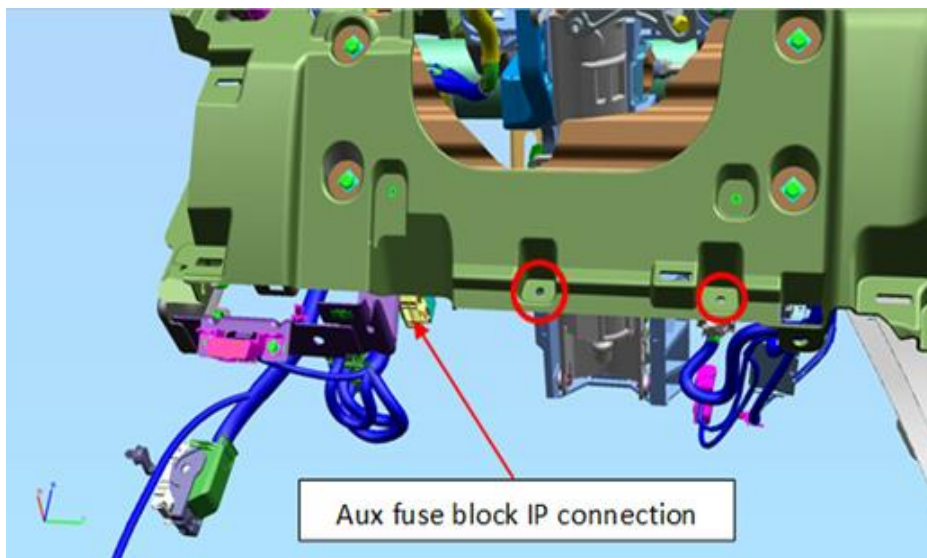
Connect the 14-pin connector Aux Fuse Block to the connector shown in figure 4 (note vehicle is shipped from the assembly plant with a blank connector in place to protect the terminals in the IP Harness. Remove this prior to connecting the connector from the fuse block)

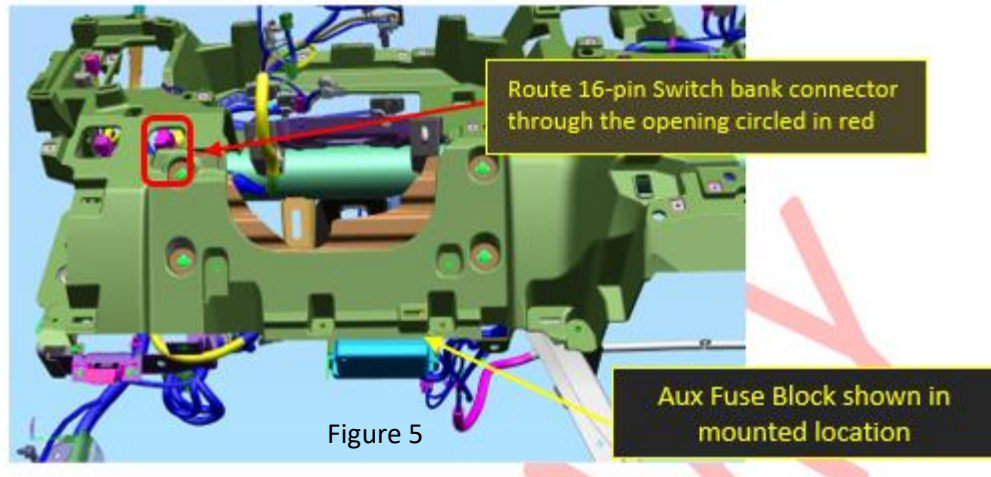
2. Route the 16-pin switch bank connector through the opening in the Instrument Panel as shown in figure 5

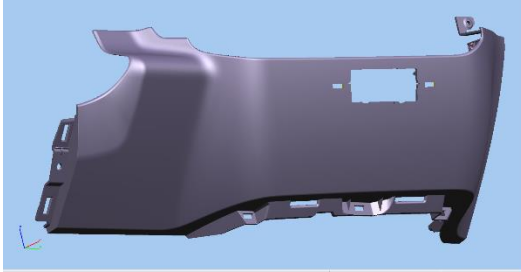
Lower Trim Panel without console (-D07)

3. Using the listed fasteners, install the Aux Electrical Center using the mounting holes locations shown in the figure above.
4. Install switches (if not already installed from the factory) in the lower trim panel extension (using new trim panel if adding the 9L7 option) as shown in the figures below

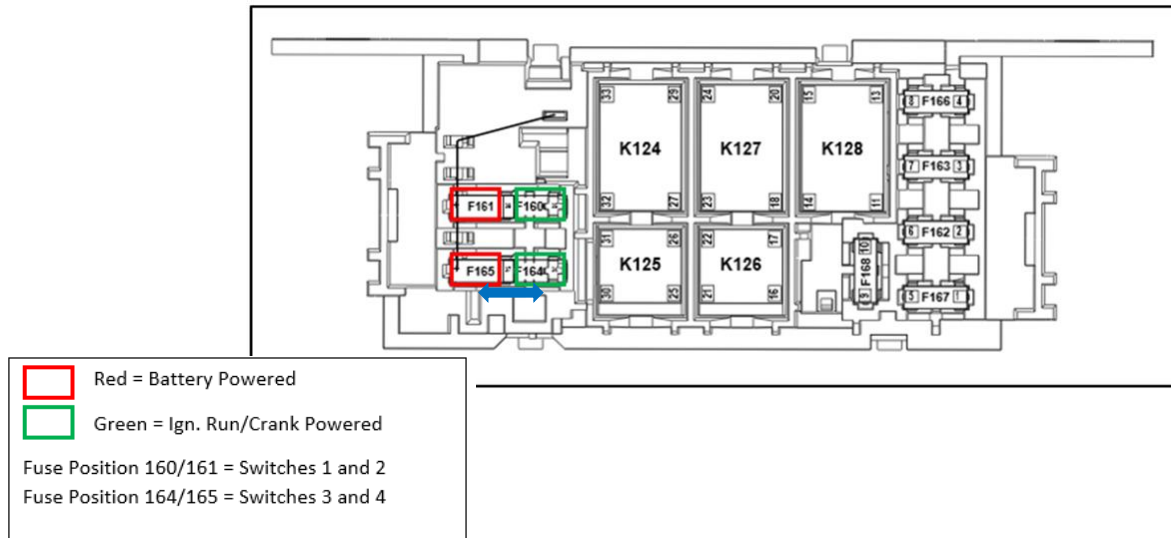
The upfitter switches are defaulted to being battery powered but can be reconfigured in pairs to operate only when in accessory/ignition ON by relocating one or two fuses as shown below.
