UI Bulletin #111

Subject: **Auxiliary Power Connections**

Models: Chevrolet Caprice PPV (w SEO K5S-auxiliary battery)

Model Years: 2011-2014

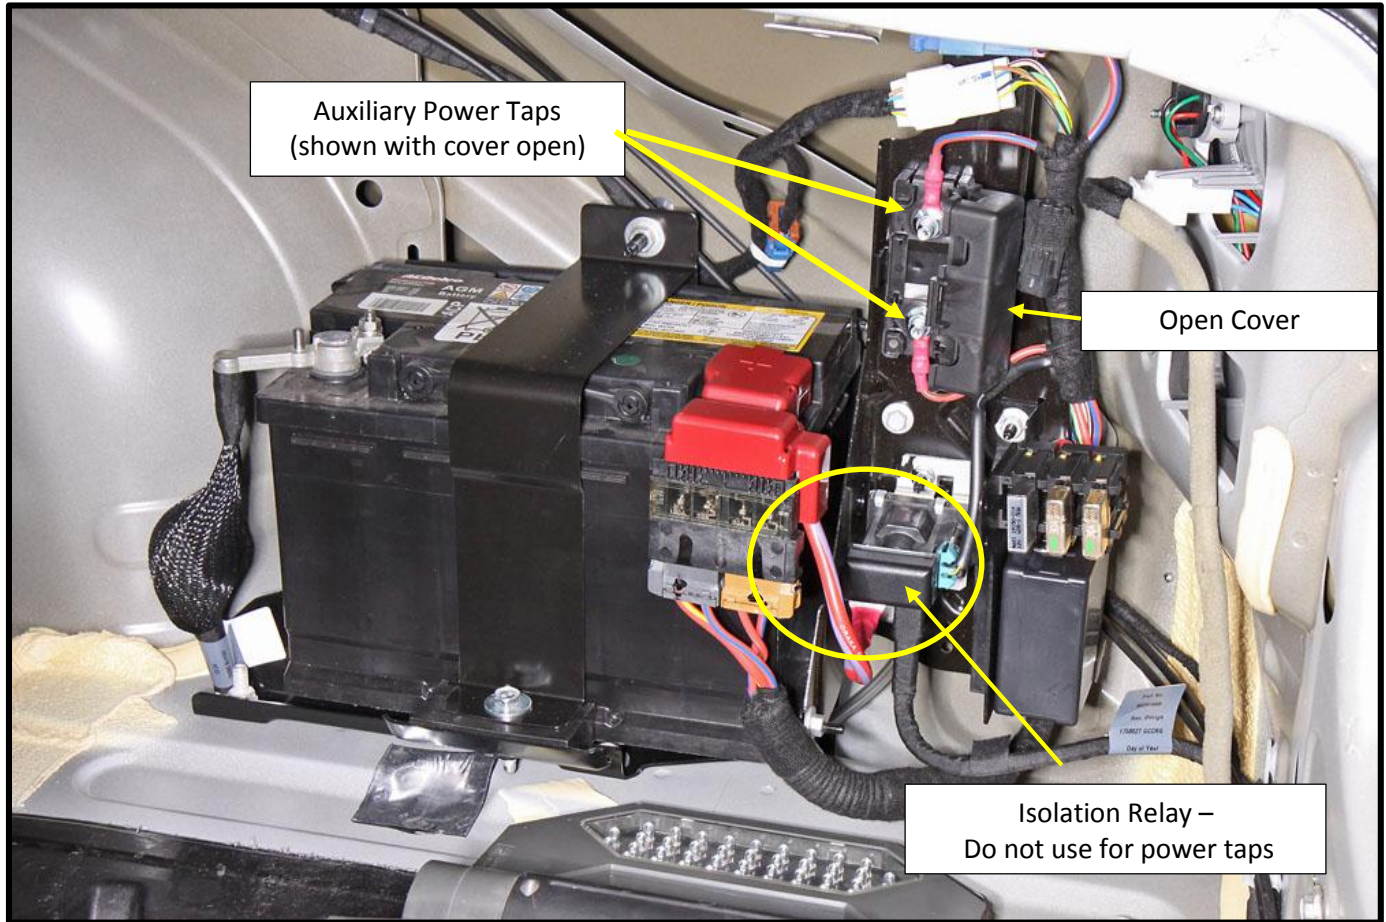
The Caprice PPV equipped with the auxiliary battery (SEO K5S) utilizes an isolation relay to protect the auxiliary battery from being discharged during engine starting. To eliminate the possibility of improper power tapping refer to the image below to identify the location of the proper power taps on vehicles equipped with the auxiliary battery (SEO K5S) which is located in the trunk of the vehicle directly behind the RH wheel.

Improper electrical connections using the power studs on the Isolation Relay rather the provided power studs. Any added power circuit in the trunk electrical center should not utilize the studs on the isolation relay
