Subject: Adding or Installing a Rearview Camera
Models Years Affected: 2019 - beyond

Models Affected: Chevrolet Silverado/GMC Sierra Full-Size box delete (ZW9) Pickups and Chassis Cabs (NEW body style)

Origination Date: June 21, 2019

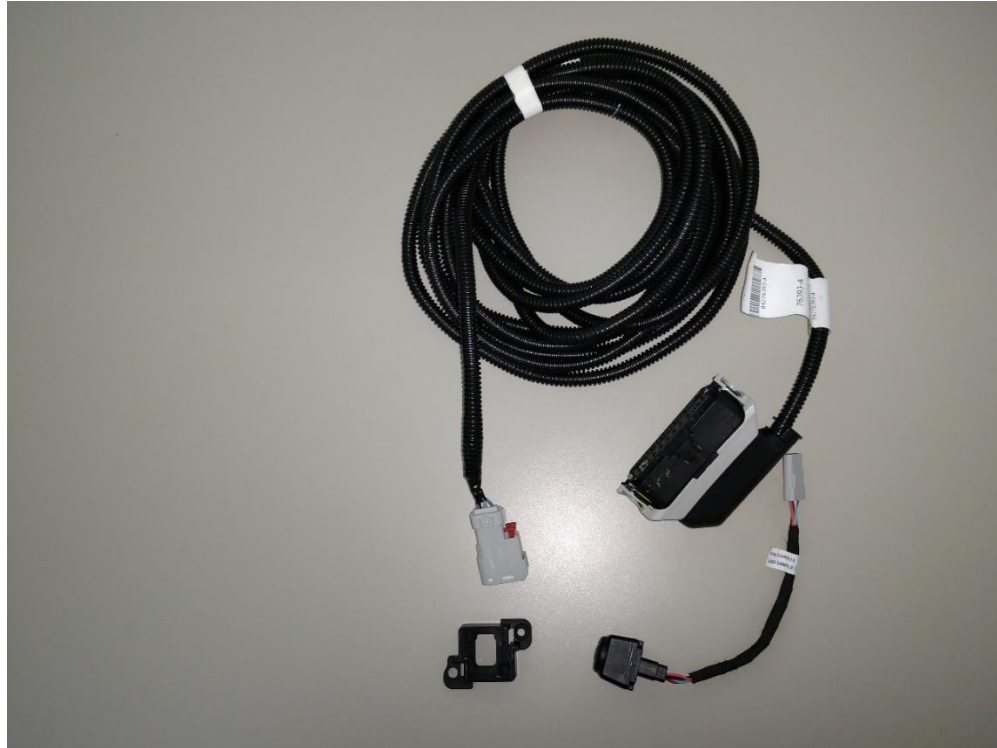
Kit P/N 84759865 (for use with 5N5 and IOR radio)		
Contents:		
Note: Kits are not available from Service Parts – Only Individual pieces as listed below		
Component	Part Number	Quantity
Camera	23390515	1
Bracket	84809886	1
Harness	84682149**	1
Attachment Clip	84606061	12

*Attachment clip not show

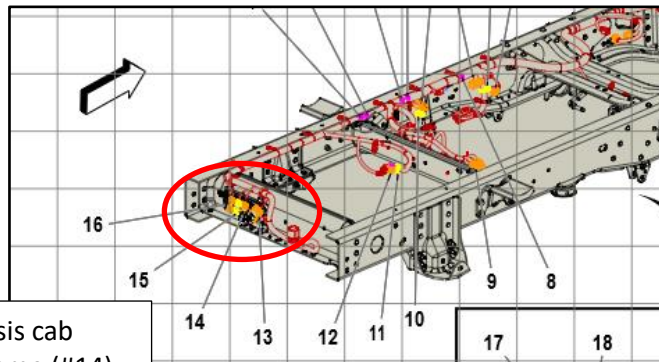
Mating connector on chassis cab models found at rear of frame (#14)

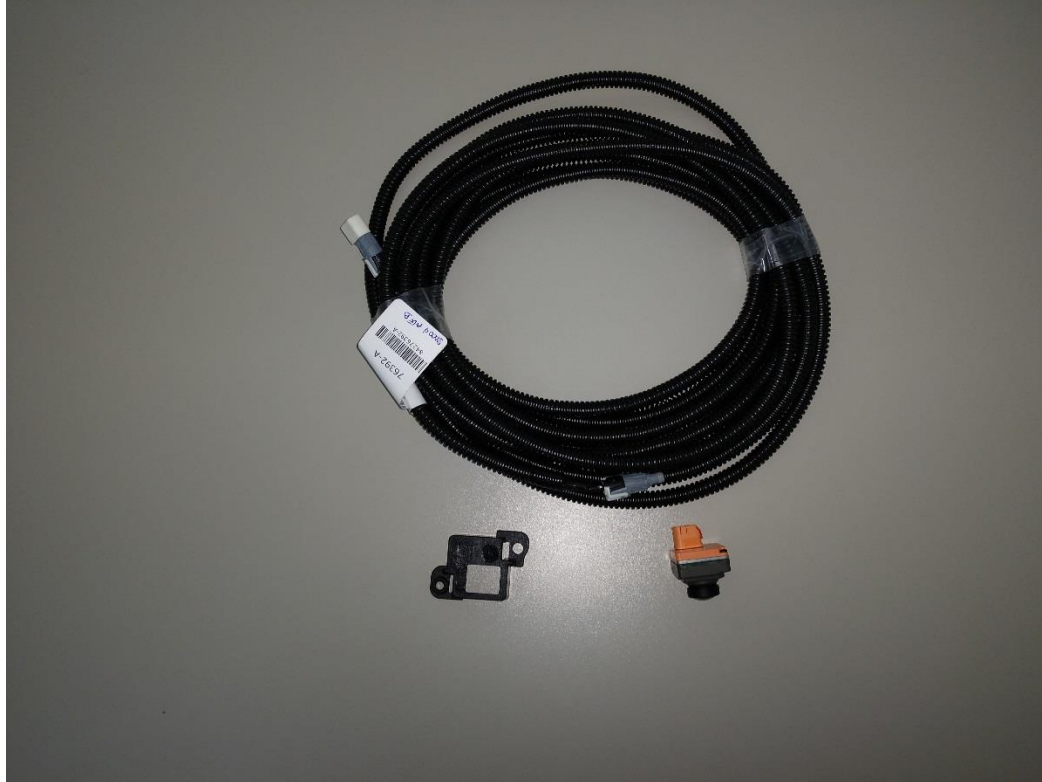
Kit P/N 84754199 (for use with 5N5 with an IOS or IOT radio)		
<u>Contents:</u>		
<i>Note: Kits are not available from Service Part – Only Individual pieces as listed below</i>		
Component	Part Number	Quantity
Camera	84383355	1
Bracket	84809887	1
Harness	84276392	1
Attachment Clip*	84602061	12

*Attachment clip not shown
