Subject:	(NEW) Auxiliary Overhead Switch Bank RPO UEH
Model Year(s):	2020 and beyond
Models Affected:	Chevrolet Silverado 4500HD, 5500 HD and 6500 HD
Origination Date:	March 19, 2020
Revision Date:	N/A

ADVISORY:

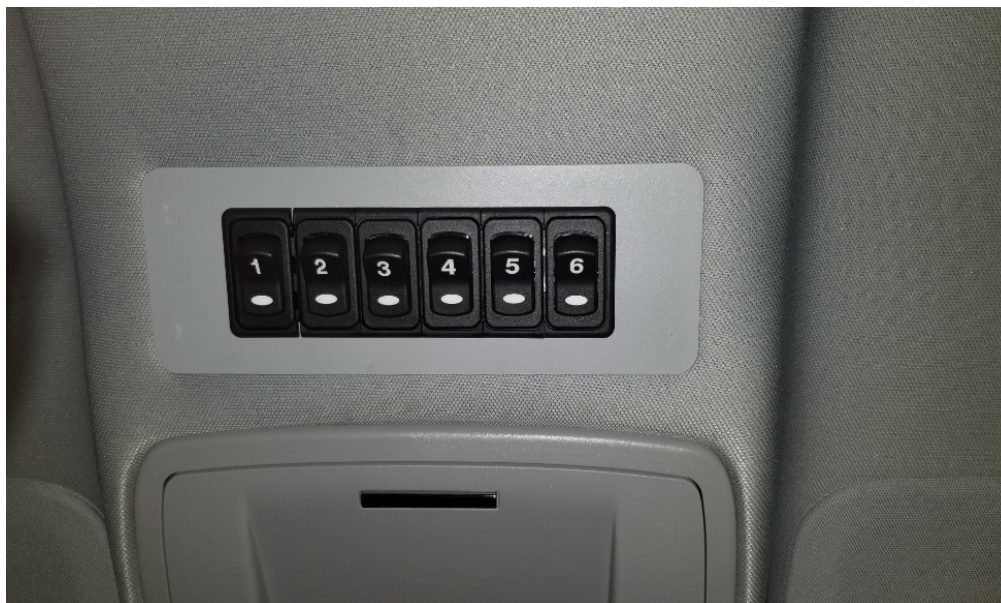
Figure 1

The auxiliary overhead switch bank consists of (6) two position, latching, rocker style switch modules with an on/off indicator window defining ignition on or switch activated. The application of each switch will be defined by the customer/up fitter. The switch bank is in the headliner just behind the overhead console sunglass storage compartment (refer Figure 1). This bank of switches provides additional controlled power circuits via blunt cut wire outputs and can be used for controlling add-on equipment for many vehicle vocational applications.
