Subject: UV Protective covers on Fuel Tanks Components

Models Years Affected: 2017 - Beyond

Models Affected: Chevrolet Colorado/GMC Canyon with box delete (ZW9)
Chevrolet Express/GMC Savana Cut-away vans
Chevrolet Silverado/GMC Sierra with box delete (ZW9) and Chassis Cab Models

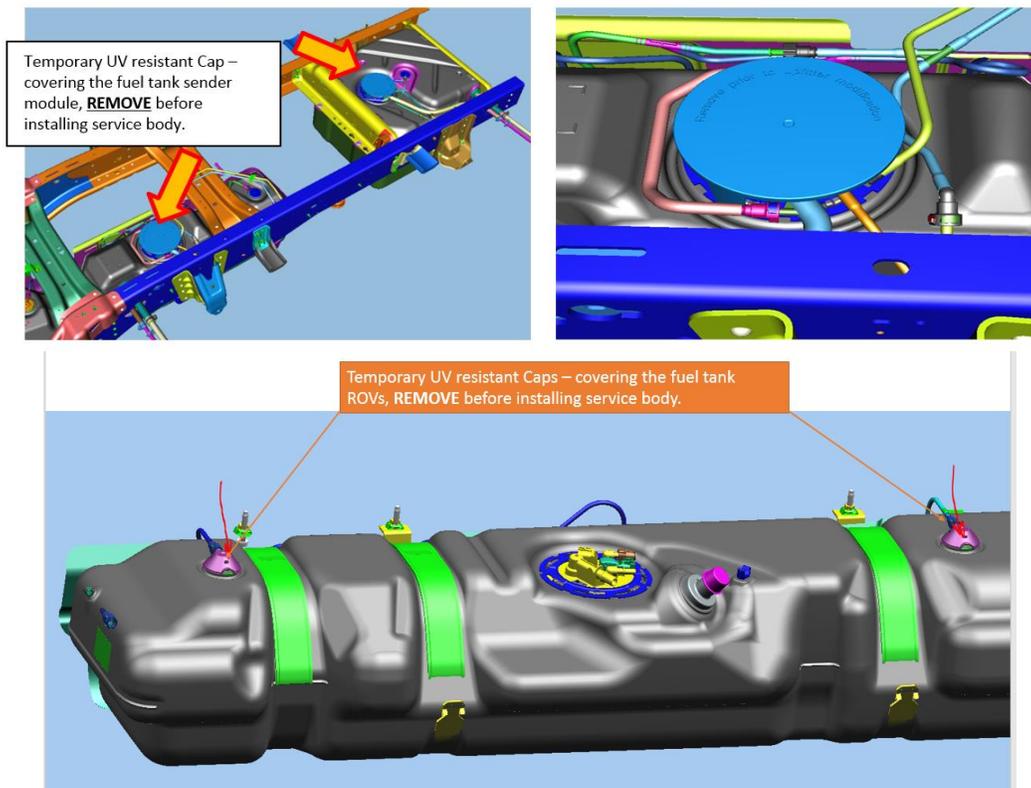
It has been determined that certain fuel tank/emission system components are sensitive to long term exposure to Ultra-Violet (UV) light. These components begin to degrade when exposed to UV light, and because of the extended exposure when stored outdoors, may lead to premature failure. To prevent damage from the long-term UV exposure on vehicles maintained in inventory outdoors, General Motors has implemented a few temporary cover/protective strategies on shipped vehicles where the fuel tank/emission system components are left uncovered following the OEM vehicle assembly process. Please refer to the examples of coverings shown below.

Upfitters are advised that, vehicles **equipped** with any of these types of temporary fuel tank component covers that removal of these coverings prior to the installation of any service bodies or boxes is **REQUIRED**. Failure to remove these covering may result in the collection of debris and possible contact/interference with fuel lines and/or electrical wiring that may cause damage to any of these components.
