Subject Installation After-Market Trailer Brake Controller
 Model Years 2019 - 2021
 Affected Models Chevrolet MD Silverado
 Affected (4500/5500/6500) w/o RPO JL1 or UY7
 Origination Date August 26, 2019
 Revision Date August 3, 2023

ADVISORY:

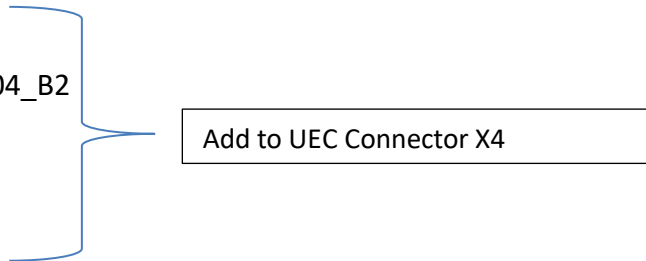
- 2109 is Park Lamps from X104_A3
- 1624 is the Trailer Backup Lamp from X104_B2
- 318 is the Stop/Turn LT from X104_G3
- 319 is the Stop/Turn RT from X104_H3
- 1242 Trailer Battery+ from X104_H6
- 22 Trailer Ground - can get from frame

47 Electric Brake (Output from BK controller X138_32 (40-way connector APTIV# 13608632)

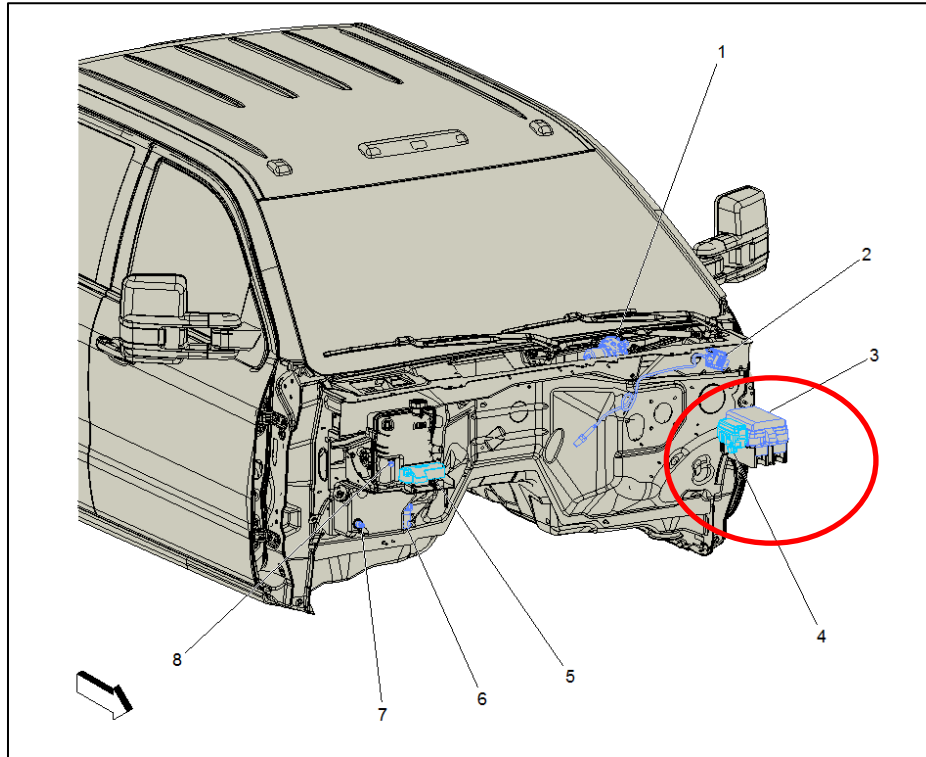
Figure 1

The bulk of the circuits that need to be added are in Connector X4 of the Underhood Electrical Center (UEC - X50A) (see item 3 - figure 1)

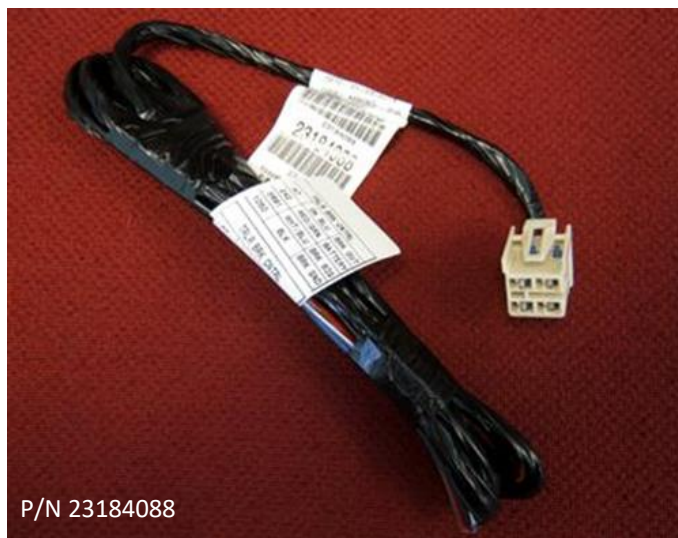
Once the chassis wiring has been completely retrofitted the after-market brake controller can installed and can utilize the provisioned connector cavity in the IP (X61) junction with harness P/N 23184088 as shown below
