UI Bulletin #186

Subject: Fluid Leak in the Center of Vehicle on Drivers Side, Tapping/Knocking Noise on Turns
Models Years Affected: 2018 - 2019
Models Affected: Chevrolet Express, GMC Savana Cut-away models
Origination Date: April 8, 2022
Revision Date: N/A

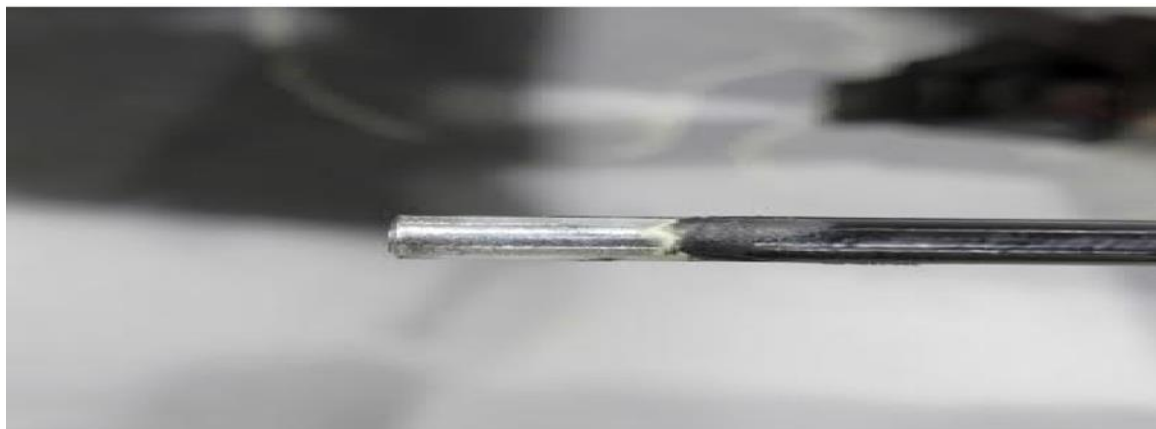
4. Using a pipe bender or equivalent, bend the tubing so that it matches the old tubing.

- If necessary, remove some of the protective coating before installing the pipe nut.
