General Motors Upfitter Integration

UI Bulletin #115f

Subject: Upfitter Circuit Provisions

Models
Affected:Chevrolet Silverado
GMC SierraModel Years:2014 and BeyondDate:March 20, 2014Revision
Date:January 12, 2018

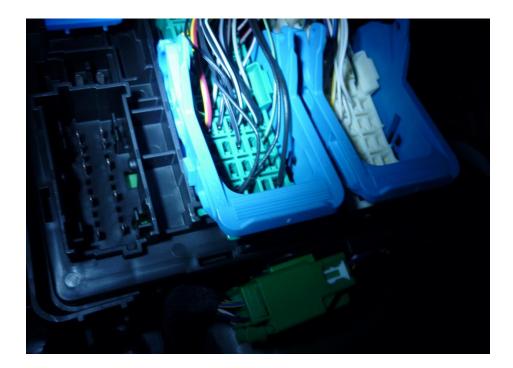
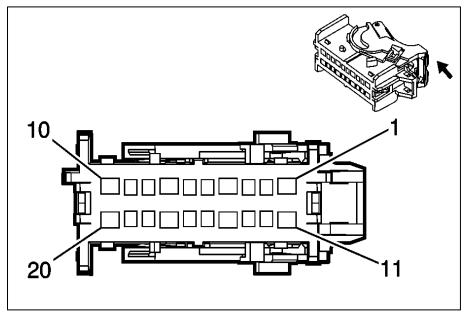
Commonly utilized circuits are available for use in the ICEM (formally referred to as the Mid-BEC or MBEC) which is located in the LH foot well, near or below the parking brake mechanism (see figure 1)

Refer to connector pin-out table for connector and terminal part number information (next page).
