## UI Bulletin #152p

Subject: Adding or Installing a Rearview Camera

Models Years 2019 - beyond

Chevrolet Silverado/GMC Sierra Full-Size Pickups Models and Chassis Cabs with Box Delete (ZW9) or Box Affected:

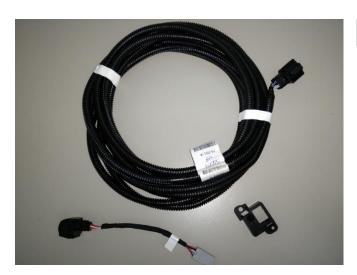
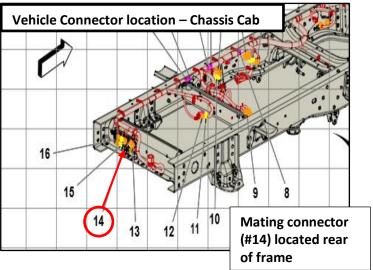
NOTICE: Do NOT modify the camera enclosure in any way or form...this could damage the sealing integrity of the camera and result in damage to the internal components
