Subject	Installation of Upfitter (AUX) Switches (9L7) components
Model Years Affected	2022i -2024
Models	Chevrolet Silverado
Affected	GMC Sierra Refer to the UI Bulletin Usage table below
Origination Date	August 1, 2023
Revision Date	August 4, 2023
۸г

Bulletin #193b

Condition/Concern:

Beginning with the 2022i the Full-Size Pickup Trucks, the Upfitter (AUX) Switch option (9L7) will require, depending on model, some or all components will need to be installed to make the feature fully functional. The installation instructions vary by vehicle trim levels and those instructions are broken down by trim option codes.

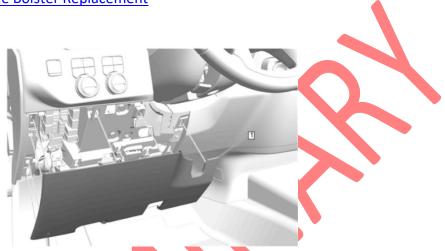
Instrument Panel Knee Bolster Replacement

For these vehicle installations the first step is to remove the knee bolster trim panel using the combined service information procedures outlined in the link below, do NOT install the new knee bolster until after performing the steps below.

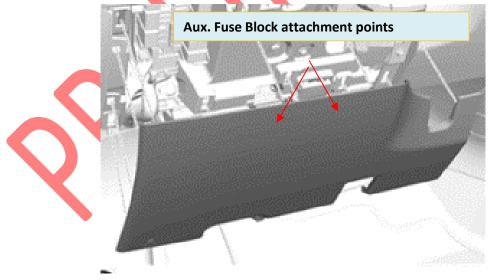
While the knee bolster is removed, the Instrument Panel Auxiliary Fuse Block should be mounted, the connector for the switch bank assembly routed and secured, the gray connector to the IP harness connected, the power cable from the battery ran and secured (not yet connected to the battery) and lastly the fuse kit installed in the Battery Fuse Block. The installation of these components is outline in the steps/sections below.

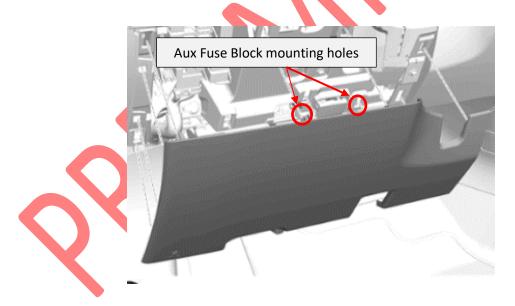
- 3. Using the listed fasteners, install the Aux Electrical Center using the mounting holes locations shown in the figure above.
- 4. Install switches (if not already installed from the factory) in the lower trim panel extension (using new trim panel if adding the 9L7 option) as shown in the figures below

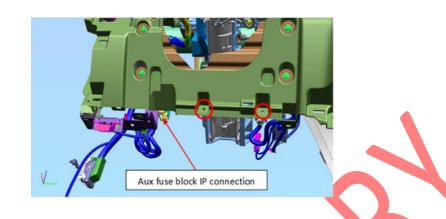
- 5. Connect 16-cavity connector from Aux Electrical Center to switch assembly
- 6. (re) Install the lower trim panel with switches.
- 7. Connect the 14-cavity connector from the Aux Electrical Center to the provisional connector (X213) located under the IP left of the steering column (figure below)
- 8. Install the provided connector body onto the power wire harness routed earlier from under-hood into the passenger compartment and connect to the Aux Electrical Center mating connector.
- 9. Reinstall the Knee Bolster trim panel Instrument Panel Knee Bolster Replacement Non 1WT or 1CX trims
