Subject Installation of Upfitter (AUX) Switches
(9L7) components

Model Years Affected 2022i -2024

Models Affected Chevrolet Silverado
GMC Sierra

Origination Date August 1, 2023

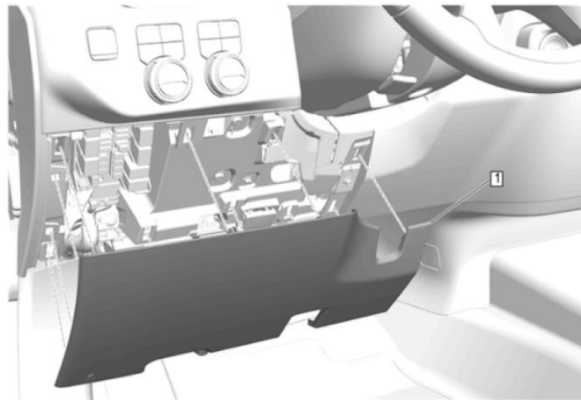
For these vehicle installations the first step is to remove the knee bolster trim panel using the combined service information procedures outlined in the link below, do NOT install the new knee bolster until after performing the steps below.

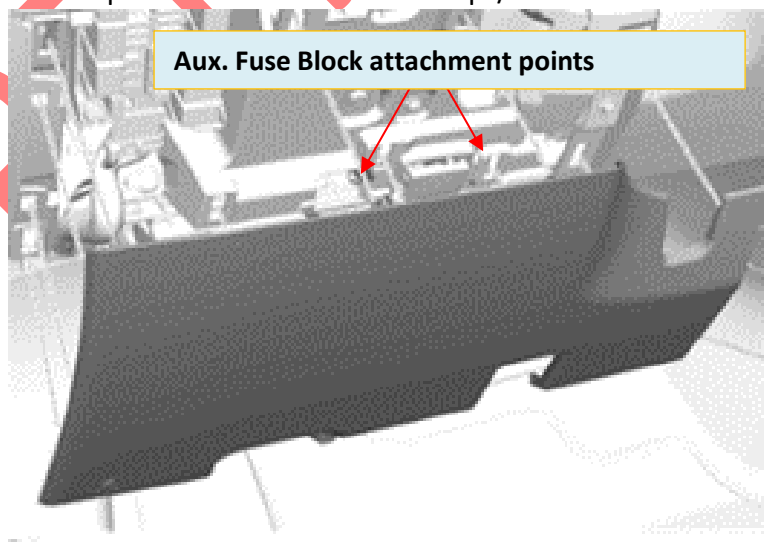
While the knee bolster is removed, the Instrument Panel Auxiliary Fuse Block should be mounted, the connector for the switch bank assembly routed and secured, the gray connector to the IP harness connected, the power cable from the battery ran and secured (not yet connected to the battery) and lastly the fuse kit installed in the Battery Fuse Block. The installation of these components is outline in the steps/sections below.

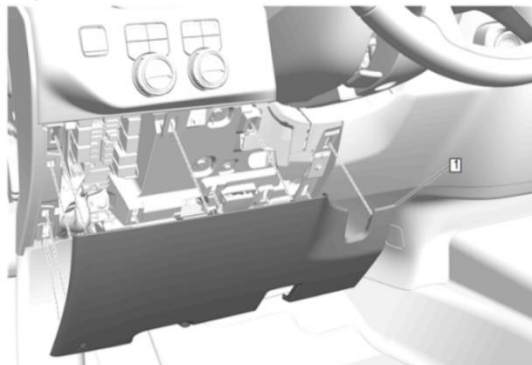
1. Remove the Knee Bolster trim panel using the procedure in the link below

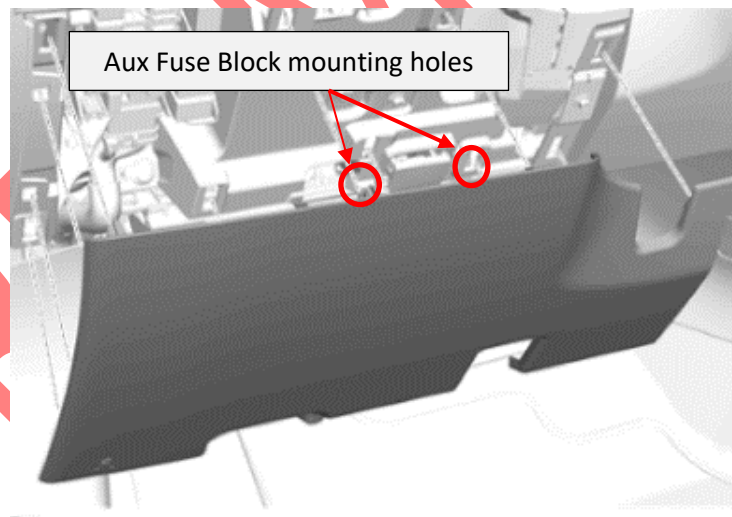
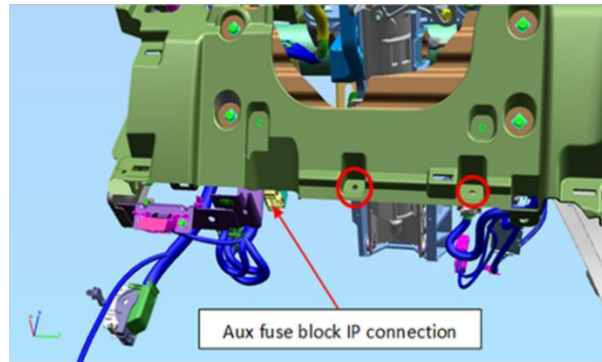
3. Using the listed fasteners, install the Aux Electrical Center using the mounting holes locations shown in the figure above.
4. Install switches (if not already installed from the factory) in the lower trim panel extension (using new trim panel if adding the 9L7 option) as shown in the figures below

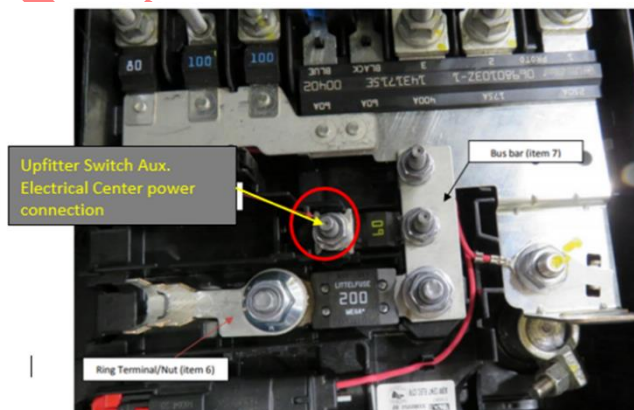
1. Once all “kit” components have been installed, the Aux Fuse Block can now be powered, for detailed instructions on adding the fuses to the battery mounted electrical center refer to the latest revision of UI Bulletin #147. (<http://www.gmupfitter.com/pages/technical-bulletins>)
2. Following the installation of the fuse kit to the battery mounted electrical center, connect the power cable ring terminal to the 60-amp fuse output side stud.
